IMCA Safety Flash 26/19

November 2019

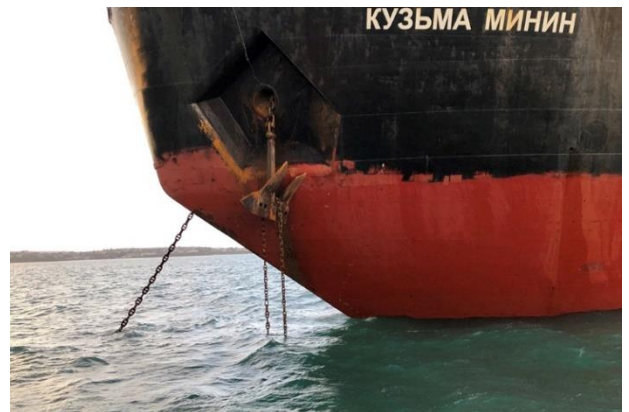
Kuzma Minin ran aground after dragging its anchor and was successfully refloated on the next high water. Damage included shell plate deformation and breached tanks. The vessel dragged its anchor in strong winds. Although the movement towards the shore was quickly detected by the bridge watchkeeper, the actions taken to proceed to sea were interrupted by the anchor becoming fouled by a discarded length of anchor chain. As focus was turned to clearing the anchor, *Kuzma Minin* was blown towards the shore at a speed of over 2 knots.

Vessels should be adequately resourced to operate safely and in accordance with international conventions, taking into account the potential consequences of vessels having insufficient fuel and oils, and the statutory requirement to maintain P&I insurance.

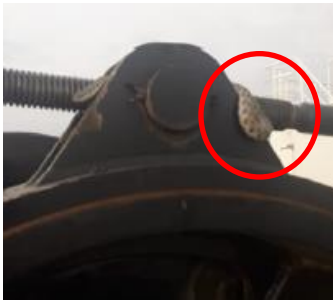
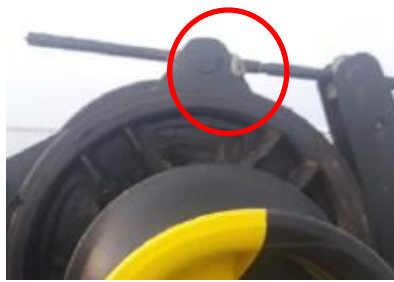
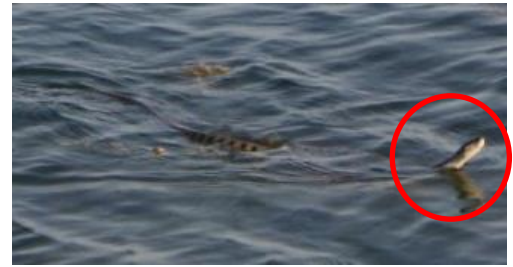
During a safety walk round, it was observed that a snake was on top of the anchor winch while vessel was at anchor near a port.

Summer is the season where personnel can come into contact with snakes due to warm weather. In ports in some parts of the world, it is a common occurrence for snakes to climb up chains and ropes.

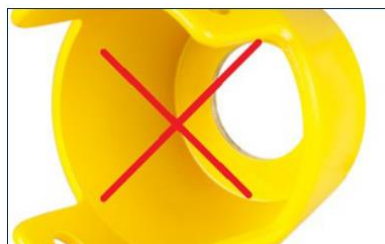
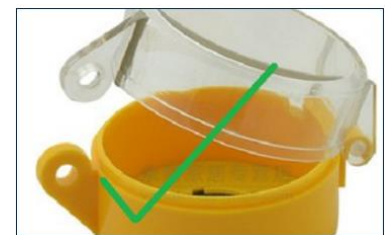
During DP operations a vessel lost its Port azimuth thruster. The vessel suspended DP operations and safely pulled out of the 500m zone to allow investigation. It was discovered that a crew member, while passing near to the port azimuth thruster control panel in the engine control room, inadvertently hit the emergency stop button with his elbow, resulting in a stoppage of the thruster.

- ◆ Lack of situational awareness;
- ◆ There was a guard in place protecting the emergency stop switch, but it was not effective.

- ◆ All similar emergency stop buttons are to be identified throughout all vessels and replaced.
