IMCA Safety Flash 27/17

October 2017

Summary

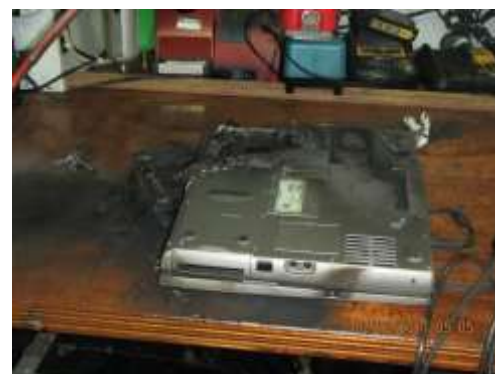
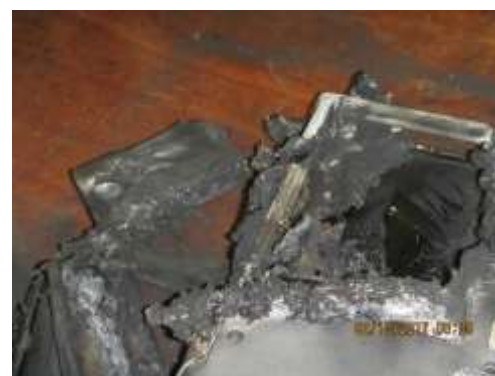
A laptop battery exploded and caught fire. The incident happened in a workshop setting. The laptop was being used to control certain operations, which had been recently completed. The laptop itself was switched off at the time but was on charge at the mains.

The laptop was on a wooden topped work bench. A loud bang was heard from the laptop, after which it caught fire. Crew were nearby and immediately extinguished the fire by using the adjacent 3kg CO₂ extinguisher. Owing to the quick reaction in extinguishing the fire, the vessel's General Alarm was not activated.

The cause of the fire was the overheating and subsequent partial explosion of the laptop lithium-ion battery.

- ◆ Address the issue of potential faulty laptop batteries – full asset review to establish whether desktops and laptops need replacing;
- ◆ Ensure all laptops are tested and inspected as required by PAT;
- ◆ Consider whether or not laptops should be left unattended whilst plugged in.

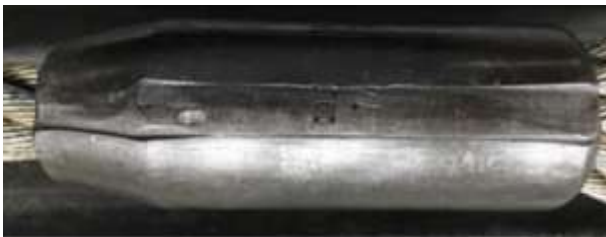
Correctly pressed 20mm steel ferrule

Steel wire ropes should be checked for the correct crimping of the ferrule. Care should be taken to ensure that the ferrule shape is correct and the condition is good. In the case of 20mm steel ferrules, the 20mm steel ferrule when pressed should have been round and not hexagonal. Any 20mm steel wire ropes not meeting that criterion should be removed from service.

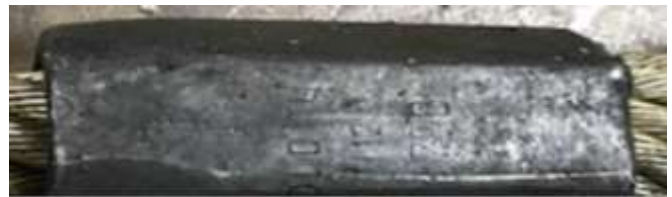
The 20mm steel wire rope was pulled out of its Flemish eye termination due to a failure of the ferrule. The Marine Safety Forum (MSF) member reporting the incident considered that the incident had the potential to have been a fatality or to have caused multiple major injuries.

Incorrectly pressed 20mm steel ferrule

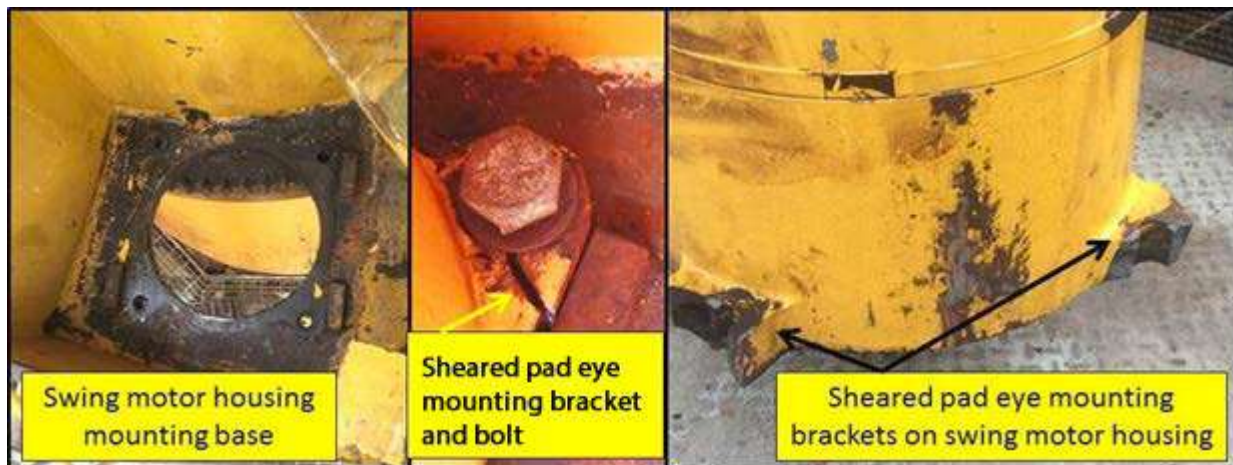
Investigation determined that the crane's hydraulic swing gear motor (slew drive system) had failed, which made it impossible to control the lateral movement of the boom. The mounting pad eye brackets that secured the swing gear drive housing to the crane cab base had sheared, allowing the housing to deflect under loading and the swing gears to disengage from each other. The disengaged swing gears prevented any control of swing motion and effectively disabled the crane during the personnel lift. The BSEE investigation concluded the following:

- ◆ The mounting bolts either backed out during operations due to vibration or other operational causes, or the bolts were never fully tightened to torque specification when the crane was installed;
- ◆ The loose bolts allowed the swing gear motor mount to deflect under loading, which put unplanned stresses on the pad eye mounting brackets until the brackets sheared;
- ◆ Inspection of these bolts for any loosening and to insure the proper torque setting is not a normal part of daily pre-use, quarterly, or annual inspection(s) of the crane;
- ◆ Abnormal movement of the swing gear motor under loading, resulting from failure of the securing bolts or mounting brackets, may only be detectable by personnel looking for that specific failure.

- ◆ **Read the full BSEE [Accident Investigation Report Incident Date 27 January 2017](#);**
- ◆ Evaluate the condition of the mounting brackets and the torque values of the bolts securing the swing drive gear housing of cranes;
- ◆ Consider incorporating specific periodic examination (quarterly and/or annual inspections) of the crane swing drives, including pad eye connections and bolts;
- ◆ Review this incident with all personnel and organisations that work with crane operations, including crane personnel, crane contractors, crane manufacturers, riggers, and inspectors.
