IMCA Safety Flash 28/16

October 2016

Focus: Hand Injuries

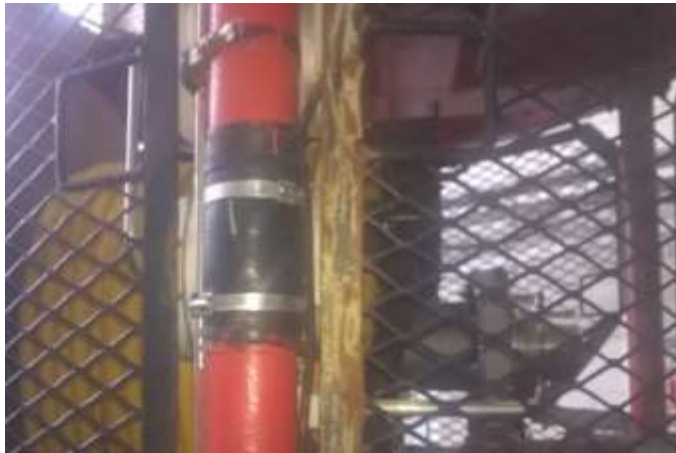
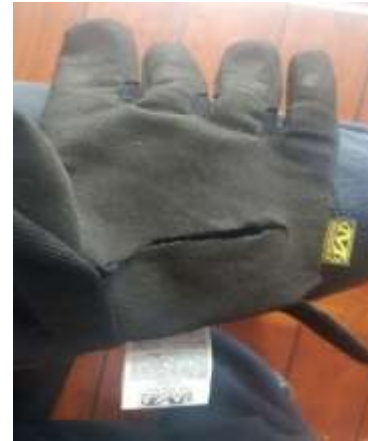
A member has reported an incident in which someone suffered a cut to the hand whilst steadying himself. The incident occurred during a dropped object sweep on the Tether Management System (TMS) in the ROV hangar. The system was split so the TMS was approximately 30 cm off the deck. A crewman stepped down from the TMS but slipped off the outer rim of the TMS. He put his left hand out to control his fall which came in contact with the sharp edge of a cut 'Jubilee' Clip. His glove was sliced through and his left palm had a wound of 2-3cm in length.

- ◆ The Jubilee Clip was immediately removed and the system was checked for any other similar clips in the same cut condition;
- ◆ All ends of the Jubilee Clips were secured – all other ROV and Trenching systems were checked for cut Jubilee Clips which were appropriately dealt with.

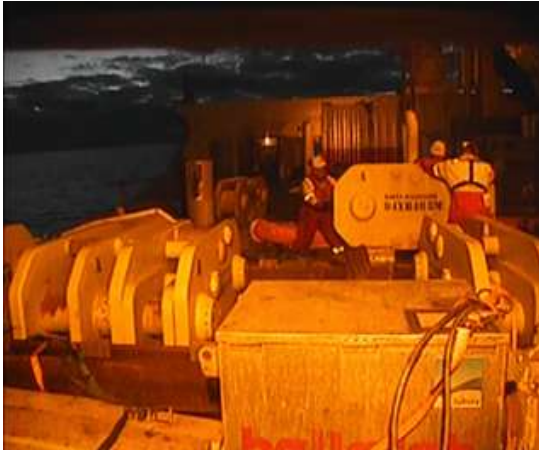
Lowering of H-link into the sled

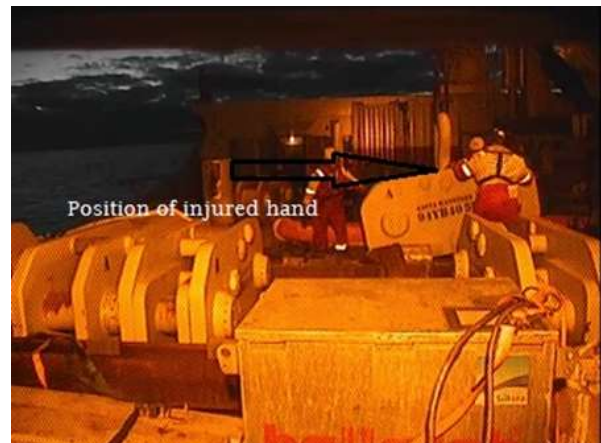
H-link started swinging when being lowered into sled

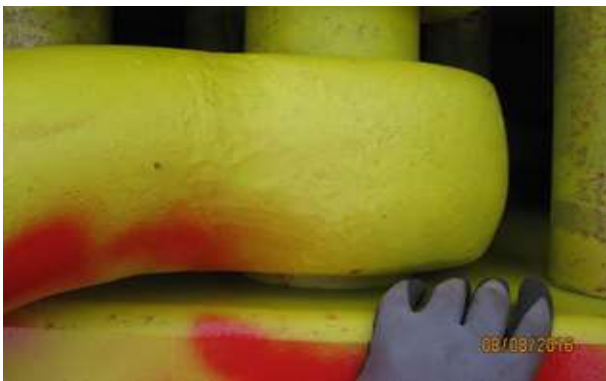
Showing gap between shackle body and H-link

- ◆ **Technical findings:** the design of the H-link sled gave the deck crew little tolerance to handle the load. The design of the H-link and shackle body was such that it allowed a wide enough gap to get a hand inside;

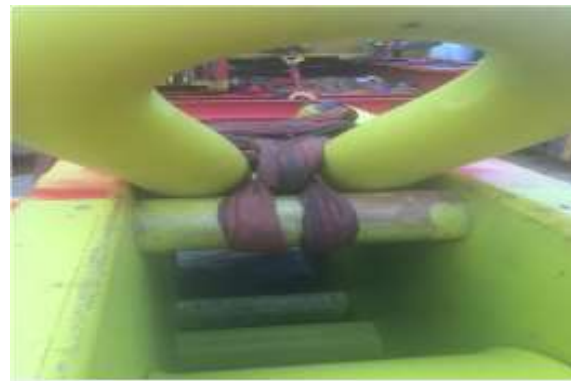
Showing pinch point

- Pinch points were not identified before the start of the operation
 - Design of the H-link sled – tight tolerances;
 - Neither procedures, nor task plans, described the hazard of these pinch points;

- ◆ Inspection of deck area and H-links to identify other hazardous areas and potential pinch points;
- ◆ H-link marked with red paint to highlight potential pinch point areas;
- ◆ Method for lifting and landing of the H-link was reviewed;
- ◆ Updated task plan/made MoC for the operation, and developed a more detailed risk assessment;
- ◆ PPE – evaluate supplying impact resistant work gloves for all deck crew;
- ◆ Evaluate and assess design of H-link and H-link sled.

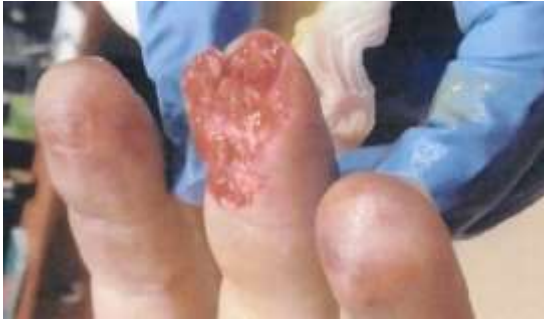
The second engineer used an air-gun to supply low pressure compressed air to the valve, instead of reconnecting the valve to the system air controlling pneumatic valves. During this pre mounting test, the valve did not open properly and got stuck in a half-open position. The engineer tried to move the valve-flap with his fingers. At the same time, he supplied air to the actuator with the air-gun. The valve-flap suddenly closed, and the tip of his left middle finger was cut off by the valve-flap. The engineer was medevacked.

- ◆ The **immediate cause** of the incident was the engineer using his fingers directly on the valve-flap instead of using the correct tools;
- ◆ The job was considered routine by the engine crew;

- ◆ Further review of company's Permit to Work procedures, Lock Out Tag Out System procedures, and Risk Assessment procedures;
- ◆ A renewed focus to be on finger/hand injuries;

- ◆ Further review of risk assessment for work on fuel system and changing of pneumatic valves.

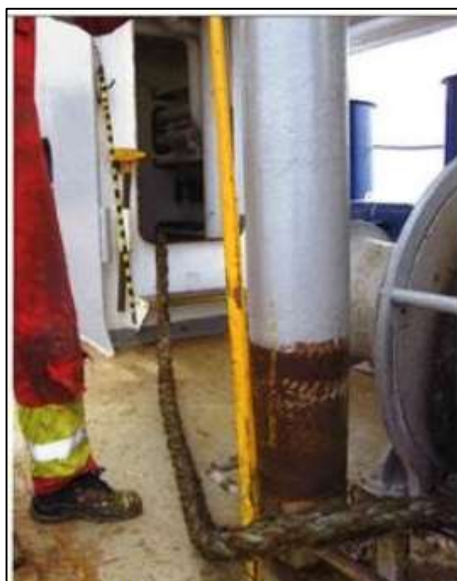
Side view showing spooling direction of mooring line.

- ◆ **Immediate cause**: an unsafe method for spooling line onto the tugger winch;
- ◆ Basic **causal factors** included:
 - poor planning: there was no risk assessment conducted before the job, nor was a toolbox talk meeting held
 - the seaman performing the work was new on board the vessel.

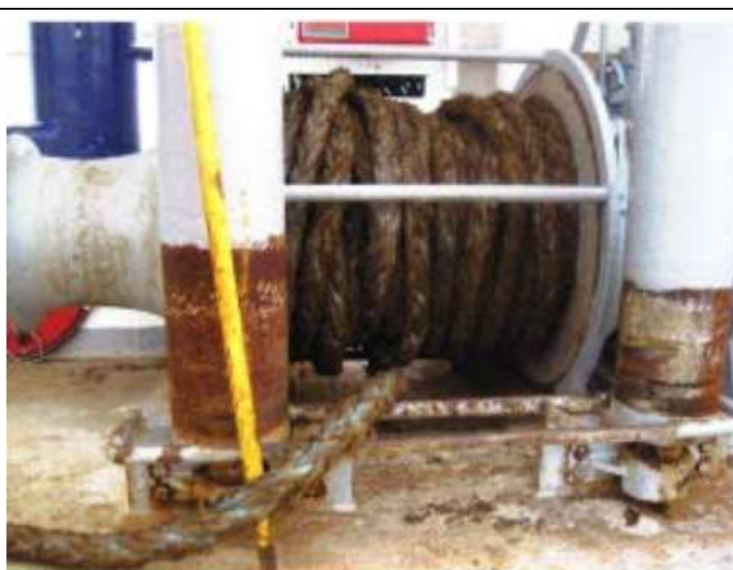
The Marine Safety Forum (MSF) has published safety alert number 16-22 regarding an incident in which a crewman suffered serious injuries to three of his fingers during mooring operations. The incident occurred when the crew of the vessel were preparing mooring lines for arrival in port. An Able Seaman was spooling a mooring line from the starboard locker to the starboard tugger winch aft. During this operation, a crow bar slipped and the seaman was forced against the guide roller. He caught his fingers between the crow bar and roller, leading to injuries to three of his fingers, including loss of one joint of a finger.

Front view showing mooring line travel to the winch and the crow bar position.

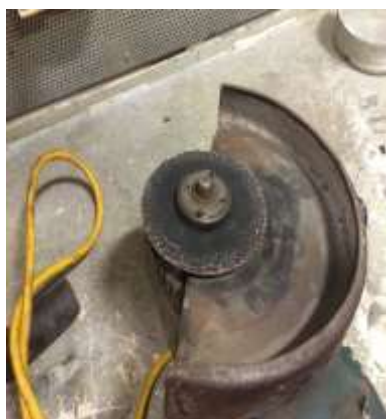
9” Grinder with heavily worn disc attached

- ♦ Grinders and grinding discs should never be used in this manner;
- ♦ Grinding discs should be inspected before use to ensure that they are in acceptable condition and are the correct size, type and rating for the grinder;

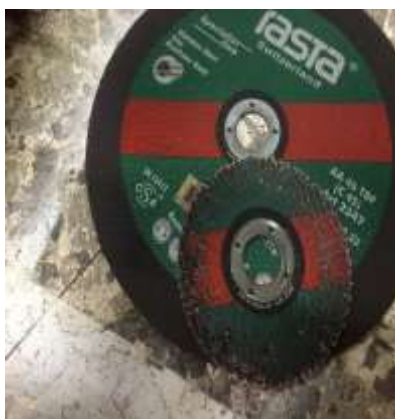
Worn disc and as new disc

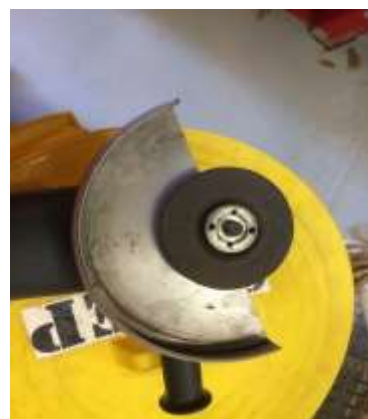
9” Grinder with 5” disc fitted

- ◆ There have been many fatalities caused by incorrect discs being used – many due to the disc shattering at speed;
- ◆ Only trained and competent personnel should use abrasive wheels;
- ◆ **If you aren't sure, ask!!**
