IMCA Safety Flash 29/16

October 2016

Focus: Cargo Handling, Crane Operations, Dropped Objects

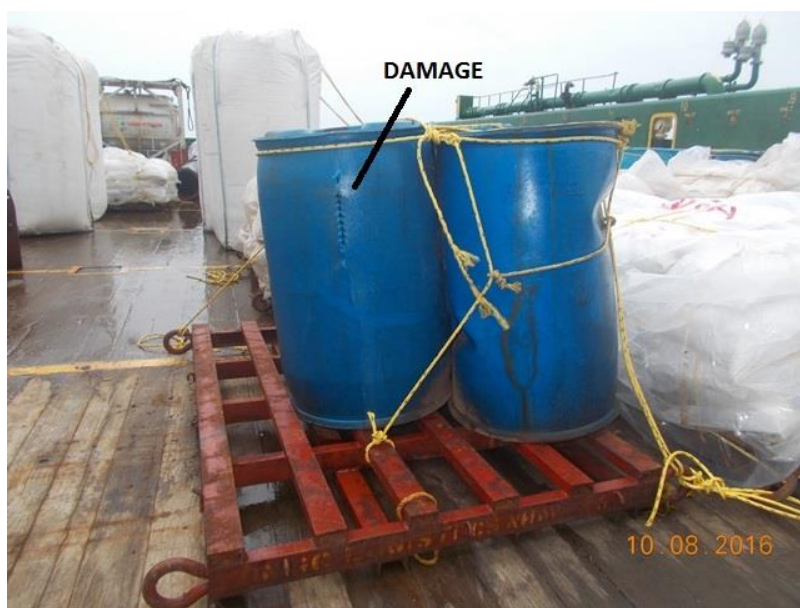
A member has reported an incident in which there was a spillage of acid during lifting operations. The incident occurred during delivery of deck cargo to a jack-up rig. While lifting deck cargo from the supply vessel, the load made contact with one of the plastic drums of acid stowed on the vessel's deck. This resulted in the drum getting damaged and acid leaked from the drum, but the leak was contained on deck and the area was immediately cleaned. No-one was harmed.

Rolling and pitching of the supply vessel allowed the load being lifted to make contact with the cargo on deck.

- ◆ During loading and lifting operations, there should be effective communication and signalling maintained between the rig crane operator and the vessel deck and bridge;
- ◆ Risk assessment should have taken into account the weather and sea conditions, and any necessary additional controls if required should be put in place as necessary;
- ◆ In case the Master feels that the weather is not favourable for safe operations, then operations should be deferred until the weather improves;
- ◆ Consideration should be given to loading hazardous substances such as acid in appropriate drums protected with a cage.

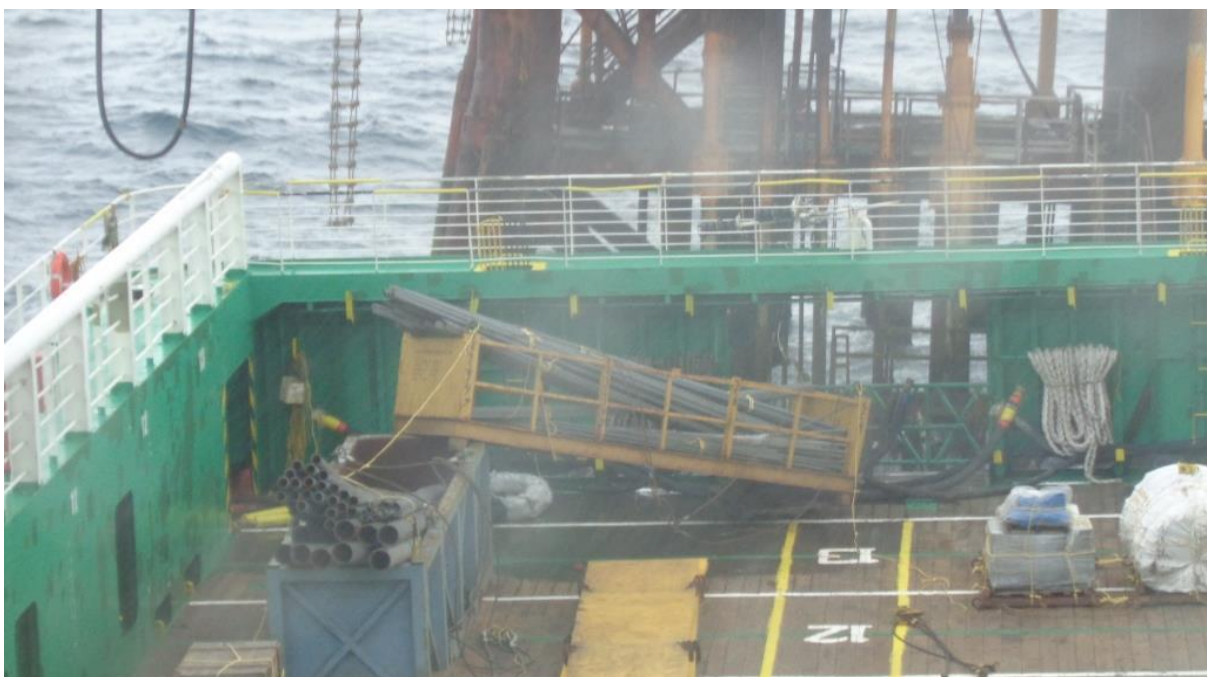
A member has reported an incident in which there was a crane failure during lifting operations. The incident occurred when a platform supply vessel (PSV) was working with a platform crane. The crane lifted the basket (filled with 5m pipes) to crash rail level, but couldn't manage to take it further. The crane got stuck in hoist mode for a moment and later the hook with the tilted basket landed and rested on top of another basket.

The crew, who were holding the tag line, moved swiftly to safety. After unhooking the lift and steadying the tilted basket with wedges, the PSV retreated from the 500m zone. Later the PSV came back in and the platform crane was used to establish the basket properly on deck.

- ◆ There was an equipment malfunction on the platform crane;
- ◆ The Master immediately informed the crane operator to place the basket back on deck and arranged for it to be secured.

- ◆ It is important that the correct load is mentioned on the cargo manifest at the time of loading the cargo at base;
- ◆ The platform crane should be properly maintained and able lift the cargo manifested for it.

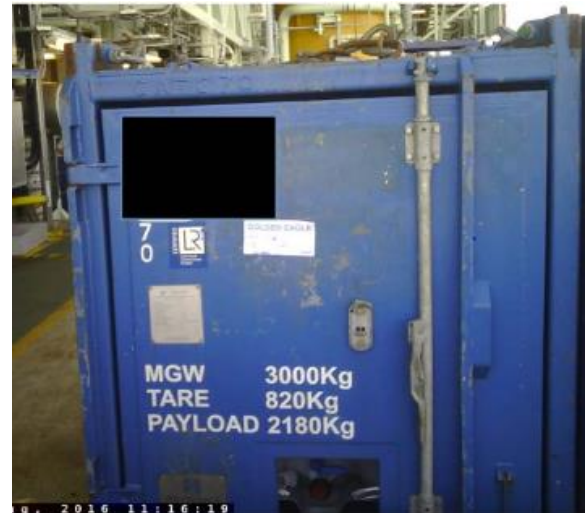
The MSF has published a safety alert regarding an incident in which the door on a cargo carrying unit (CCU) unlatched during lifting operations. The incident occurred when an IBC carrier was being stowed on-board a PSV. As with the rest of the cargo, the door had been closed and secured with a tie-wrap prior to shipment. As the container was being lifted across the installation, it was observed that the door handle had unlatched. On opening the IBC carrier, it was identified that the IBC itself had not been secured within the carrier.

On further investigation, it was determined that the IBC carrier was of inadequate design. There were no securing points within the unit to enable the IBC to be secured and externally there were no buffers to prevent the door handle from being snagged by other cargo. It would have been possible for the IBC to have shifted internally creating sufficient force to open the IBC carrier door, with the result that the IBC may have fallen out during lifting operations from the platform.

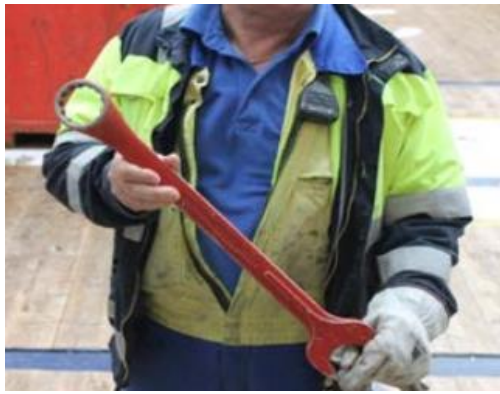
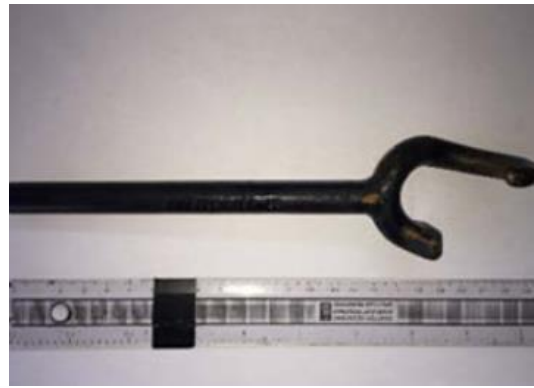
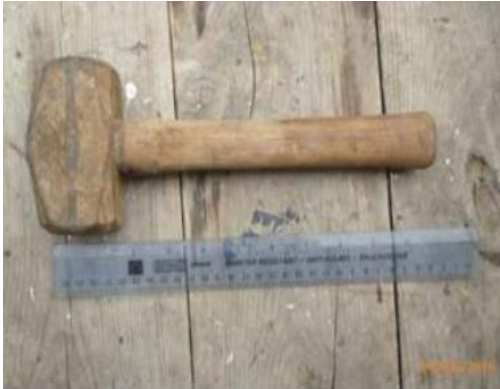
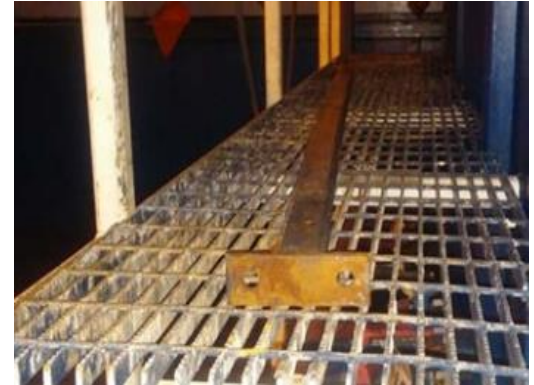
The issue of dropped objects and potential dropped objects remains a persistent problem within the offshore, renewables and marine contracting industries. This vessel owner noted that during the whole of 2015, they had received 19 dropped or potential dropped object incidents. However, by mid-Q3 2016, the same vessel owner had already received a total of 18 reports – and this increase took place in spite of reduced exposure due to the downturn.

Members may wish to look closely at cargo and loading operations and reiterate that there can be no relaxing of vigilance against complacency. The following pictures are all items from back-loaded cargo and all are over the weight necessary to cause a fatal injury if they were to fall and strike a crew member.

- ◆ Continued observance of the highest standard of good seamanship in remaining well clear of lifts in a safe area until the cargo is landed on the deck and it is clear to approach;
- ◆ All dropped or potential dropped objects should be reported as soon as identified;
- ◆ Continued sharing of lessons and engagement with all stakeholders to encourage proper identification of causes of dropped object incidents.
