IMCA Safety Flash 30/16

November 2016

Summary

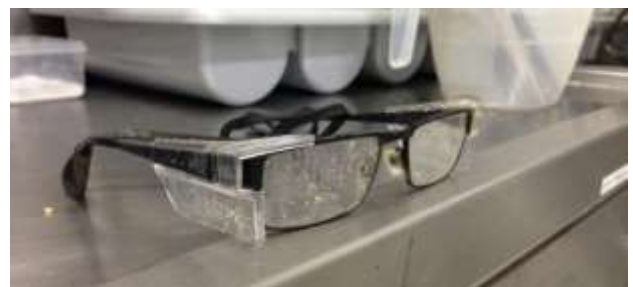
A member has reported an incident in which someone suffered an eye injury following being hit in the face by food taken from a microwave oven. The incident occurred when a crew member reheated pre-cooked poached eggs by covering them in water in a bowl covered with pierced cling film and heating in a microwave oven. The eggs were reheated at two cycles of two minutes at 900W of power and then removed from the oven. Approximately a minute after removal from microwave, the contents of the bowl blew up into the person's face. Despite the wearing of prescription safety glasses (see photo) and the prompt action of an adjacent crew member in applying copious amounts of cold water, a resultant burn to the eye necessitated a medevac for assessment and further treatment onshore.

Fortunately the burns, although painful, healed rapidly and the injured person was able to return to work after two weeks.

- ◆ Although the reheating of pre-cooked poached eggs occurred frequently, there was no standard method or written instructions for doing so;
- ◆ The 'normal' method of immersing the eggs in several changes of hot water was not universally understood;

- ◆ The warnings in the microwave oven instruction book regarding the heating of poached eggs was not heeded (the yolk has to be pierced before heating);

- ◆ There were no warning signs posted on or adjacent to the microwave oven;
- ◆ Familiarisation training for new crew did not include the use of this equipment;

- ◆ There was poor perception of the risks inherent in the use of a microwave oven;
- ◆ There was no recognition of it being 'work equipment'. As a consequence, no importance was attached to a suitable or sufficient risk assessment for the microwave oven or any other pantry equipment, or to risk assessment for associated pantry/mess-room tasks not part of the normal professional operation of the galley.

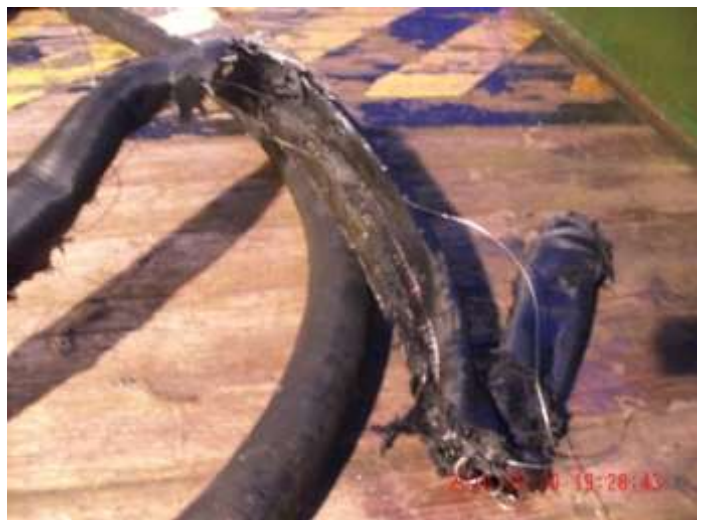
A member has reported an incident in which a hose parted. The incident occurred whilst an anchor handling tug (AHT) was delivering deck cargo and fuel oil to a drill ship. Crew noticed that the hose was fouled below the water line of the AHT. Pumping was immediately stopped and the hose was blown down. The hose was then disconnected from the vessel manifold. An attempt was made using the drill ship crane to pick up the hose but this was unsuccessful. The AHT tried to clear the hose by going closer to the drill ship. Attempts were made to use both the AHT vessel crane and the drill ship crane to free the hose, and while this was happening, the hose parted. No oil leak was observed.

- ◆ **Root Cause:** Floatation collars were missing on the hose;
- ◆ The parted hose could have fouled the ship's propeller resulting in a dangerous situation;

♦ **Lessons Learnt/Preventive Action:**

- the length and condition of the hose should be checked before work starts
- where necessary, floatation collars should be used on hoses
- willingness to **stop the job** needs reiterating.

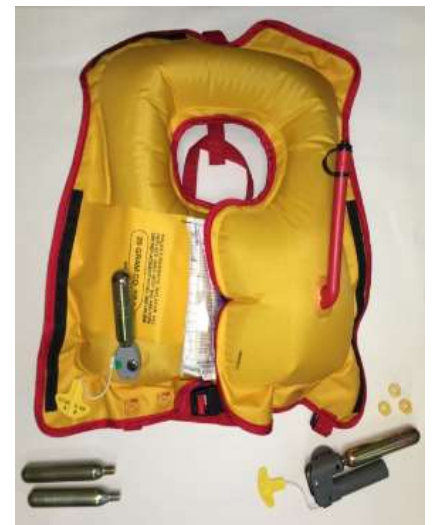
The United States Coast Guard (USCG) has published marine safety alert No. 13/16 regarding the importance of routine maintenance, service, and inspection of inflatable life jackets.

The safety alert reminds all users of inflatable life jacket users of the importance of performing periodic maintenance on their equipment. The USCG notes that fatalities have been documented where inflatable life jackets have failed to inflate properly.
