IMCA Safety Flash 34/16

December 2016

1 Offshore Crane Safety Systems

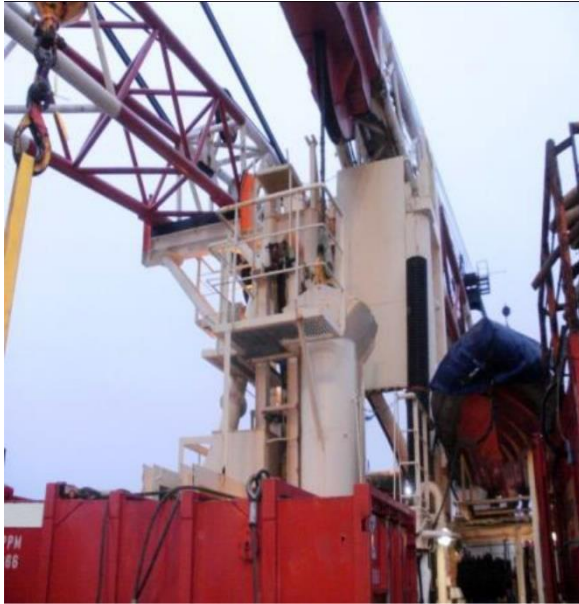
Aft crane

A member has reported an incident in which a section of H-beam steel plate fell from a crane boom rest. The incident occurred during the booming up of the vessel's aft crane. The main hook "headache ball" or hook snagged the adjoining twin fall main block storage structure H Beam (Photo 1). This caused a 50 cm section of storage structure H-beam steel plate to be damaged (Photo 2). The H-beam section, weighing 20 kg, fell 40-50 cm into the main hook bucket which is 2 m in depth (Photo 3). There was a risk potential for the steel plate to have fallen 4.3 m to the vessel deck area below.

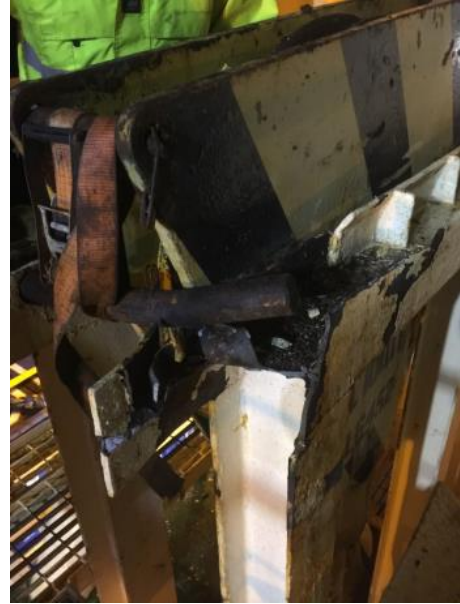
Section of H-beam (post collision with headache ball and hook)

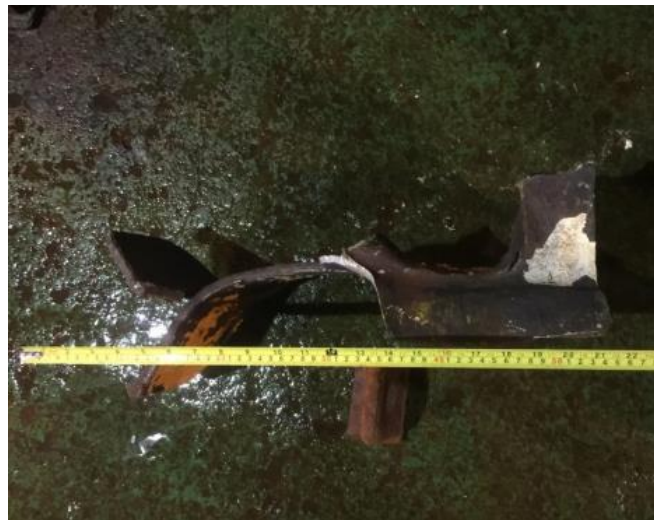
Section of damaged H-beam

- ◆ No Banksman in place for removing the crane from the rest;
- ◆ Ineffective communications between the crane operator and the banksman.

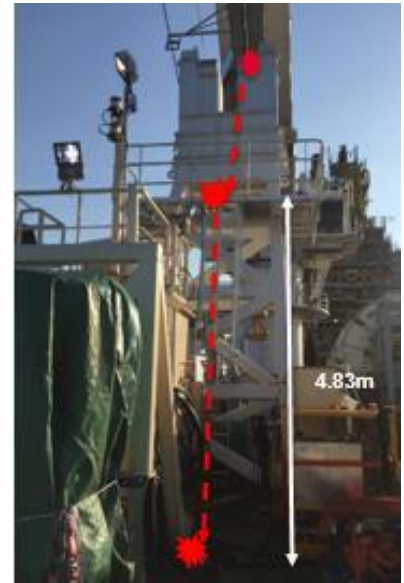
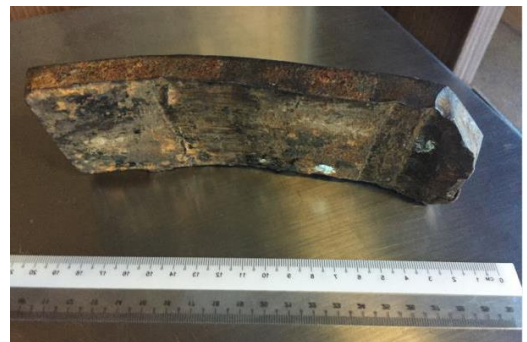
Upon investigation, a steel plate (1.38 kg), later identified as sea-fastening dog plate, had fallen from the crane crutch, struck an access platform and fell a further 4.82m to deck. While there was no-one in the vicinity at the time, according to the Drops Calculator the falling steel plate had the potential to cause a serious injury.

- ◆ Following examination of the crane crutch along with records of recent dropped object inspections of the area, it was concluded that the dog plate had been placed on the crane crutch Teflon pad and the movement of the crane boom as it was raised and lowered out of the crane crutch over a period of time, had 'rocked' the plate aft to the edge of the pad until it fell;

- ◆ The **root causes** of this incident were an inadequate crane boom inspection process and inadequate control or supervision of the yard scaffold crew.

- ◆ Crane boom rests and all items located on the rest should be subjected to regular and robust dropped object inspection through a planned maintenance system;

- ◆ Drops or Crane Boom Rest Inspections should be conducted in a manner where there is clear visual assess to boom pads either by direct access or other acceptable means;

- ◆ Drops inspection report sheets should provide clear instructions and guidance on conducting a robust drops inspection and should be added to Planned Maintenance Work Orders for completion;

- ◆ Supervisors controlling maintenance or refurbishment works of 3rd party contractors should be satisfied that the worksite is safe and in good order upon completion of all works.

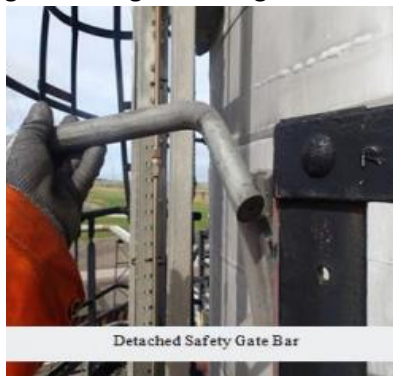
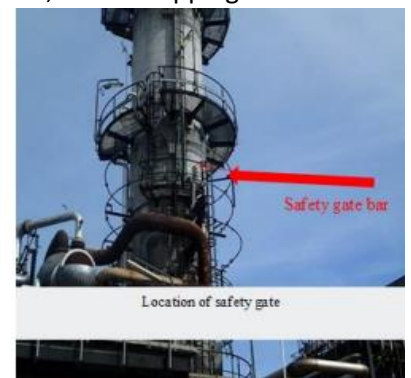
Step Change in Safety has published the following safety alert regarding a near miss incident in which there was a potentially very serious failure of a safety gate at height. During a routine inspection, whilst stepping from a ladder onto a gantry, the crewman performing the inspection discovered that the safety gate bar was adrift from its hinge bracket. The crewman narrowly avoided a fall. He replaced the gate bar and immediately reported the event. There were no injuries.

Investigation revealed that a retaining plate and bolt were missing due to the bolt working its way loose. The bar was repaired immediately. Ongoing checks of all such safety gates took place to ensure they are functioning correctly and safely. In the long term, a review was arranged of the maintenance strategy of the safety gates.
