IMCA Safety Flash 16/20

May 2020

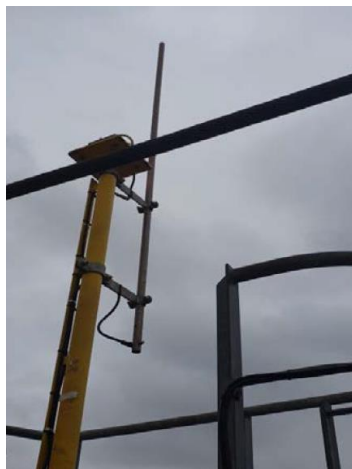
A lightning conductor mounted on top of a service crane came free from its mounting and dropped 75 meters. The conductor fell through the deck carousel hatch and landed on the carousel bottom plate. Five crew members were working in the carousel; however, they were not positioned under the open deck hatch area.

- ◆ The mast has been vibrating during high winds causing the lightning conductor to work itself free from the threaded housing;
- ◆ There was no material failure;
- ◆ The lightning conductor was not secured to its housing by any means other than the threaded connection – no secondary securing;
- ◆ The potential for the lightning conductor to become unscrewed was not recognised;
- ◆ The connection is not easily visible during regular drops inspections;

Mast and lightning conductor

- ◆ Consider the potential for a similar incident to occur on your vessels;
- ◆ Perform an inspection of all similar equipment at height and assess the secondary securing arrangements in place.

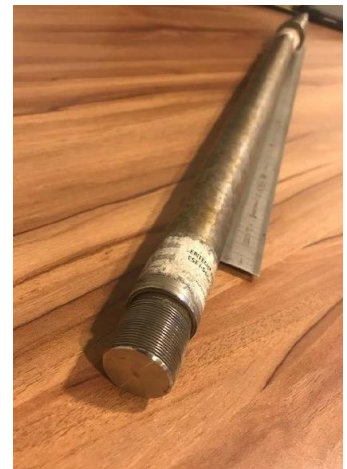
Lightning conductor

- ◆ Equipment was not part of planned maintenance system.
