IMCA Safety Flash 17/20

June 2020

1 Inadvertent activation of condensed aerosol fire extinguishing system leads to a fatality

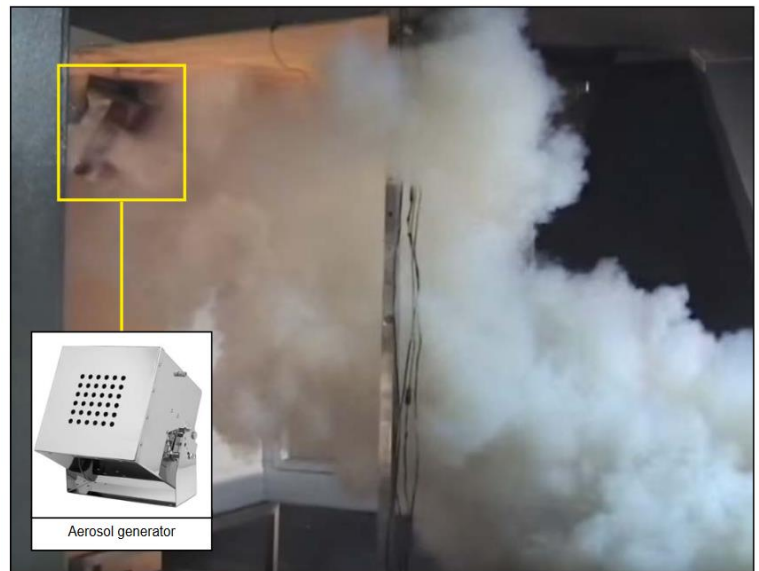
Figure 1: Typical discharge of a condensed aerosol fire suppressant (not at time of accident)
