IMCA Safety Flash 19/20

June 2020

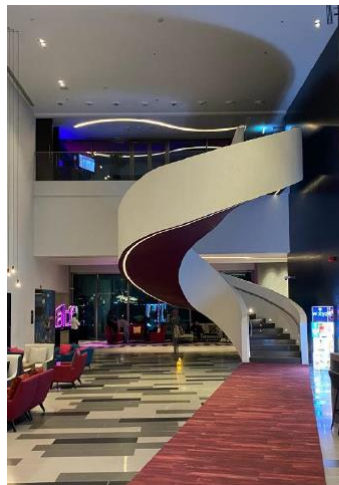
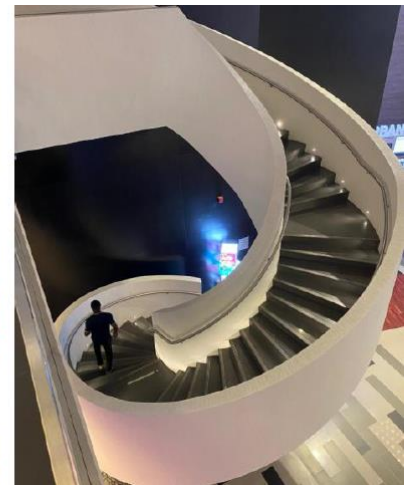
Whilst engaged in business travel, an employee of one of our members slipped and fell when descending a hotel staircase. He sustained multiple fractures and dislocation of the left wrist. He used his left hand to try to 'break' the fall which incurred serious impact injuries. The injured person reported to the company office the following morning before being transferred to hospital where an x-ray confirmed the extent of the injury, which required surgery.

During the interview about the incident it was confirmed that the injured person had been using his mobile phone while going down the stairs and was not holding the staircase handrail.

- ◆ **DON'T use your mobile phone when walking up or down stairs!**
- ◆ Keep your eyes on what you are doing, maintain three points of contact wherever possible when going down the stairs;
- ◆ Always hold the handrail, when ascending or descending stairs;
- ◆ Stay alert to your environmental surroundings and adopt good hazard awareness, even when not in the workplace.

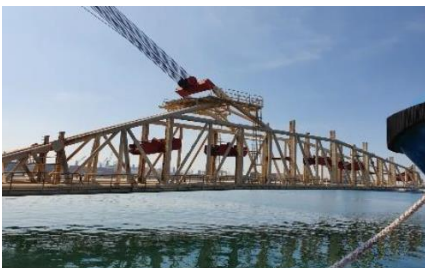
A member of the crew fell overboard through an opening in the stinger. The incident occurred with the vessel alongside in port. A team of three electricians were conducting function checks on a new roller box camera on the stinger. One of the team fell about 2 metres into the water through an opening in the stinger floor grating. The person remained conscious and was able to swim to a lifebuoy that had been pre-deployed as part of the task. He was recovered via the quayside ladder and was given first aid treatment for minor scratches on his neck and ear.

Stinger as seen from the quay

- ◆ Adequate planning and risk assessment before starting work;
- ◆ Appropriate review of work area before start to ensure the specified controls provide safe working conditions;
- ◆ Stop work authority should be re-emphasised as an obligation and responsibility for all;
- ◆ Specific risk of falling overboard should be considered not only for work over the side but also for work near the side.

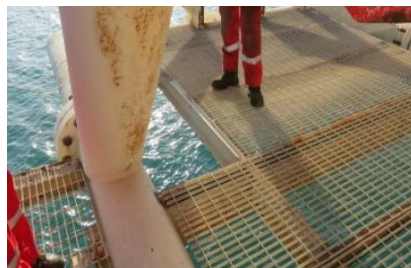
Opening through which person fell

- ♦ A requirement to move the vessel prevented the work on the stinger being completed on the quayside, which would have removed the fall potential;
- ♦ Two weeks before the incident, a management inspection of the stinger had identified damage to handrails and walkway grating including the section from which the fall occurred. Repair was considered low priority because this area was not one that was normally accessed, and remedial work was neither planned nor immediately actioned;

- ♦ The work team involved in the incident observed unsafe conditions, including openings in walkways and missing handrails, *but did not stop the job* to re-assess, or apply any Management of Change procedure.

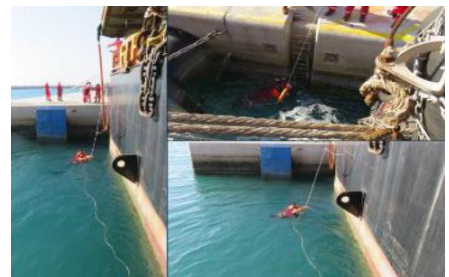
A view of the rescue of the person

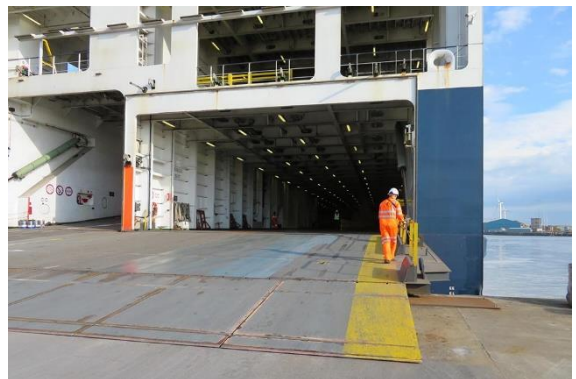
- ◆ The semi-trailer was being pushed ashore by one of the port's tractor units;
- ◆ The third officer was facing down the ramp and talking on his mobile telephone when he was struck;
- ◆ He was unaware of the trailer approaching from behind;
- ◆ The driver of the tractor unit was not expecting any pedestrians to be on the stern ramp and could not see the third officer due to the trailer blocking his view ahead.

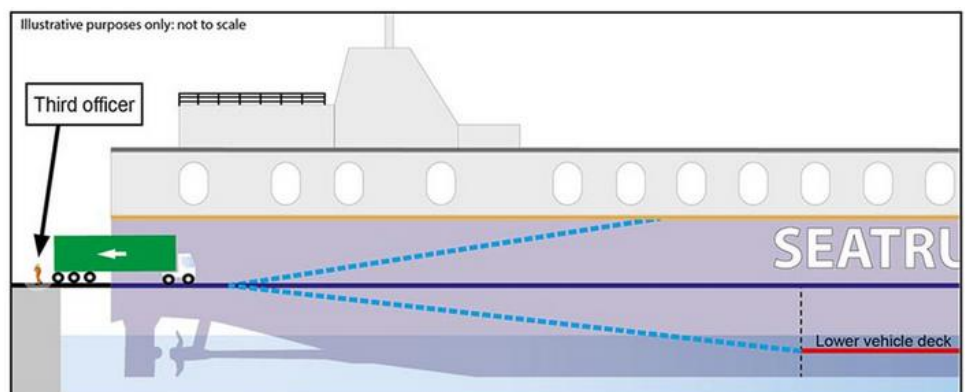
- ◆ This is one of several similar accidents in recent years where both maritime and land-based industry best practice guidance have not been met: there was no physical barrier on the stern ramp to segregate vehicles and pedestrians and there were no controls in place to monitor the stern ramp and stop vehicles when pedestrians needed to walk across it;
- ◆ The use of mobile telephones and other communications media is an increasing source of distraction on working decks and in other hazardous workspaces on board ships, for which formal guidance is currently lacking;
- ◆ This was the second work-related death in 15 months to have occurred on board ferries operated by Seatruck Ferries Ltd and berthed in Liverpool.
