IMCA DP Station Keeping Event Bulletin 01/17

March 2017

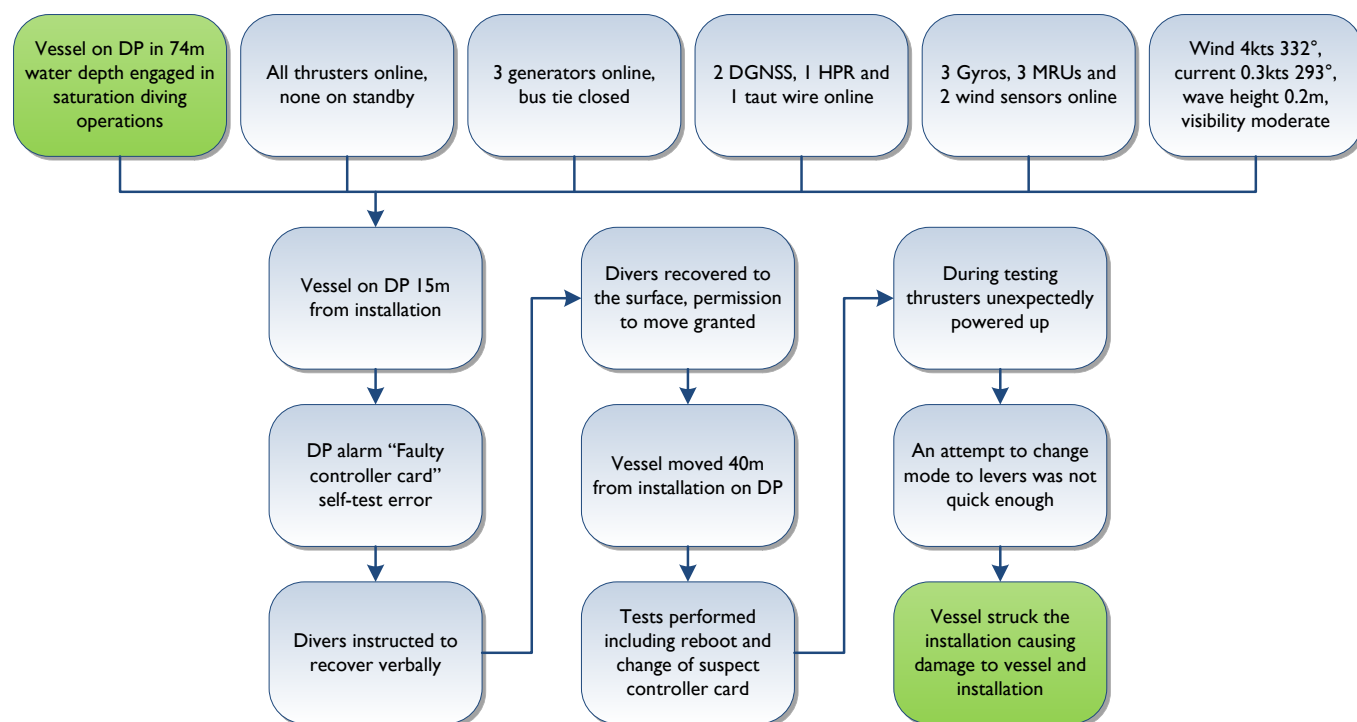
DP Event Investigation and Testing Inside the 500m Zone – DP Incident

The report concluded that the vessel should have proceeded out of the 500m zone to a safe area prior to investigating the fault and conducting tests.

- ◆ There is no doubt that in circumstances such as this, where investigation and testing is required following a DP event, it should be conducted in a safe location and as a minimum outside the 500m zone.
- ◆ The DP system's level of redundancy always needs to be considered during investigation and testing.
- ◆ It is not evident from the report, but it is wondered whether complacency contributed to this bad practice.
- ◆ The original reported DP alarm should have resulted in a DP yellow alert.
- ◆ The vessel might have considered using the independent joystick (IJS) rather than individual levers.
- ◆ Emergency handling of the vessel should be practised on a regular basis.

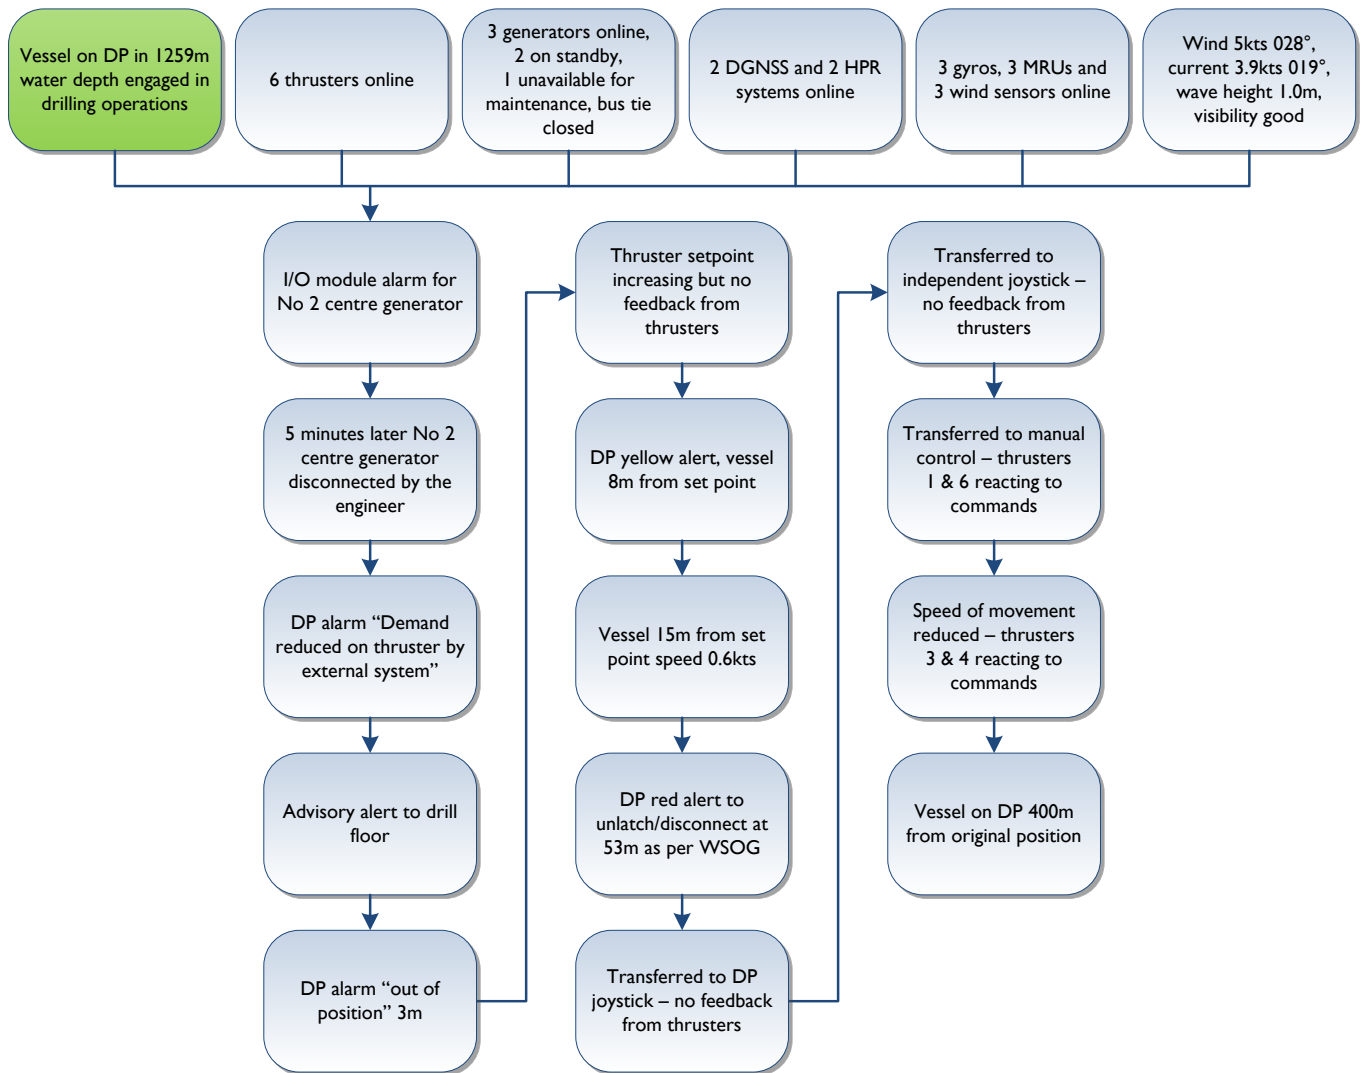
Load Sharing Imbalance Causes Loss of Position – DP Incident

The power plant was configured to work in closed bus mode. No 2 port, No 2 centre and No 2 starboard generator were online. No 1 port and No 1 centre generator were on standby. No 1 starboard generator was on long term isolation due to turbocharger overhaul.

The vessel's power management system (PMS) developed a fault in an I/O module for No 2 centre generator. This fault caused the generator circuit breaker status to freeze in the 'closed' position. The alarm indicated a generator fault causing the engineer to disconnect the faulty generator. The breaker opened on the generator and due to the fault on the I/O module the status of the breaker was still showing connected and a load sharing imbalance was noticed by the PMS which attempted to correct it. As the disconnected generator could not take any load, the imbalance persisted and the PMS drove the bus frequency down to the point where it triggered the frequency based thrust limitation function on all thrusters leading to loss of position and an emergency disconnect.

- ◆ It is recommended that the failure modes and effects analysis (FMEA) should consider the PMS interface so that this type of failure mode is identified.
- ◆ It would appear the PMS was not properly tested for operations in closed bus tie operations.

- ◆ The fact that frequency issues occurred suggests advance generator protection was either not present or not functioning correctly.
- ◆ The vessel's DP operations manual and well specific operating guidelines (WSOG) must be questioned.
- ◆ The value of the current factor (3.9kts) should be questioned.
- ◆ It should be noted that when thrusters are operated via the IJS they are still under the control of the PMS.

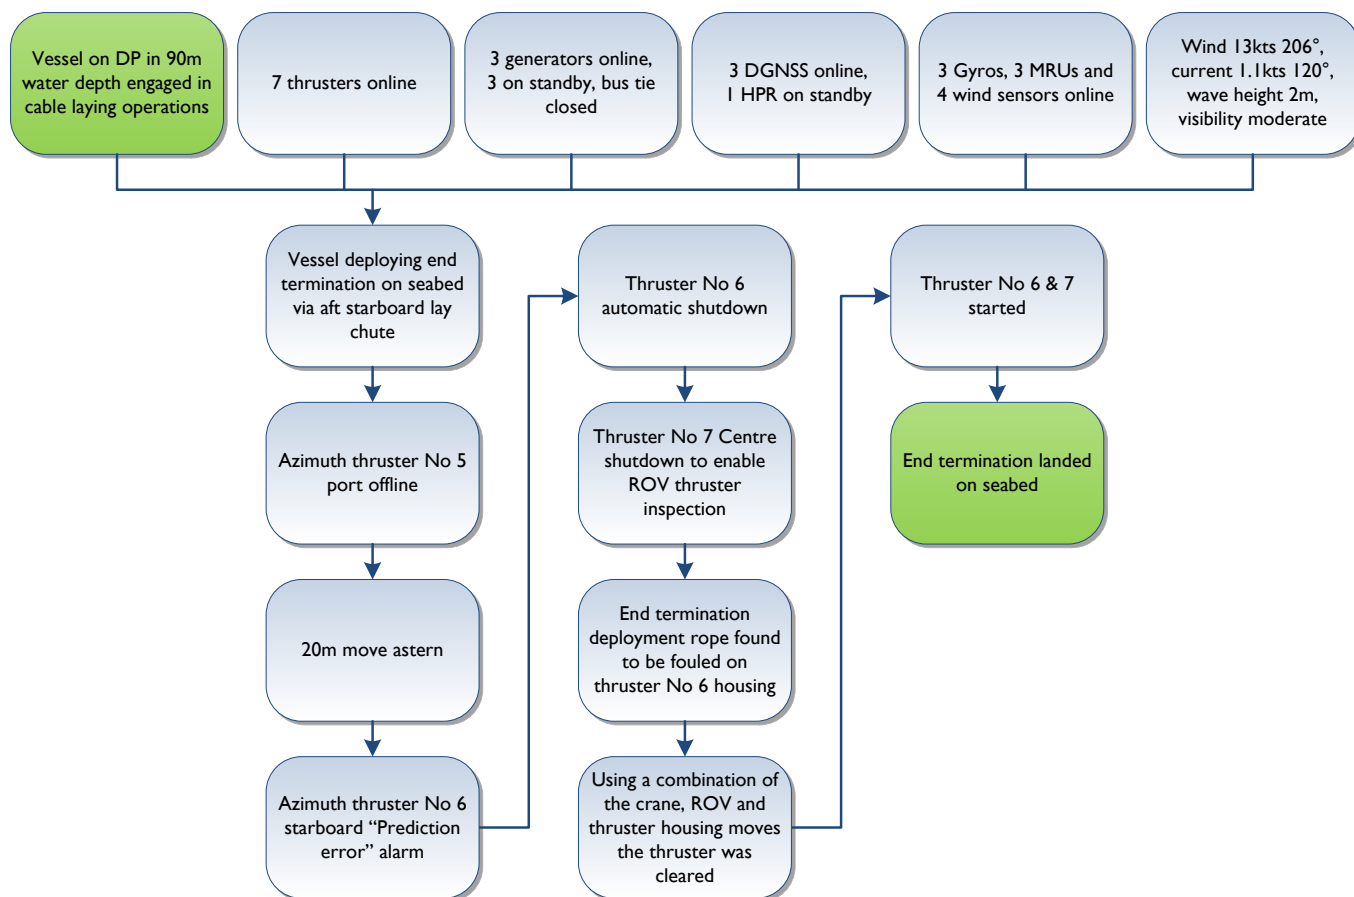
Inadequate Communication and Planning Causes Fouled Thruster – DP Undesired Event

During the over boarding of the end termination through the starboard aft chute, the cable laying shift supervisor asked the bridge to isolate thruster No 5 (port quarter) instead of thruster No 6 (starboard quarter). He did not realise he was isolating the opposite thruster and consequently the thruster closest to the lay chute was still running. Moreover, he asked the bridge to move backwards and in the same direction where the end termination was being laid down. This movement contributed to the end termination deployment rope fouling thruster No 6.

- ◆ There was either a lack of operational planning or it was inadequate.
- ◆ The event highlights the need for accurate and verified communication between key control centres.
- ◆ With three satellite derived position systems on line and the acoustic system on standby the vessel was not complying with the requirements of IMO Circular 645.

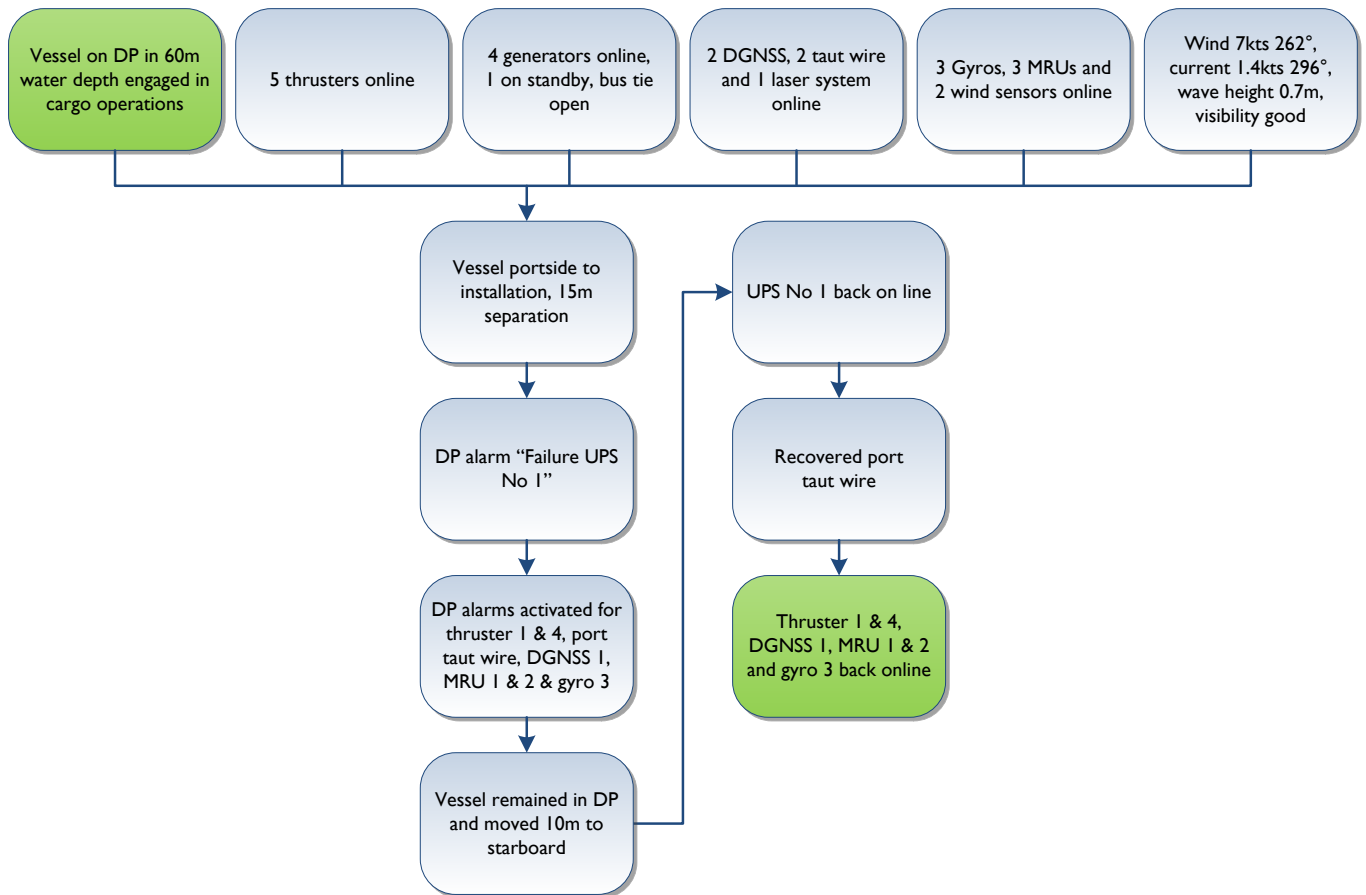
UPS Failure Causes Partial Blackout – DP Undesired Event

One of the fans in UPS No 1 failed causing the UPS to overheat and shut down.

The fan has been replaced and the temperature alarm tested.

- ◆ The failure of UPS No 1 and subsequent failure of the other equipment should have resulted in a DP yellow alert.
- ◆ With redundancy compromised the vessel needed to consider a move further away from the installation and out of the 500m zone.
- ◆ Fans, filters and alarms should be adequately covered at component and sub system level by the vessel planned maintenance system.

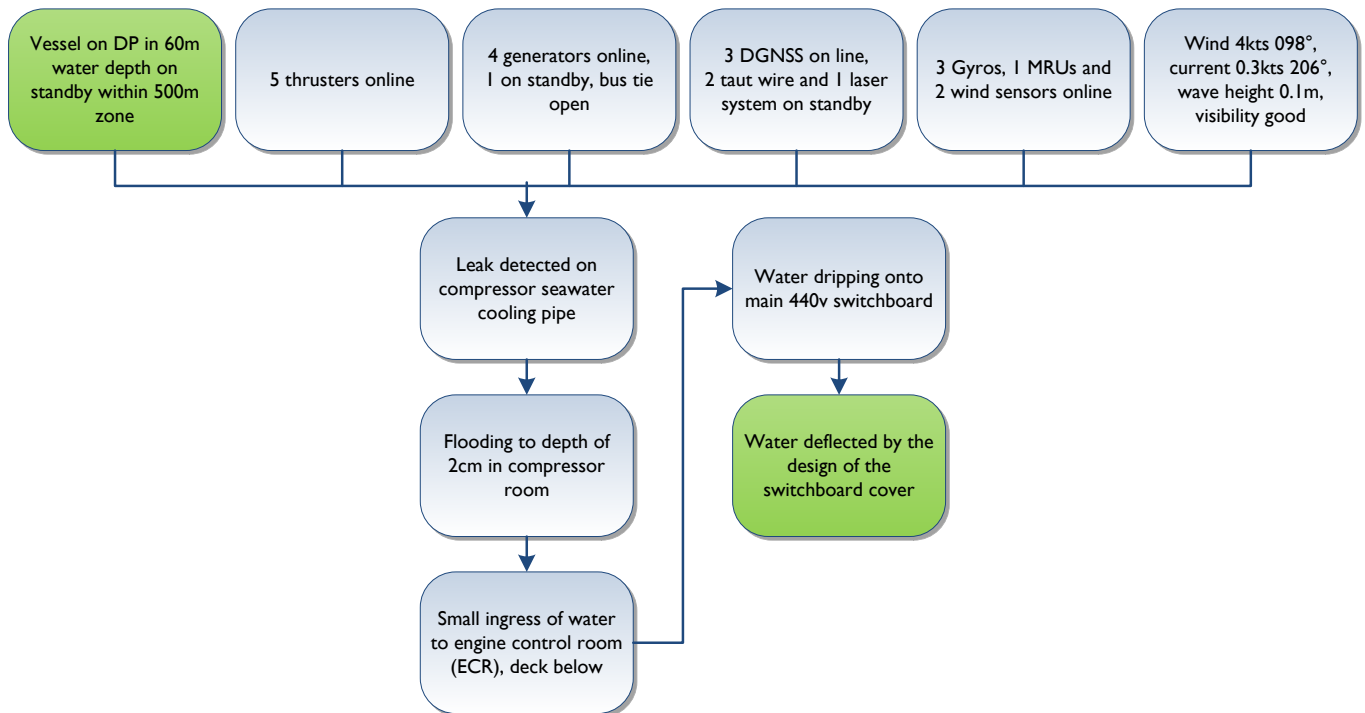
Cooling Pipe Leak Threatens Main Switchboard – DP Observation

A failure of a plug (old decommissioned cooling line for fridge compressors) on seawater cooling pipe for the Ac compressors resulted in flooding in the incinerator room (the water level was about 2cm depth) with small ingress of water in the engine control room on top of main 440V switchboard through a cable penetration.

The small water ingress (water dripping onto switchboard) was deflected by the design of the switchboard cover (class approved design) with a small quantity of water collecting on top. The quantity of water on top of the switchboard was so small that no immediate action was necessary to remove or control it during the incident. The top of the switchboard was dried after the leak was stopped and accumulated water had been removed from the incinerator room above.

Due to the desire to inspect inside the switchboard, with the vessel on standby but inside the .500m zone, the decision was taken to move outside the 500m zone as a precaution.

- ◆ The good practice of moving outside the 500m zone is noted.
- ◆ Decommissioning of pipework by removal rather than plugging is the preferred method.
- ◆ With only one motion reference unit (MRU) on line its failure would affect the stability of all position reference systems selected to the DP system.
- ◆ Submission of DP observations, as learning opportunities, is much appreciated by members of the IMCA DP Focused Workgroup.
