IMCA DP Station Keeping Event Bulletin 01/18

February 2018

Unintentional Selection of Manual Mode – DP Incident

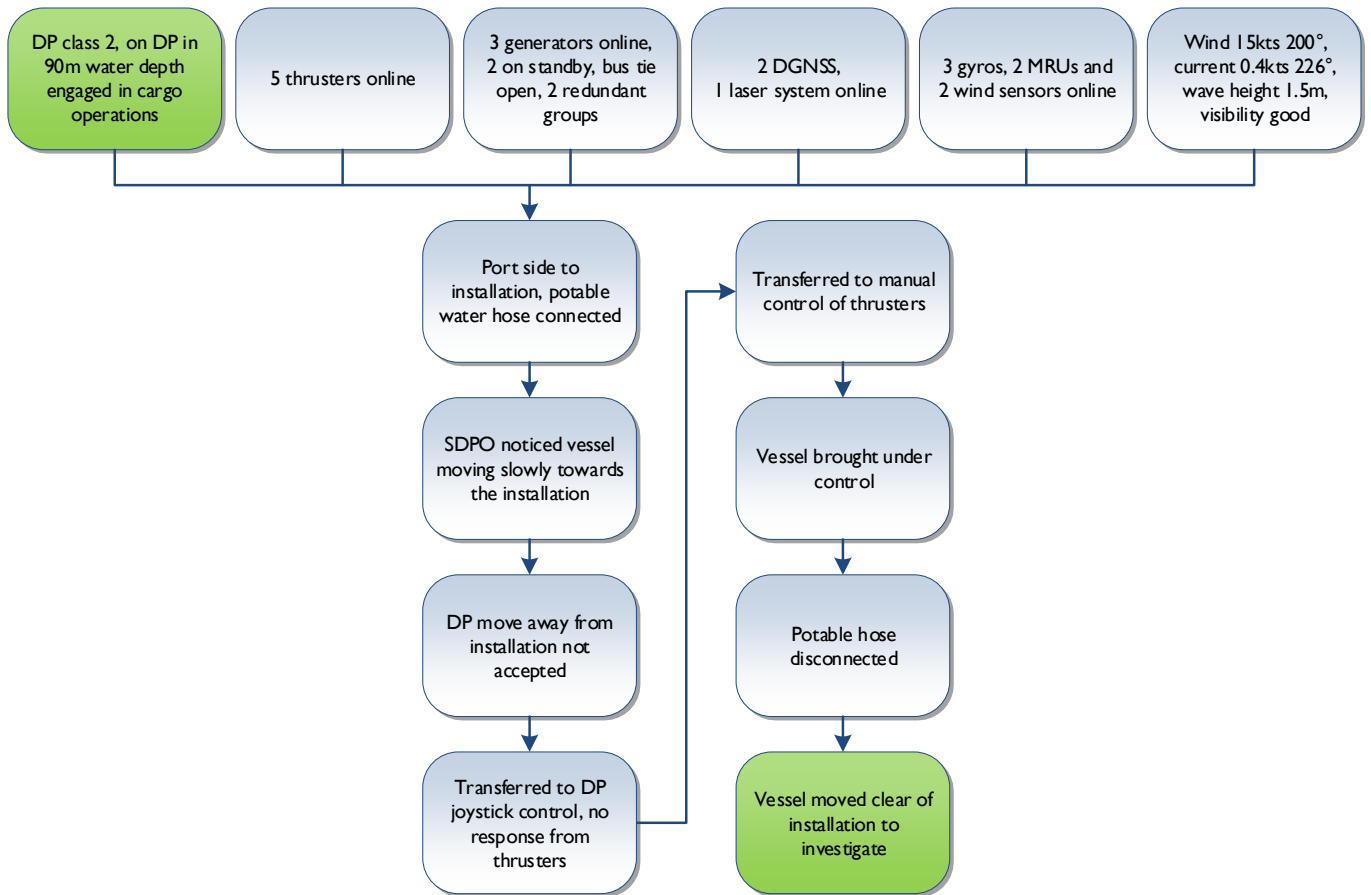
Comments from the report:

- ◆ **Initiating event:** Inadvertent selection of manual mode whilst in full DP mode
- ◆ **Main cause:** Human factor – The vessel mode of operation was changed from automatic DP mode to manual DP mode by a double press of the DP manual position button
- ◆ **Secondary cause:** Computer – No additional barrier (e.g. notification) when manual position selected

The vessel operator reported that there was an upgrade available to warn the DPO of the change of DP control status and therefore provide additional protection against accidental change of DP control status. The report concluded that all company vessels would be upgraded to include this function.

- ◆ It is important that DPO training focuses on good practice, an action should be followed up continuously to verify the intention of the action is reached or being executed
- ◆ This type of event has happened on other DP vessels, it is noted that some vessel operators have fitted a cover or made 'mode of operation' buttons stand out from others
- ◆ The incident highlights the importance of vessel operators risk assessing the operation of the DP control station and taking appropriate action as required
- ◆ Consideration should always be given to using joystick auto heading, which can provide tighter control of the vessel, prior to switching to individual manual control of the thrusters

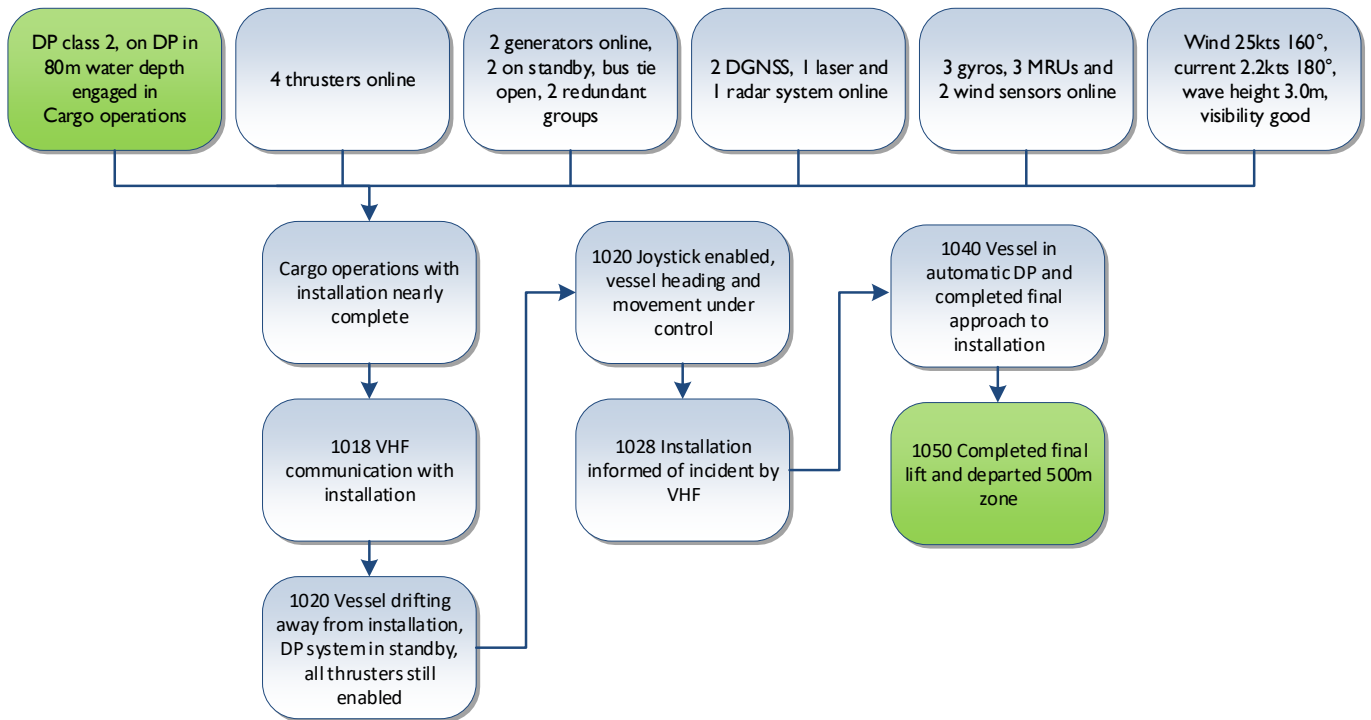
Unintentional Deactivation of the DP System – DP Incident

Comments from the report:

The initiating event was the unintentional activation of the DP standby button whilst in Automatic DP control. The radio used to call the installation control was situated over the DP control panel. In order to put the DP system in 'Standby Mode' it required the operator to Press the 'Standby' button twice. There were no alarms generated during the incident. After leaving the 500m zone attempts were made to re-enact the situation of the VHF radio handset pressing the button but this failed to put the system in standby. Follow Up – Information was sent to the DP system supplier including export files from the operator station. It was proven that the 'Standby' button was activated. The time difference between double taps was so small it was almost 1 single tap, this could explain activation by the VHF handset. To stop this from happening again, a clear flip top button cover will be fitted to both DP operator stations and a procedure initiated that the handset must be placed back in its cradle after each use.

- ◆ It is poor design that makes it necessary to lean over the DP control panel to use the VHF
- ◆ Vessel operators are reminded of the critical nature of DP mode selection buttons and should assess if the DP system is susceptible to unintentional deactivation of any critical mode
- ◆ If so, appropriate action should be taken without delay
- ◆ Recent action that the Committee is aware of is:
 - The fitting of a plastic flip cover to protect mode selection buttons
 - Installation of an additional function that requires the operator to confirm the mode change via a pop up window on the operator station
- ◆ A very short time period was allowed for DP stabilisation following the incident, the system had been switched to standby therefore time was required to build up the mathematical model.

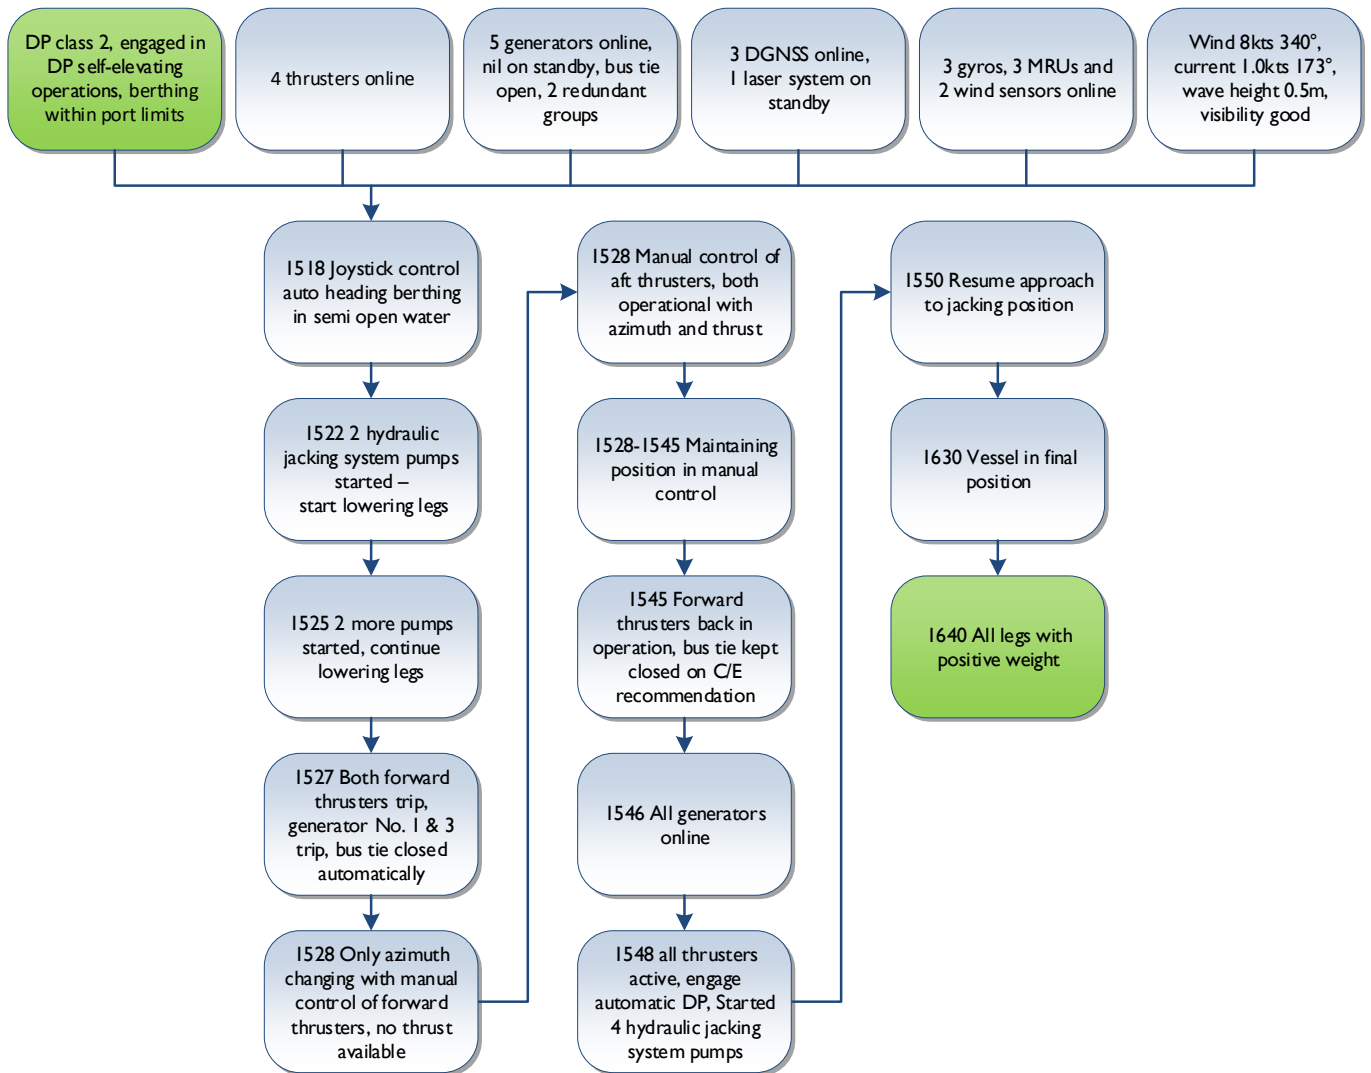
Lack of Maintenance Caused a Problem Involving the Bus Tie Breaker – DP Undesired Event

Comments from the report:

The power management system was set for semi-automatic mode as required for DP2 operations. Uncontrolled and unsynchronised closure of the bus tie breaker resulted in simultaneous trip of DG1 and DG3 with a consequence that the forward thrusters tripped. Based on conclusions from the technical analysis the primary reason (root cause) of the event had been identified as lack of maintenance of the DP critical system(s) more precisely the bus tie breaker. The ship was provided with a computerised planned maintenance system (PMS) which should cover all maintenance activity on board. The maintenance requirements of some major DP components were not included in the PMS.

- ◆ From the information supplied there was minimal DP stabilisation period allowed for at the start of the operation or following recovery when the vessel again engaged DP control
- ◆ It took 18 minutes to restore both forward thrusters – could this have been achieved more quickly?
- ◆ It is assumed that a partial blackout occurred, causing loss of both forward thrusters – normally the thrusters would be arranged such that the worst case failure (WCF) would cause the loss of one forward and one aft thruster

- ◆ It appears that the control of the thrusters was taken manually, however it should be questioned whether the automatic DP system or JSAH would have maintained the vessel in position
- ◆ While post-failure recovery time is definitely an issue, it seems that vessel design and operating configuration could be the root causes
- ◆ The event does highlight the importance of identifying and maintaining all items of critical operational equipment.

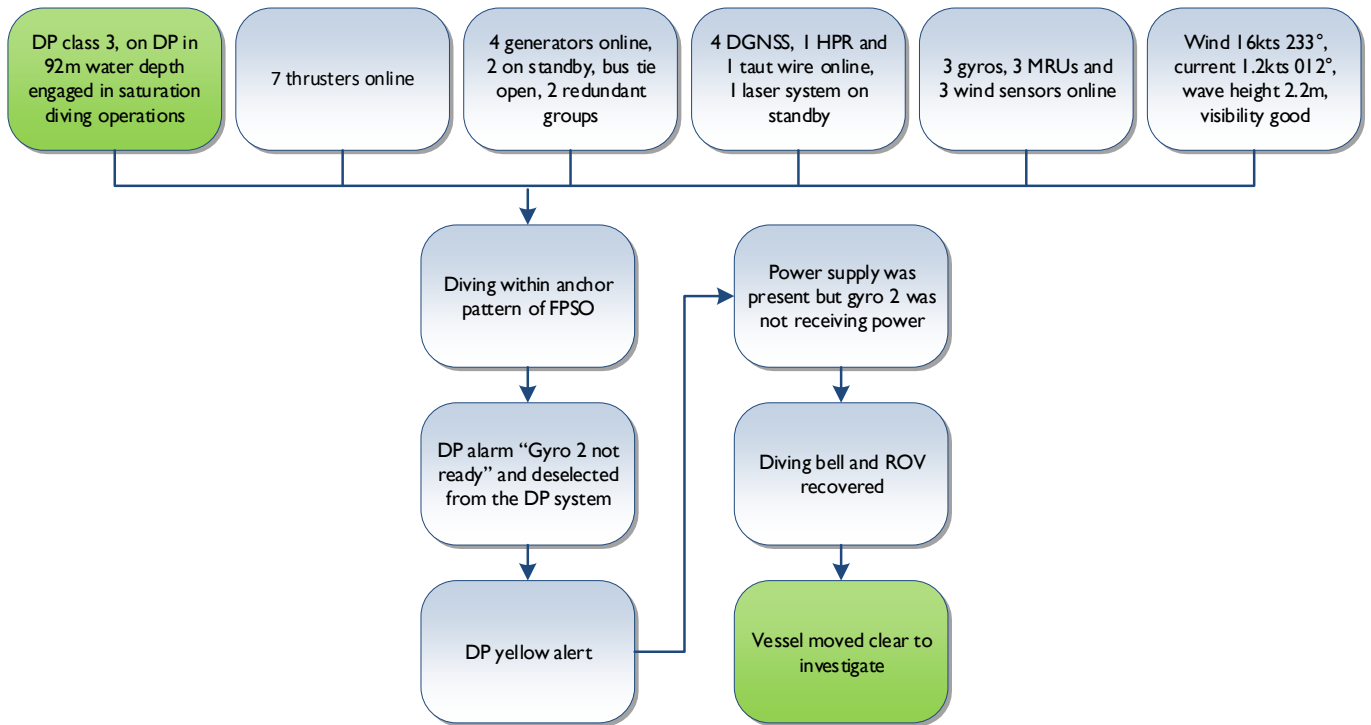
An Unassociated Failure of One Part of a Gyro System Affected the DP System – DP Undesired Event

Comments from the report:

A new gyro was installed as a replacement but failed to start with first attempt. Further investigation revealed that the 'Gyro 2 remote control unit' located on the forward bridge had a fault, failure of it caused Gyro 2 to shut down. When the 'Gyro 2 remote control unit' was disconnected the new gyro was switched on with no further problems. After a stabilisation period the Gyro was tested, found operational and the signal to DP reinstated. DP operations were resumed. In conclusion the original Gyro 2 was and remains healthy.

- ◆ It can be assumed that good operational activity planning took place and the ASOG indicated a yellow alert to be activated with the loss of one gyro
- ◆ The logic of systems connected to the DP system need to be fully understood so that a failure in one part of a connected system does not affect the DP system
- ◆ With the availability of so many position reference systems it may be better to use 2 DGNSS and keep the other 2 DGNSS as monitoring
- ◆ It is unclear what the gyro 2 remote control unit is required for, but it appears to have introduced an additional failure mode of the gyro and should have been identified in the DP FMEA.

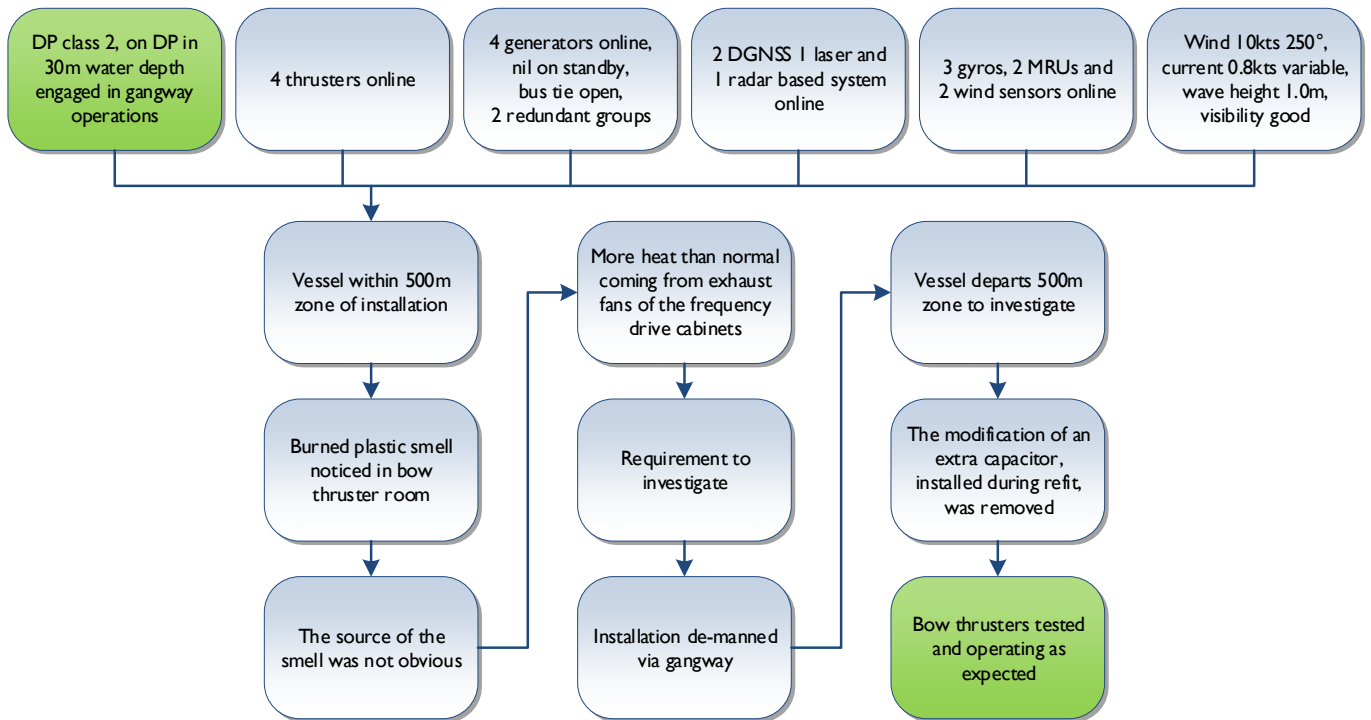
A Retrofitted Capacitor Caused a Bow Thruster Frequency Drive to Overheat – DP Observation

Comments from the report:

A wrongly installed extra capacitor at the bow thruster frequency drive caused overheating of this equipment. The extra capacitor was installed by the electrical designer and supplier of this equipment. It was also removed following consultation with the original equipment supplier.

- ◆ Further investigation should be initiated, including the supplier/manufacturer, as to why the extra capacitor was installed and whether another solution is required to ensure the thrusters function correctly in the future
- ◆ Vessel operators should ensure that a robust management of change procedure is followed
- ◆ A good response and sequence of events taken to minimise escalation
- ◆ A good choice and use of position reference systems is noted.
