IMCA DP Station Keeping Event Bulletin 02/16

June 2016

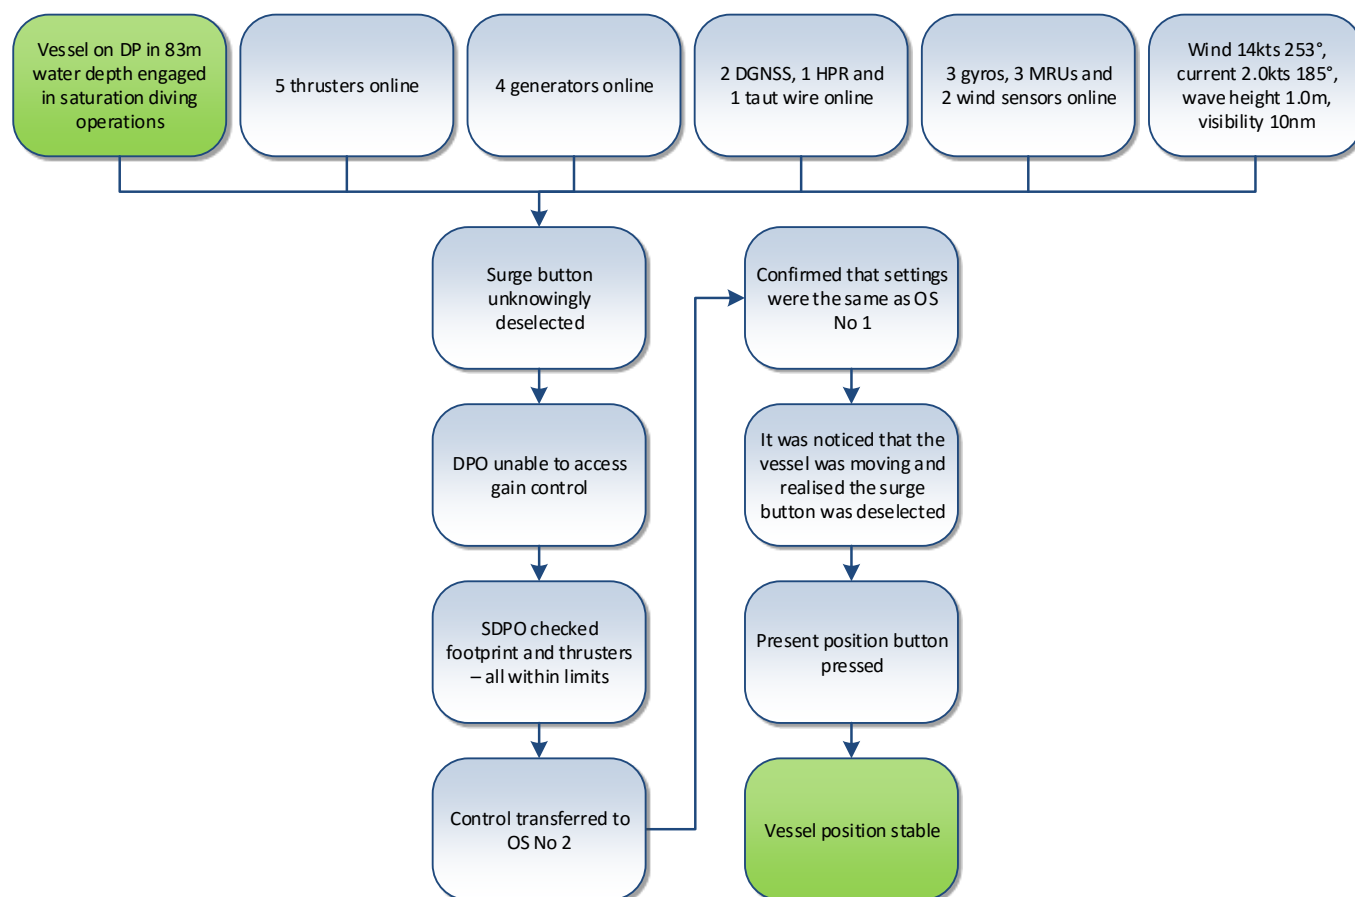
1 Unintentional Deselection of a DP Control Function

- ◆ This event highlights the possible consequences of deselecting critical DP system buttons. Significant changes to any system should not be made during critical phases of an operation.
- ◆ It was considered highly likely that the DPO was performing multiple tasks when the surge button was unknowingly deselected.
- ◆ Tools are available within position reference systems to monitor vessel position and alarm if the vessel moves outside a set limit.
- ◆ Vessel operators should note that this type of event continues to occur and might therefore consider whether additional barriers should be put in place for critical switches.

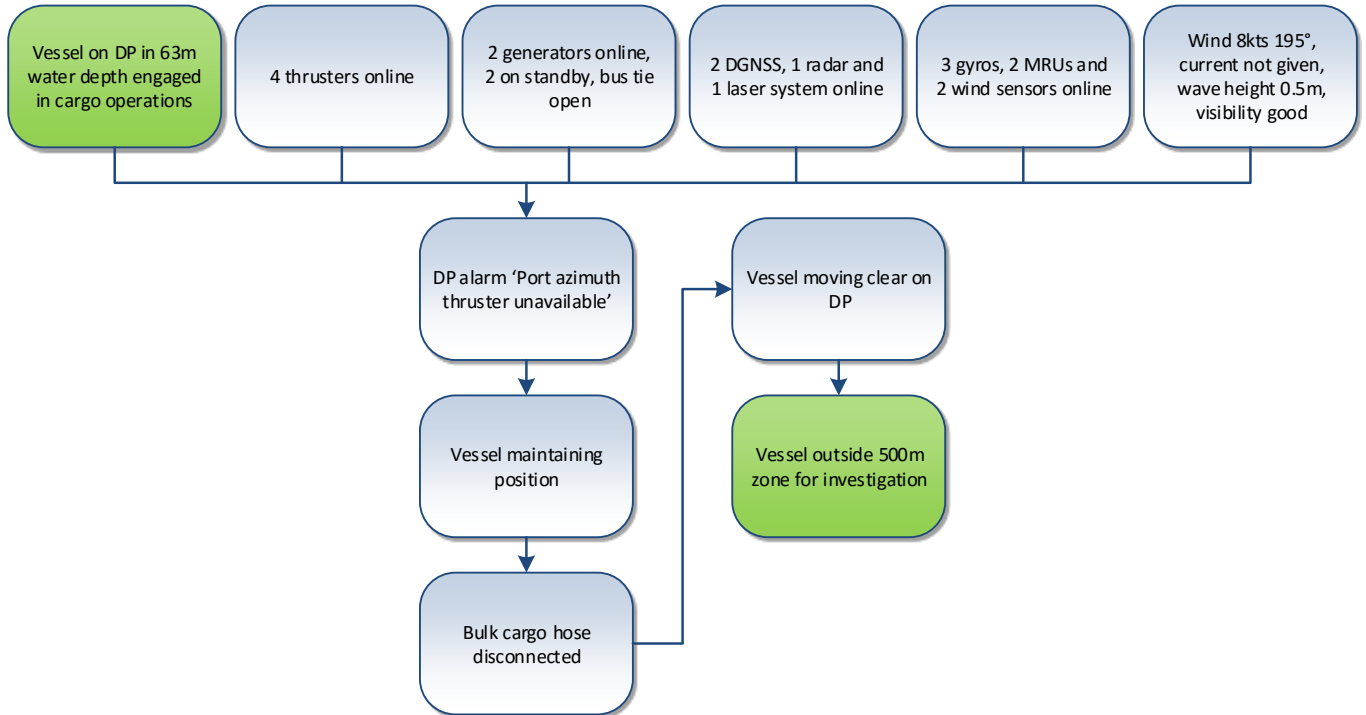
2 Thruster Failure and Unavailability

- ◆ The crew followed good procedures by suspending operations in a controlled manner ready for investigation.

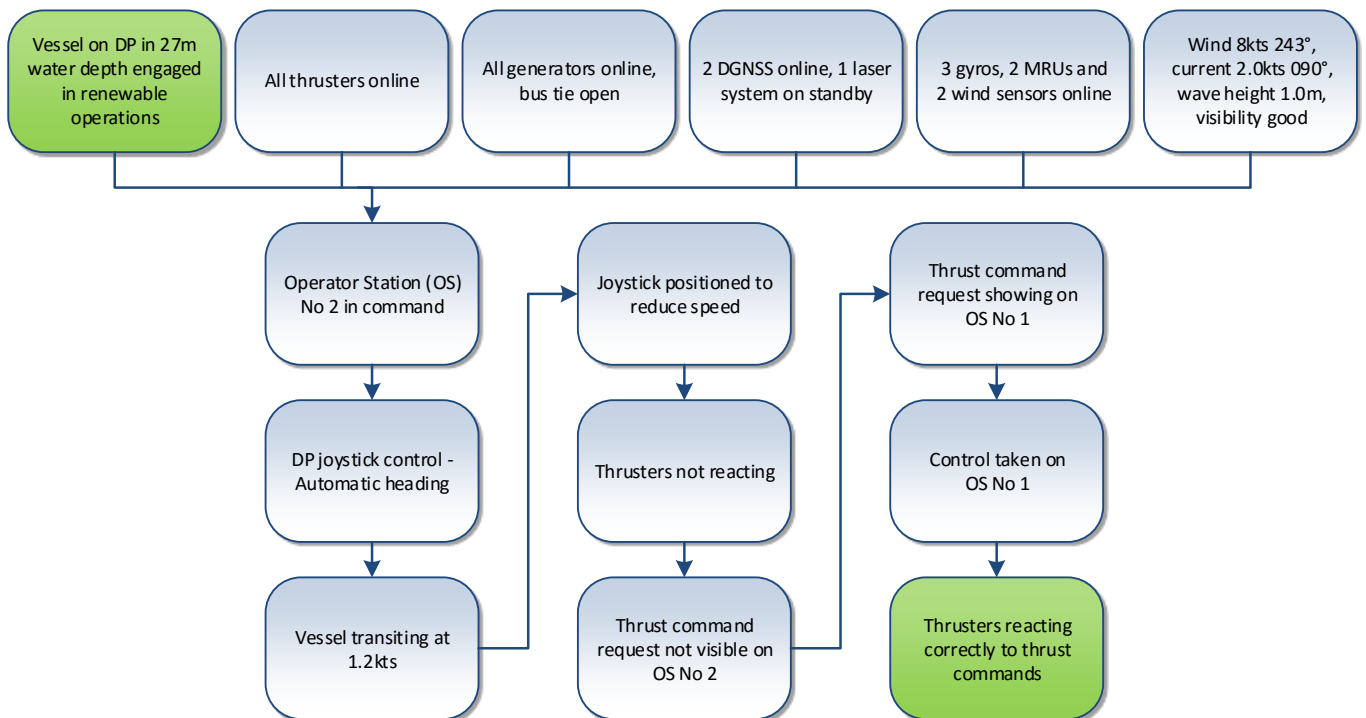
3 Differences Between Operator Stations

- ◆ Whilst it is not clear what caused this event it does stress the importance of field arrival and set up tests designed to identify operator station differences.

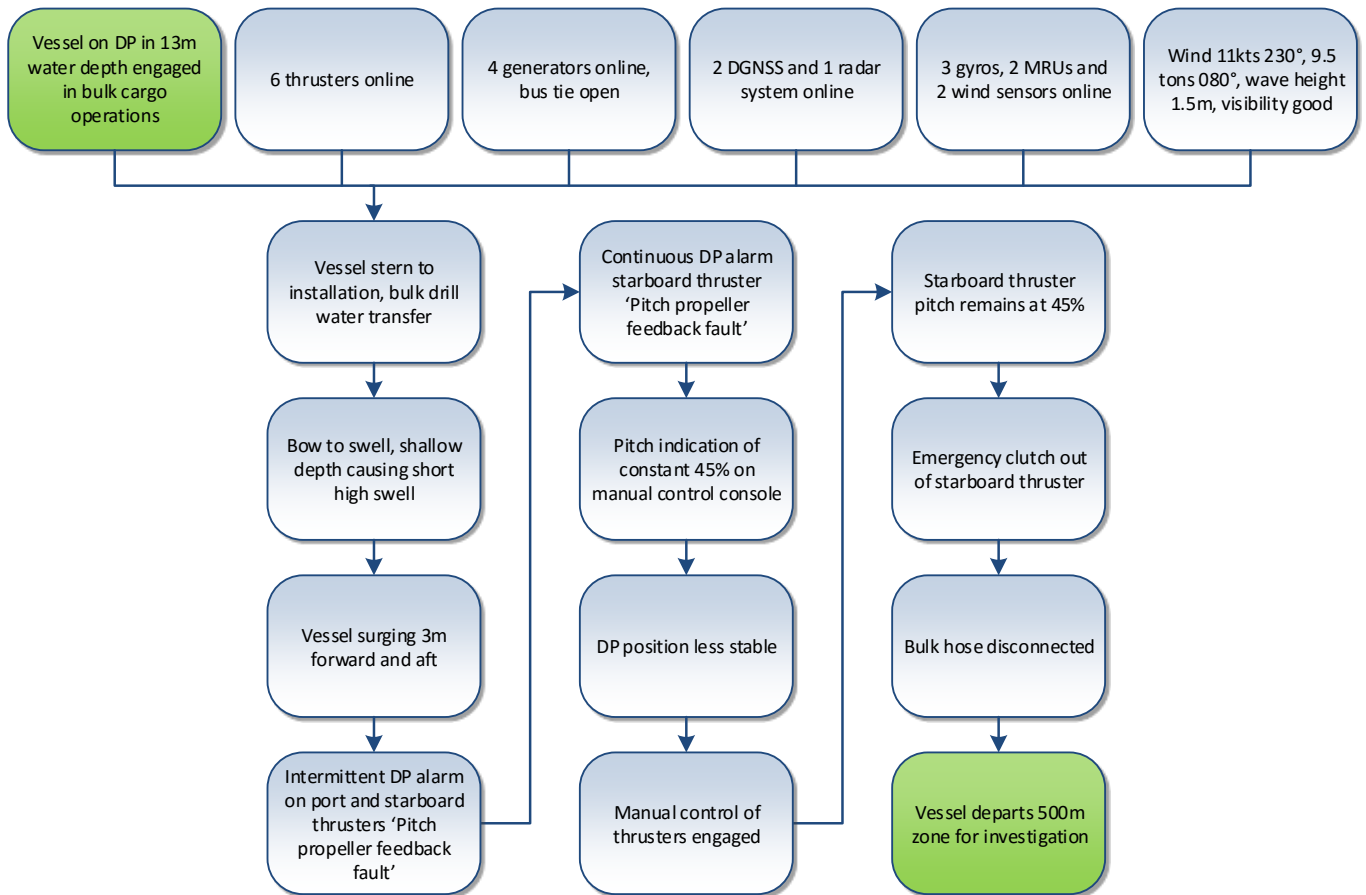
4 Thruster Fault

- ◆ All available means should be used to identify the faulty thruster and then shut it down as deselecting it from the DP system might not be effective.
- ◆ Depending on the time frame, it is recommended that the bulk transfer hose is disconnected prior to engaging manual control of thrusters.
- ◆ It should be noted that on a vessel that utilises main propellers for DP, pitch should fail safe to zero. This is because the second propeller, working astern, would not be able to compensate for the erroneous thruster working ahead.

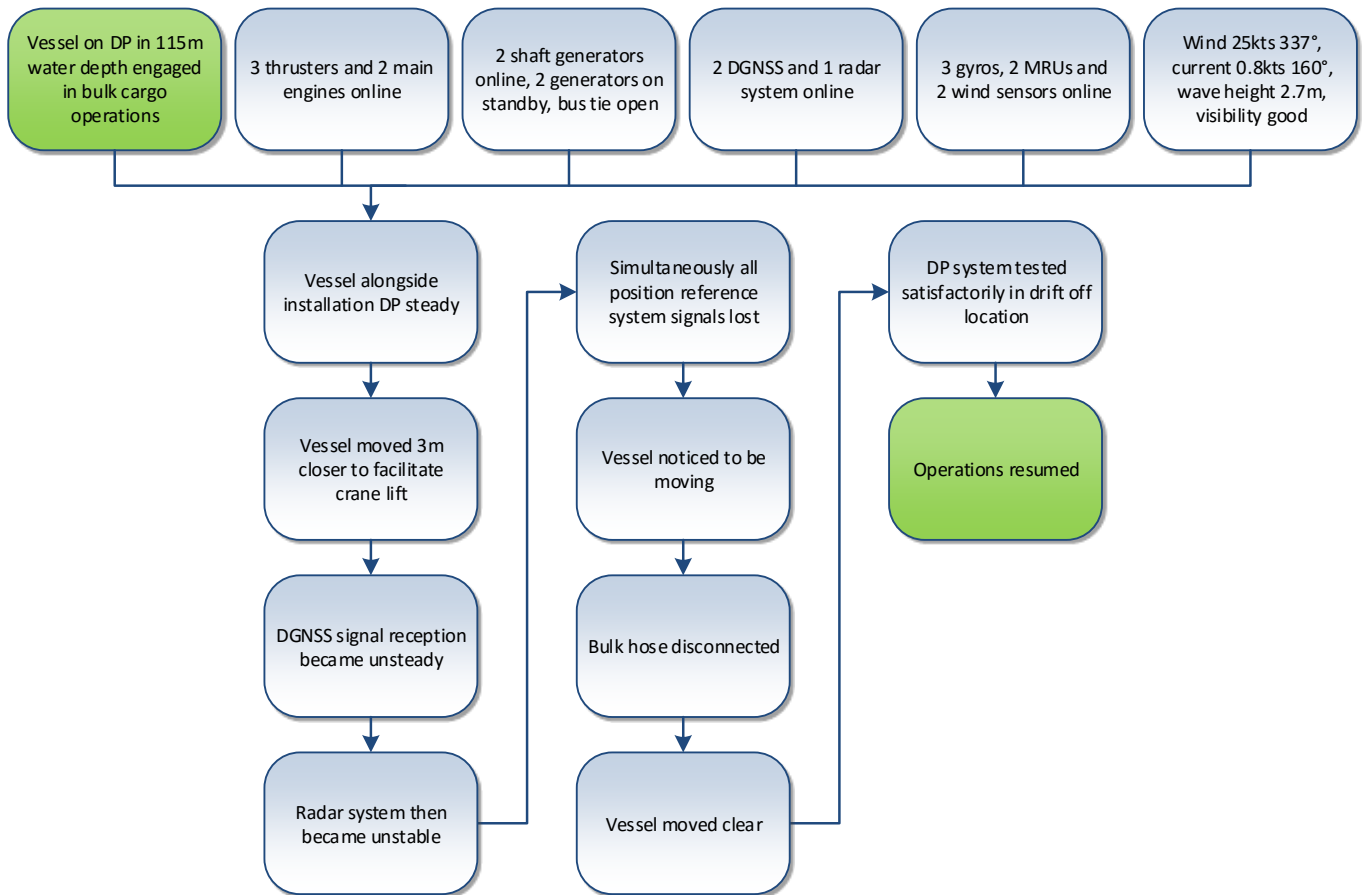
5 Instability of Position Reference Systems

- ◆ It is not clear from the report whether it was the differential correction signal or satellite constellation that was shielded, however operators need to be aware of shielding and shadowing in similar situations.
- ◆ The GNSS constellation screen should be consulted and considered prior to moving closer to a possible obstruction.
- ◆ The reflector for the radar system might not have been sited for optimum performance; did the crane shield the radar from the reflector?
