IMCA DP Station Keeping Event Bulletin 02/18

May 2018

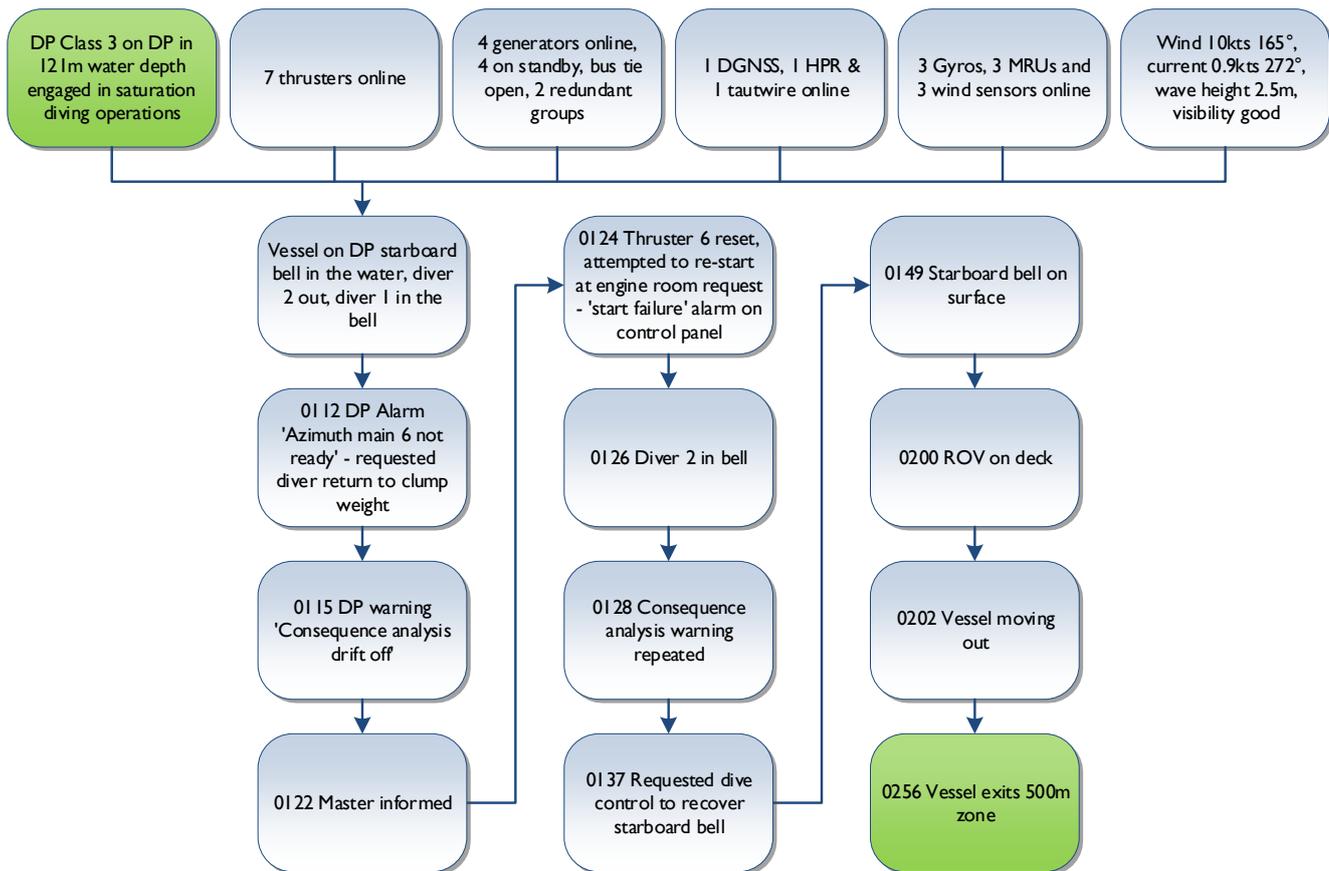
Electrical Fault Causes Loss of Thruster – DP Undesired Event

One of the three frequency converters on the port azimuth thruster was found to be burnt out.

- ◆ The DP Yellow Alert should be initiated
- ◆ The vessel had lost redundancy, but was not losing position. It is highly likely the damage caused by the burnt-out converter would have been visible, so thruster 6 should have been checked prior to restarting.
- ◆ The best policy is often to take time and assess the situation prior to attempting a restart.
- ◆ Reducing the maximum power available from one azimuth thruster to 60% would require the capability plots to be revised in order to reflect this limitation in post failure position keeping ability. It is assumed that appropriate DP capability plots were produced to support the revision in the ASOG.

- ◆ The thruster was isolated and faulty converter dismantled.
- ◆ Under the instructions from the manufacturer, the thruster was set up to work up to a maximum of 60% of the load.
- ◆ The activity specific operating guidelines (ASOG) was revised to reflect the new power limits on the main propulsions.

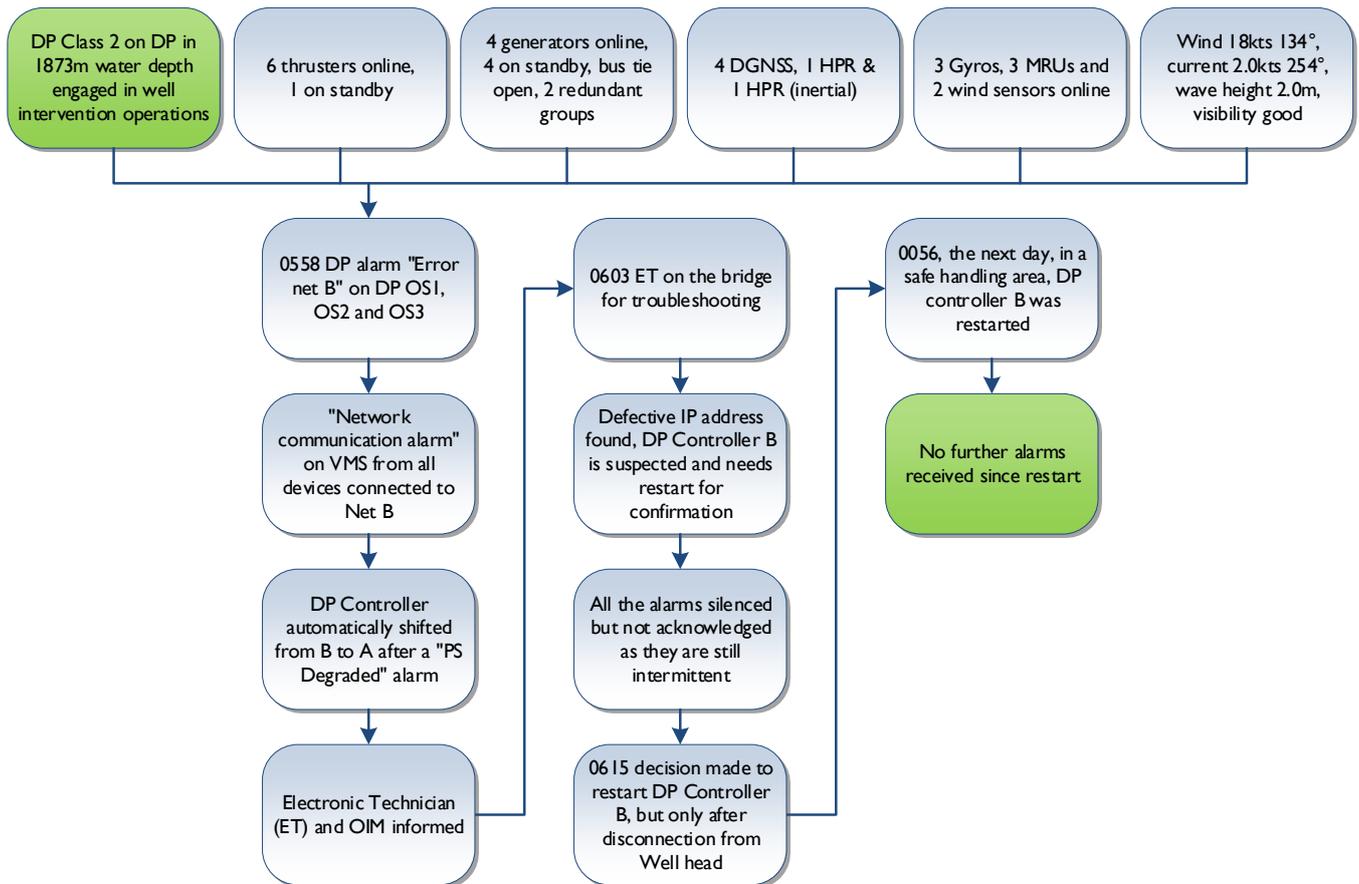
DP Controller Problems – DP Undesired Event

- ◆ Redundancy was lost; therefore, a yellow alert should be initiated.
- ◆ Good practice is to acknowledge and investigate the cause of alarms, even if they are intermittent, otherwise alarms can be missed.
- ◆ It should be noted that good practice is to restart the DP controllers as part of field entry trials and practice restart procedure during DP operational drills.
- ◆ The wisdom of having 4 DGNSS selected to the DP should be questioned. They are likely to be susceptible to similar faults and therefore provide a false sense of security. Also, the use of 4 position reference systems of the same type would create a bias and therefore dilute the effectiveness of the other selected systems.

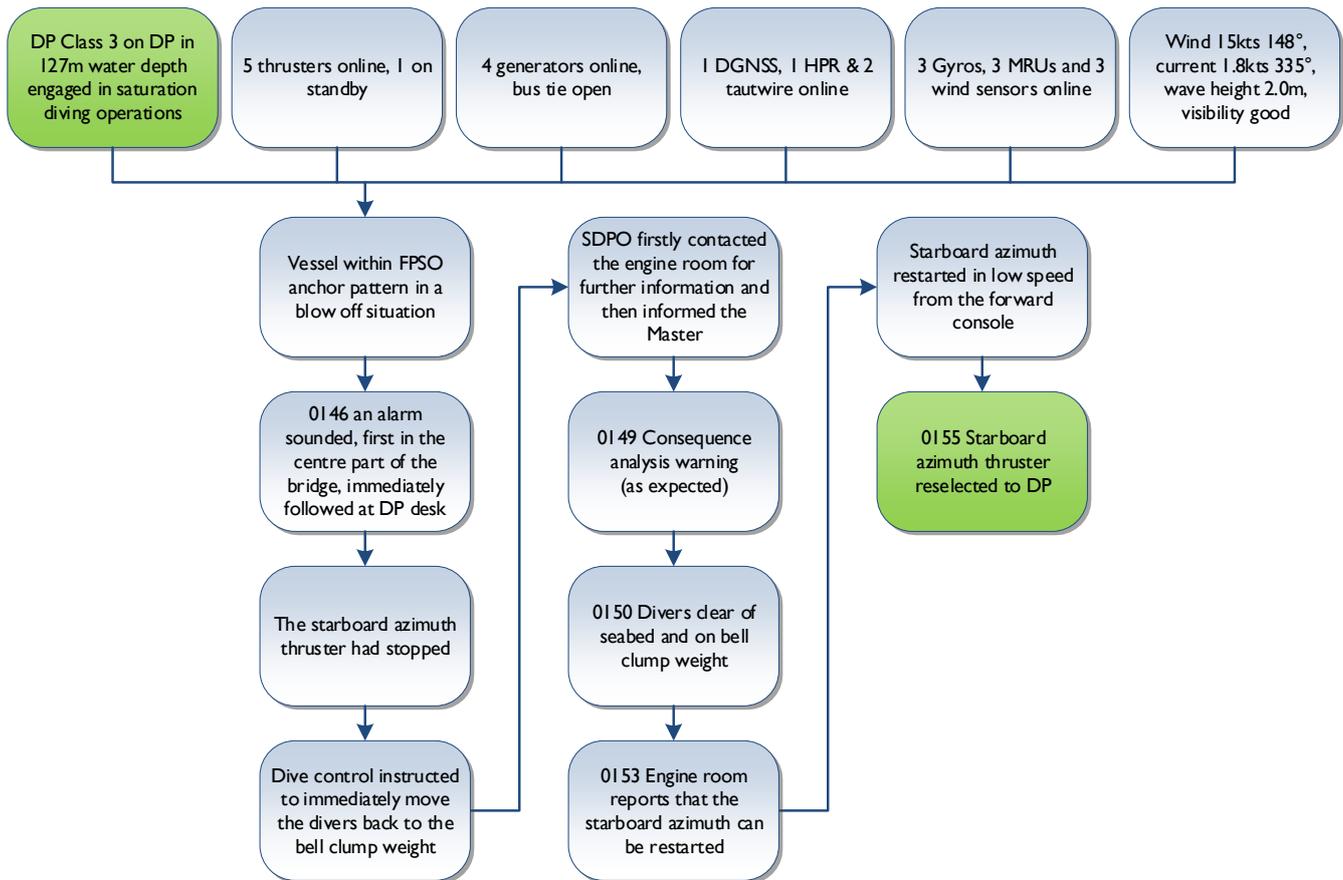
Routine Maintenance Leads to Loss of Thruster – DP Undesired Event

During a routine weekly maintenance operation, a ships engineer took an oil sample from the starboard azimuth thruster sample point, which is a small valve located on the line to the pressure switch. The location of the oil sample point on the line to the pressure switch creates a risk of inadvertently activating the switch if the sample valve is opened too much. When obtaining the sample, the valve was opened fully, reducing the pressure to the pressure switch. The pressure switch then tripped causing the thruster to stop; the oil pressure in the thruster was maintained and not at risk. Once the sample valve was closed the pressure on the line to the pressure switch returned to normal. The starboard azimuth was started back up in DP and, following a short investigation, pre-dive checks were carried out and the bell deployed to continue diving operations.

- ◆ The loss of redundancy should have initiated a yellow alert but this was not in the report.
- ◆ Planned maintenance of critical equipment should be controlled by a permit to work (PTW) system.
- ◆ It appears that during the event, co-operation between the bridge, engine room & diving departments was good.
- ◆ The event highlights a poor design, for example the sample point could have been down stream of the oil pressure sensor and in this situation, it would seem reasonable for an alarm to be triggered rather than the thruster shut down.

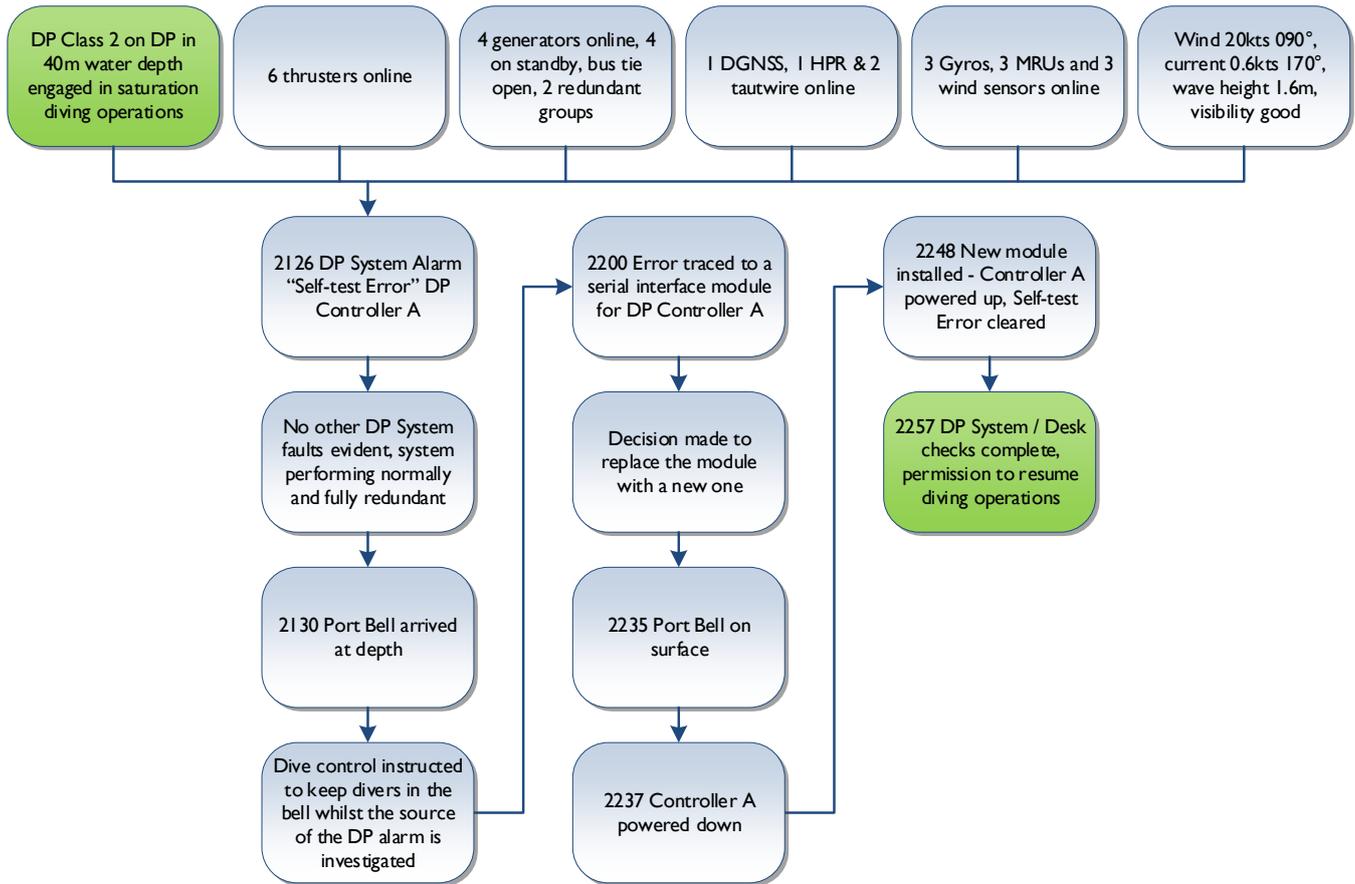
Good Practice Following System Self-Test Alarm – DP Observation

The error was traced to a serial interface module for DP Controller A and confirmed that the red error lamp on this module was illuminated. Whilst indicating an error, the module was still performing correctly in so far as there was no effect with its data feeds. The decision was made to replace the module with a new one, dive control was requested to recover the bell to surface and hold it there whilst replacement was carried out.

- ◆ The actions taken were all in accordance with good practice.
- ◆ 40m water depth only provides for a small envelope for seabed based position reference systems (PRS).
- ◆ In these depths of water, it is advisable to make use of surface based PRS, in this instance DGNSS was used.

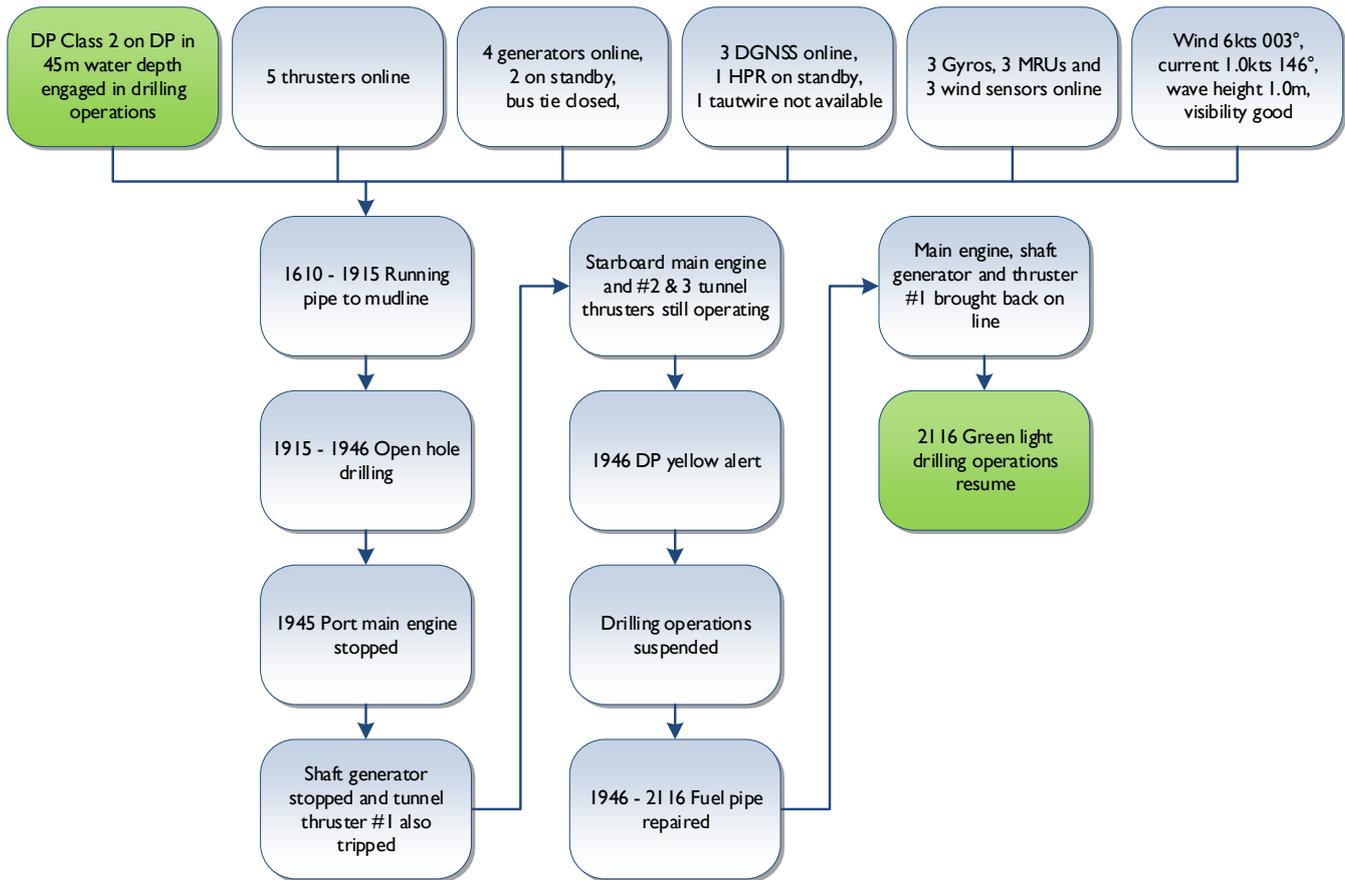
Leak in Fuel Supply Line Causes Engine to Shut Down – DP Undesired Event

A fuel leak developed in a corroded supply pipe to the port main engine. This caused air to be drawn into the system and the engine to shut down. Redundancy worked as designed. The split fuel system ensured that only the port side of the engine room was affected and operations were suspended due to loss of redundancy.

- ◆ It was noted that 3 DGNSS were selected to DP; clearly this is not in accordance with DP equipment class 2 that requires position reference systems to have at least 2 different principles of operation.
- ◆ The vessel was operating closed bus and while the failure did not exceed the vessel's designed worst case, a different fault on the electrical system may have resulted in a more significant DP system failure.
- ◆ Water depth of 45m only provides a small envelope of operation.
- ◆ Actions taken in response to the failure appear to be appropriate and in line with good practice.
- ◆ The planned maintenance system (PMS) for critical piping systems should be reviewed. For an F.O. supply line to fail due to corrosion should warrant complete inspection of the rest of the system, and a review of past inspections/maintenance so that similar faults are not missed in the future.
