IMCA DP Station Keeping Event Bulletin 03/17

July 2017

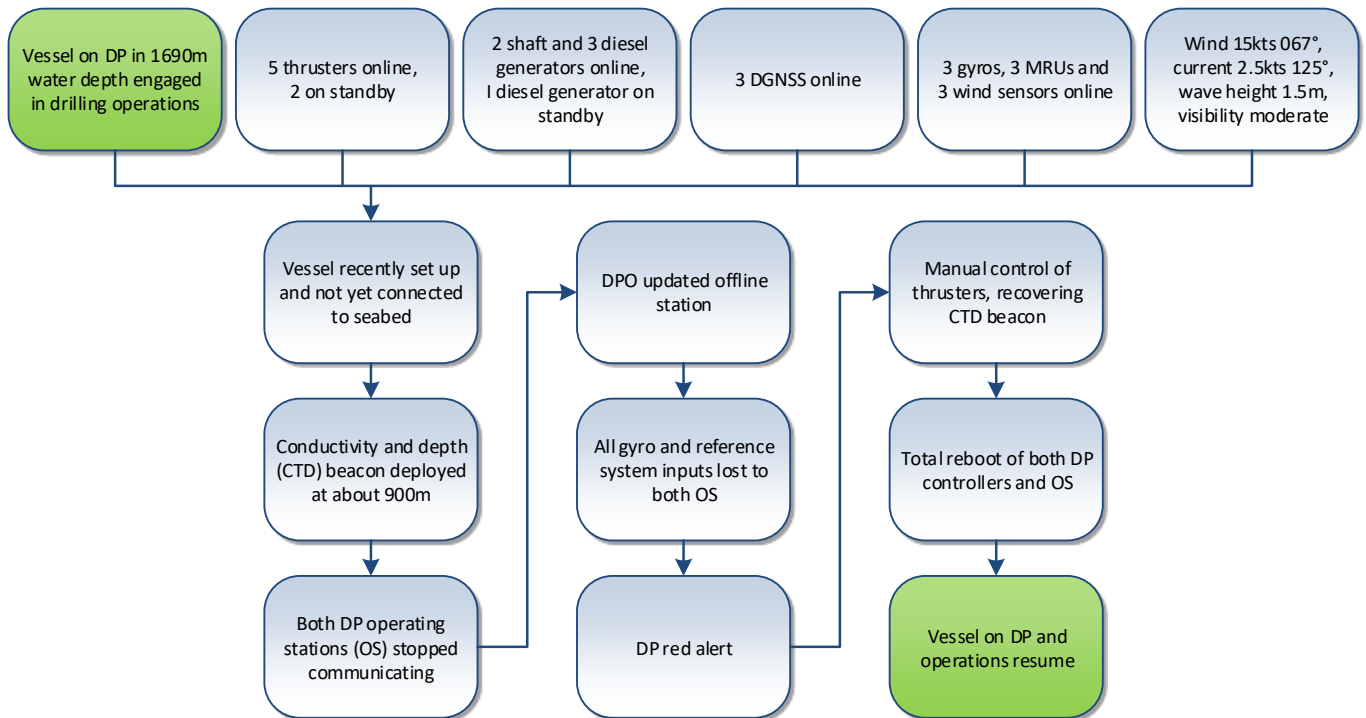
Both DP Operating Stations Stopped Communicating – DP Incident

- ◆ It is possible that as the vessel was only recently set up on DP, field arrival trials had not yet been completed.
- ◆ The use of DGNSS as the only position reference system for DP equipment class 2 operations is not good practice, however it is recognised that deployment of the CTD beacon could be in preparation for initiating a DP acoustic system.

- ◆ It is not clear, from the information provided, of the exact sequence of events: sensors and position reference systems are hard wired to the DP controller or Fieldnet connections, located in the DP controller cabinet, they are not connected directly to the DP OS and therefore position keeping capability should not have been affected by the OS not communicating.

- ◆ One possibility is that it was the DP controllers that stopped communicating and caused the problem; if this was the case the question should have been asked how this single point failure could have happened.

- ◆ The vessel would probably be controlled better using the independent joystick rather than individual manual control of the thrusters.
- ◆ The report suggests the possibility that the vessel returned to operations without sufficient testing to find the root cause of the problem.

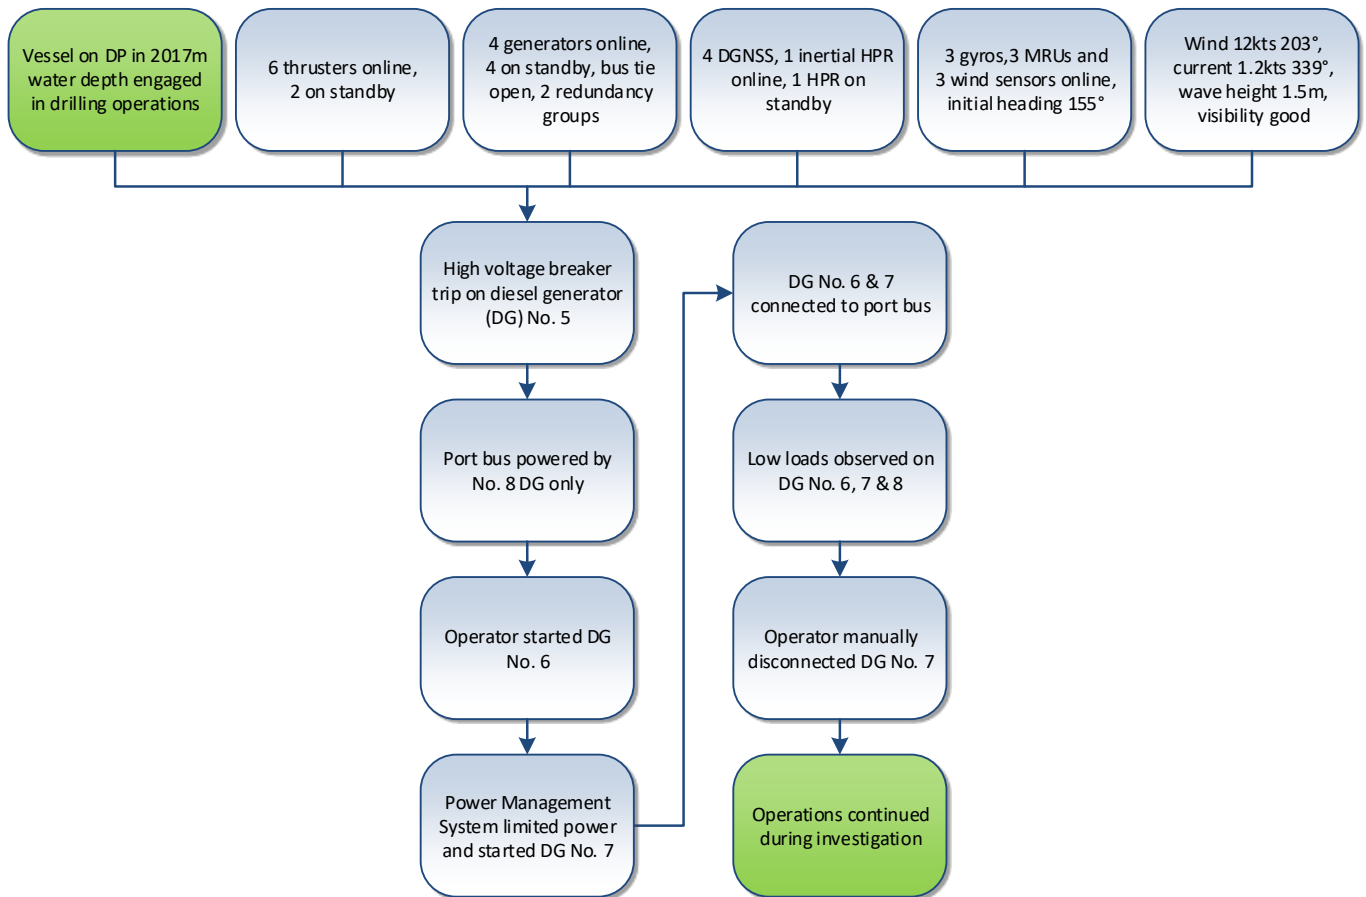
High Voltage Breaker Trip – DP Observation

Investigation started at the breaker for DG No. 5 in the port switchgear room. The breaker showed tripped and there was a fault present on the auto voltage regulator (AVR). DG No. 5 was locked out and investigation continued, the AVR breaker 'S1' was found tripped. Further investigating found that one of the wires from this breaker had chafed on the inside of the box and resulted in a short and evidence of arcing to ground. The damaged wires were replaced and the rest of the wires in the junction box adjusted to avoid future problems.

After replacing the worn wires and test running the engine it was noticed that the load indicator on the PMS panel was showing a negative reading, which was incorrect. This signal was a feedback from the breaker module and was in fact sending a false milliamp signal to the PMS. Racked the breaker out to perform a hard reset, the kilowatt signal from the relay went to zero.

- ◆ The investigation explained that the AVR breaker trip caused the DG No. 5 breaker to open presumably as a result of a reactive power (kVar) protection scheme. It seems from the investigation notes that there was no connection between the original fault and the negative active power (kW) signal.
- ◆ Similar wire checks should be made on all other engines.
- ◆ Having four DGNSS enabled in the DP controller is not a good practice as the total 'DGNSS weight' is reducing the 'acoustic weight' to insignificant.
- ◆ The DP alert status should be initiated in accordance with activity specific operating guidelines.

DG No. 5 was run, tested and connected to the 11kV bus, all in proper working order.

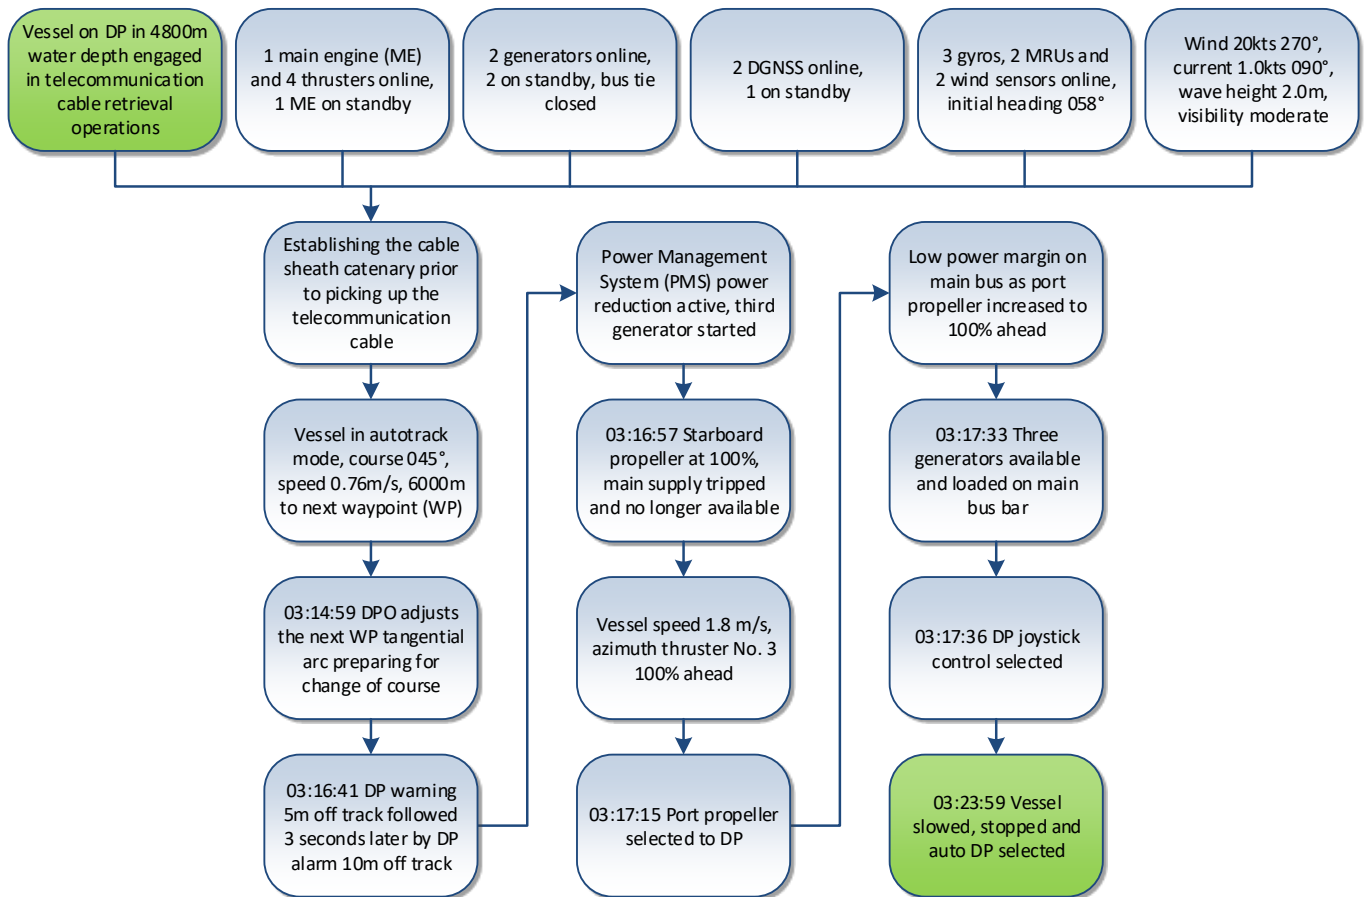
Following a Track on DP Causes Power Issues – DP Incident

- ◆ The initiating event was a sudden increase of propulsion to full ahead.
- ◆ The main cause was attributed to the computer with unexpected thrust allocation.
- ◆ The secondary cause was human factor due to a slow reaction to switch to manual mode.

- ◆ This is an extremely deepwater operation, although margins are large, DP control is still desirable.
- ◆ The limitation of using DGNS as the only position reference system should be known and acknowledged by those involved in the operation.
- ◆ From the information available it would seem this could be an operator initiated problem. Chosen settings of gain, corridor limits, rate of turn and speed of the vessel could all have contributed.
- ◆ The operator could have selected the 'Stop' function on the DP console to stabilise the situation, instead of selecting joystick.
- ◆ It is important that instructions for switchboard configurations are supplied and followed.
- ◆ The starboard propeller tripped at 100% load; this should not happen.
