IMCA Safety Flash 24/20

August 2020

1 Hull damage caused oil leakage from settling tank

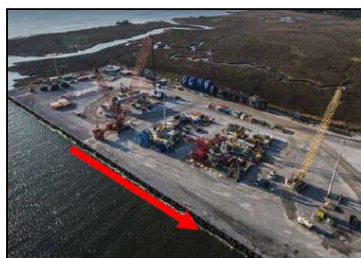
Berthing movement at Core Base

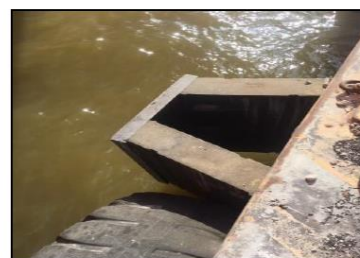
Fendering arrangement as expected

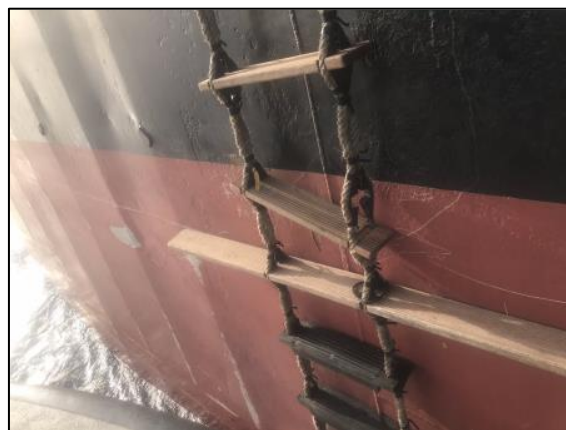
During the embarkation of the Pilot to the vessel, the Pilot observed that a step on the Pilot ladder was not in good condition (broken). The Pilot implemented the **Stop Work Policy** and informed the Master of the vessel, noting that the Pilot ladder would need changing before he would embark. The pilot ladder was subsequently replaced and the pilot boarded the vessel.

The Pilot ladder was not in good condition. It had not been inspected before it was put in place by the vessel crew.

- ◆ The technical specification of pilot ladders meets **IMO requirements as per Resolution A.1045(27)**;
- ◆ Persons ordering or sourcing new pilot ladders should **clearly know the IMO requirements** and should specify to suppliers that every step on the ladder should be free of knots;
- ◆ New pilot ladders are **thoroughly checked before use** to verify quality and to ensure that the steps are clear from knots;
- ◆ Pilot ladders are **always checked by the officer in charge** before rigging and use to ensure it is fit for purpose, in good condition and secured properly to the vessel.

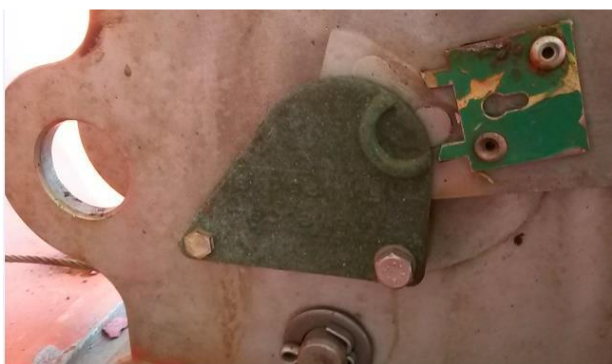
The misaligned forward hook with 'padlock symbol'.

- ◆ The alignment of the cast plate was also aligned differently to all other hooks. The padlock symbol indicated the hook was correctly closed when it was not;

- ◆ The 'padlock symbol' was not mounted at the edge of the quadrant as the other hooks on board were;
- ◆ The mechanism was incorrectly assembled with the forward 'Duplex-E Hook' locking mechanism misaligned;
- ◆ The forward hook was incorrectly set to release at 35° instead of 55° as required by the manufacturer;
- ◆ Previous records made no reference to any alterations being made to the system and it could therefore not be established when the incorrect alignment occurred;
- ◆ No damage to any components was found; no components needed to be replaced;
- ◆ The forward hook required adjustment to release at the correct setting of 55°;
- ◆ Once the cam had been realigned to release at 55°, the 'padlock symbol' was moved to correctly indicate that the hooks were closed.

- ◆ Confirmed and checked the hook settings of all lifeboats, and fully investigated any unexpected difficulties with release mechanisms;
- ◆ Ensured that third-party contractors servicing lifeboat hooks are properly qualified and approved;
- ◆ Reiterated the importance of always following the manufacturer's instructions and company procedures for maintenance-related launch and recovery of small boats/lifeboats;
- ◆ Communicated that lifeboat that do not show the correct setting of the hooks should not be used.

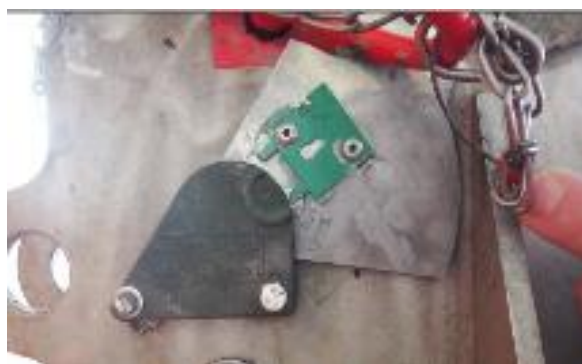
Forward hook after realignment with 'padlock symbol' moved to correctly show safe condition.

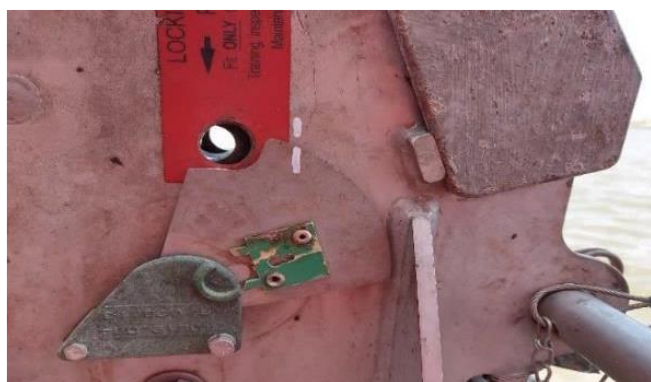
Locked position (0°)

The cam on the release hook rotates approximately 80° between the closed and fully released position. The hook is designed to release at 55°. At full travel, the cam had rotated too far and blocked the hook from being released.

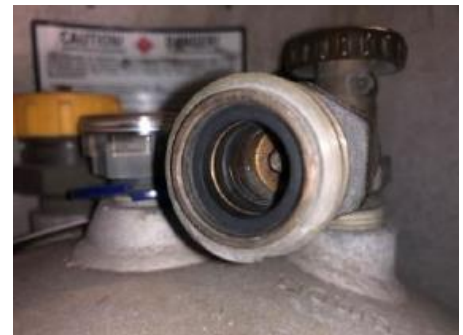
Internal O-ring

In a vessel alongside, a new fuel gas cylinder was connected to a gas-powered forklift truck. When the delivery valve was opened gas leaked from the connection between the cylinder and the hose. The cylinder was removed and the internal O-ring seal was found to be damaged.

A replacement cylinder was brought to the forklift but before fitting it the crew member checked the condition of the O-ring and found that it too was damaged. Fortunately, a number of full spares are carried on board and one was found that was in good condition.

The two cylinders with faulty O-rings were returned to the supplier for fitment of the correct O-rings. The branch manager of the gas supply company was alerted to the incident. He was most concerned that the cylinders were delivered to a customer without proper examination of the O-rings. They took this as a serious quality control issue and apologised for the occurrence, eventually tracing the batch of refills to a particular time, place and person.

- ◆ Closely examine exchanged or pre-used equipment for proper condition, especially where potentially hazardous materials or stored energy is concerned. **It always pays to check.**
- ◆ O-ring seals are small but vitally important components which should be treated with the greatest of respect.
