IMCA Safety Flash 27/20

September 2020

1 Near miss: sudden Loss of air from diver bail-out bottle

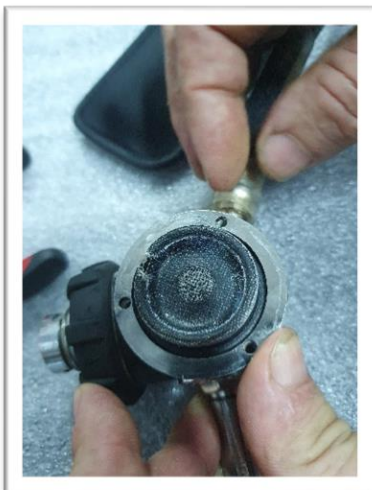
Photo 1

Investigation revealed that there had been a failure of a roll diaphragm from an Xstream first stage regulator attached to the diver's bail-out bottle (Photo 1). The regulator was stripped down to reveal worn structural fibres inside the diaphragm had weakened allowing a hole to form. Photo 2 shows a comparison between the failed and new diaphragm. The damage can be seen on the right unit showing the exposed fibres.

- ◆ Follow manufacturer's guidance;
- ◆ Enhanced company planned maintenance system to include that the roll diaphragm is to be changed out in addition to the service kit items.

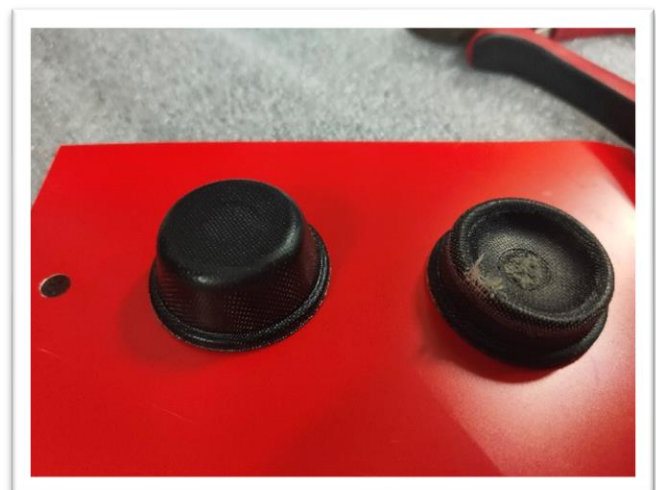
Photo 2

The roll diaphragm was inspected during the six-monthly maintenance and was deemed good enough quality to remain in service. Human judgement is subjective in deeming this part serviceable.

Our member noted that there was no clearly defined replacement criteria for the diaphragm; consideration was being given to replacing the part every six months.

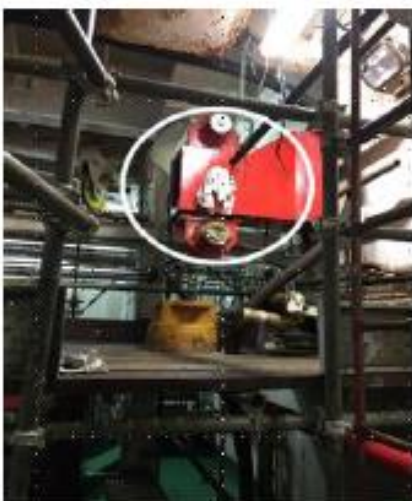
Original sheave location at aft winch station

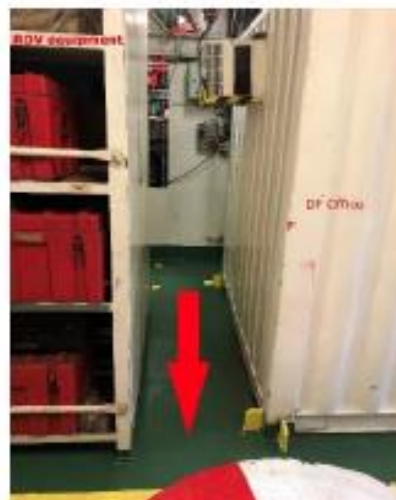
Transit between office space and storage area

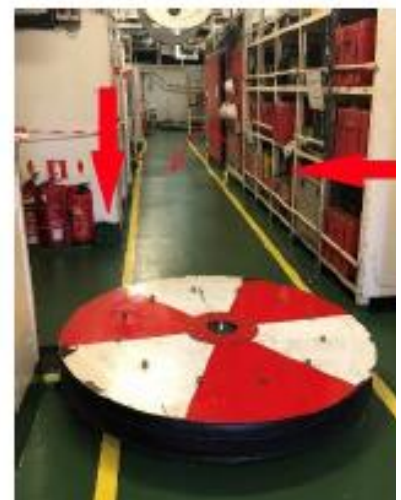
Sheave positioned across walkway post

A Safe System of Work (SSOW) was not effectively integrated and implemented at the worksite.

- ◆ Ensure subcontractor activities are correctly interfaced with company safety management systems;
- ◆ Ensure that the requirements for Risk Assessment, Permit to Work and effective Toolbox Talk delivery are clearly understood by all, particularly where subcontractors are involved;
- ◆ Permits to Work should only be issued after confirmation that **all** requirements and precautions for the task have been applied;
- ◆ Ensure all aspects of upcoming work is adequately discussed, reviewed, managed and controlled;
- ◆ Ensure measures in place to protect from COVID-19 are factored into the planning, supervision and completion of work activities.

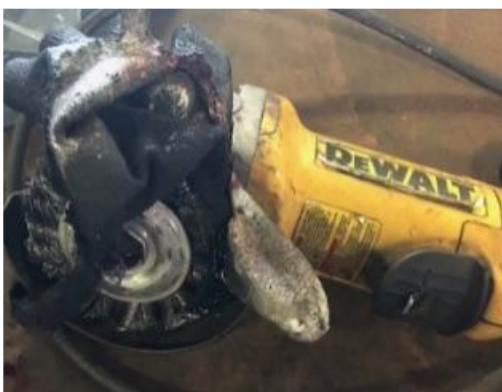
A worker was injured whilst cleaning equipment using a portable handheld angle grinder fitted with a wire brush. The rotating brush caught an edge and kicked into the worker's gloved left hand. The glove was pulled into the rotating wire brush resulting in a deep abrasion to the hand.

Glove and wire brush

- ◆ The task risk assessment was incomplete.
- ◆ The grinder was being used without the side grip handle fitted;
- ◆ No consideration was given to where to place the hand relative to the rotating brush;
- ◆ Given the operator's position, the grinder could not be used safely. The operator should have moved to the other side of the component to complete the task, and deployed the grinder in a horizontal position;
- ◆ There was no formal power tool / abrasive wheel training in place;
- ◆ There was inadequate supervision of the task.

- ◆ Task risk assessment amended to include all hazards and control measures;
- ◆ Angle grinder side grip handle obtained and fitted and its use made mandatory as company policy;
- ◆ Review of power tool/abrasive wheels training and competency evaluation requirements;
- ◆ Supervisors' responsibilities discussed and reaffirmed.

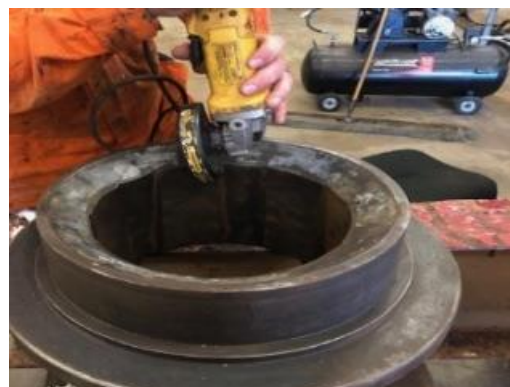
Hand position - RECONSTRUCTION

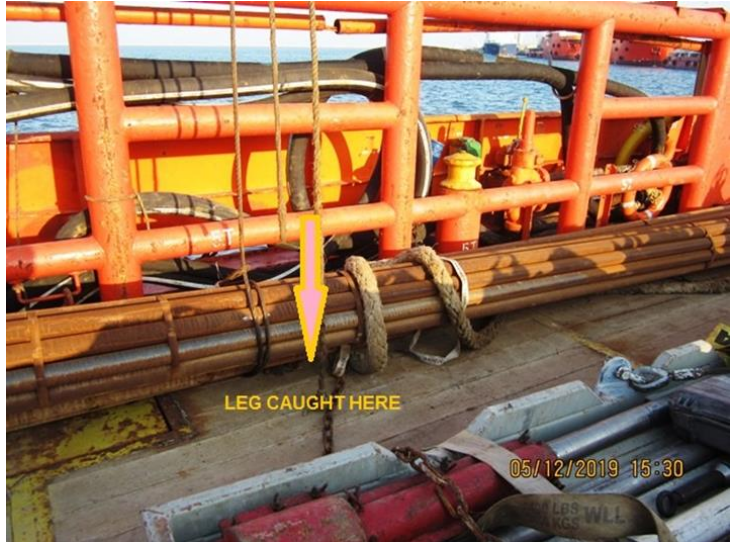
A load shifted during cargo operations, pinning a crewman's leg between the deck and the load, causing a broken leg. The incident occurred on a vessel which was in port to load cargo. The cargo consisted of various items including containers and multiple bundles of tubulars. The crane driver lifted the tubulars into position with the deck ratings providing voice communication to ensure that the load was in the correct position. Once confirmed correct, the crane driver payed out the crane wire allowing the deck ratings to disconnect the sling from the lifting hook. Shortly after disconnection, the load shifted striking an AB in the left leg, pinning his leg between the deck and the tubulars.

- ◆ The task of loading tubulars was considered routine and therefore was not risk assessed adequately;
- ◆ The likelihood of the tubulars not being secure and moving once landed had not been identified as a risk, and the injured AB was positioned in the line of fire with nothing to prevent the tubular load striking the leg.

- ◆ Risk Management processes did not identify hazards associated with task;
- ◆ Personnel were positioned in line of fire with no physical means of holding moving load;
- ◆ Vessel relied on a third party onshore provider to bundle load correctly with no checks.

- ◆ Ensure agreed lifting plans and configuration of unusual loads with third party or client prior to lift;
- ◆ Vessel crew should inspect and supervise the loading process;
- ◆ Deploy pins or chocks to prevent load moving to impact personnel;
- ◆ Personnel reminded not to stand in line of fire during/ or post lift.
