IMCA Safety Flash 28/20

September 2020

1 Unsafe lifting operations

Incident 1 Unsafe Lifting Operations By sub-contractor

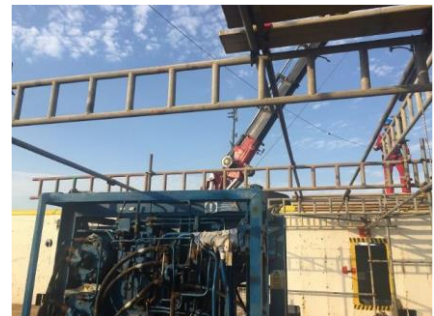
On a platform supply vessel (PSV) involved in demobilization operations alongside, the crane operator attempted to lift a winch frame located on at the main deck while there was scaffolding structure still over the winch frame. In addition, crew were still dismantling the scaffolding and so were **in the line of fire**. Upon observing this unsafe condition the job was immediately stopped by the vessel team.

- ◆ Line of fire – there was scaffolding over the lifting area and the presence of personnel in the line of fire was not considered by the contractor;
- ◆ Incorrect lifting method - scaffolding pipes were placed under the winch platform with the purpose to roll it over with partial lifting, creating a risk of the winch sliding back off its platform as it was not welded on it;
- ◆ People were in a rush – the contractor’s lifting crew were in a hurry to complete the job on that day, as windy weather was forecast for the next day.

Equipment located on deck

- ◆ SIMOPS! Take into account what else is happening around you. Avoid any conflicting activities during any lifting operations;
- ◆ All lifting operations should be properly planned and risk assessed.

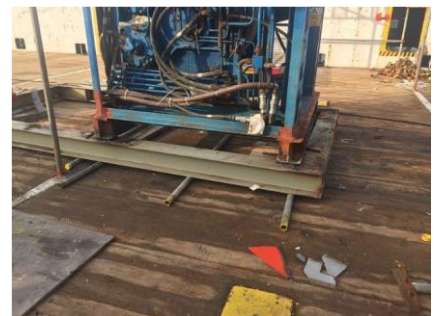
Scaffolding pipes under winch frame

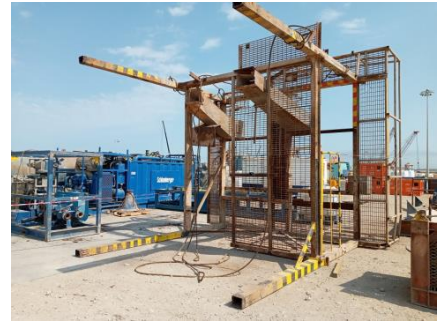
A client's lifting crew attempted to load a metal structure to the vessel deck. The operation was stopped by the vessel Master. He questioned the certification of the lifting point and the lifting gear, as having no colour code signs. As no certificates could be provided, the vessel Master refused cargo and took the matter up with company management and the client's representatives.

Metal structure proposed for lifting

- ◆ Crew to conduct vessel inspections to ensure valid colour code applied to all lifting equipment and accessories, as per Safety management system;
- ◆ Reiterate the importance of checking lifting equipment condition **before and after** the task.

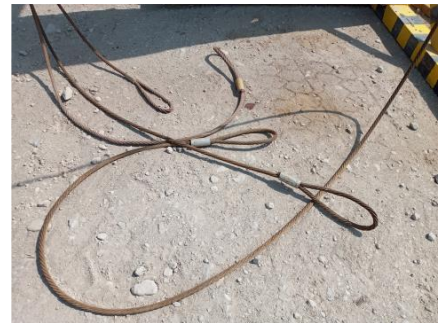
Wire slings with no certificates/colour code

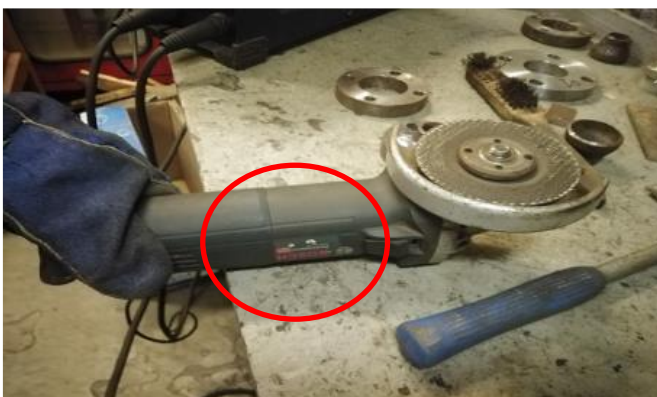
During a routine vessel inspection, crew were observed using a grinder with a selector switch as opposed to a paddle switch, which was contrary to procedures and communication from previous incidents and safety bulletins.

Selector switch grinder (not permitted)

- ◆ Upon investigation, it was discovered that the vessel had the approved (paddle switch) grinders on board, but they were seen as being too bulky for the job; the crew removed the old grinder (smaller size) from the quarantine box and put it back into use.
- ◆ On inspection of the quarantine box, it was noticed that there was no manner of securing the box in order to prevent someone from accessing quarantined equipment.

- ◆ Inadequate supervision, to ensure equipment designated inappropriate does not re-enter service - crew members deliberately used equipment that had been taken out of service.

- ◆ Devices in “quarantine” should be rendered temporarily unusable or put strictly under lock and key;
- ◆ A hazard hunt was carried out to ensure that selector switch grinders were no longer in use.

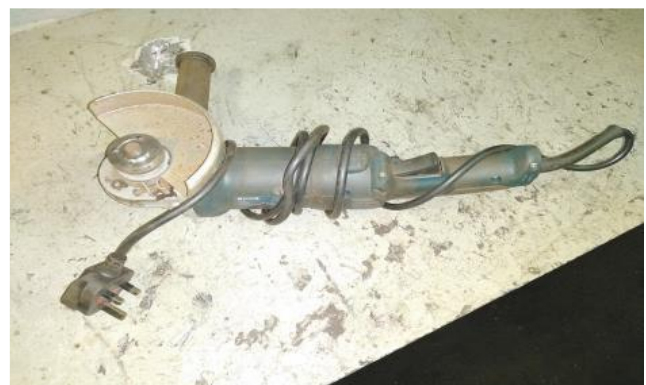
Paddle switch grinder (permitted)

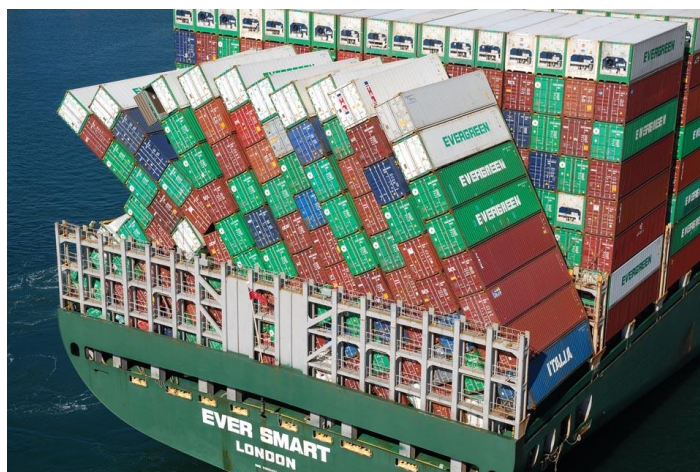
The United Kingdom Marine Accident Investigation Branch (MAIB) has published [Accident Investigation Report 14/2020](#) relating to an incident in which 42 freight containers were lost overboard during a storm. In October 2017, UK registered container ship *Ever Smart* suffered a container stow collapse while on passage between Taipei, Taiwan and Los Angeles, USA. The master had changed the ship’s passage plan to avoid severe weather caused by a developing depression east of Japan. The ship continued in heavy seas; rolling and pitching heavily with frequent bow flare slamming. Once the weather had abated, the crew discovered that the container stacks on the aft most bay had collapsed and toppled to port. Of the 151 containers in the stow, 42 were lost overboard and 34 were damaged. Superficial damage was caused to the ship.

- ◆ The loss of the containers most likely occurred during a period of heavy pitching and hull vibration in the early morning;
- ◆ A combination of factors resulted in a loss of integrity for the whole deck cargo bay; in particular, the containers were **not stowed or secured in accordance with the cargo securing manual**; [IMCA emphasis]
- ◆ The container lashings might not have been secured correctly

The MAIB recommendations to the owners were to improve standards of:

- ◆ Stowage plans produced ashore;

- ◆ Knowledge of the dangers of bow flare slamming;
- ◆ Lashing gear maintenance management.

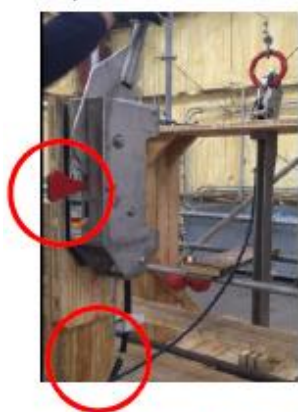
The Coast Guard investigated a casualty involving the unintended on-load release of a lifeboat hook from a davit fall wire. Prior to the incident, damage was noted to a control cable between the release handle and one of the hooks. However, the damaged cable remained in service. The damage may have subsequently worsened over time and contributed to the unintentional release.

Image 1: The release handle is in the locked and closed position. However, the cable is damaged.

- ◆ *Conduct thorough inspections of control cables between the release handle station and release hooks, as well as any other similar cables communicating between the release station and the hydrostatic interlock, if installed, looking for current damage and for potential hazards or other conditions that might compromise the cables in the future;*

- ◆ *Replace cables that show signs of wear or damage to any layers;*
- ◆ *Implement an inspection regime that allows for cable damage to be identified and, as necessary, for cables to be replaced in a timely manner;*

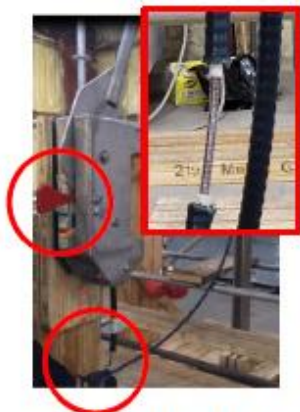
Image 2: Forces cause the outer layers of the cable to separate. The release handle stays closed.

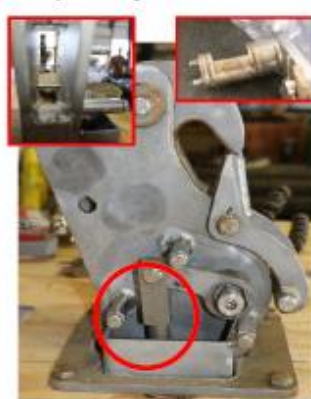
Image 3: At the hook end, the cable end rod moves. This causes the locking shaft to rotate.

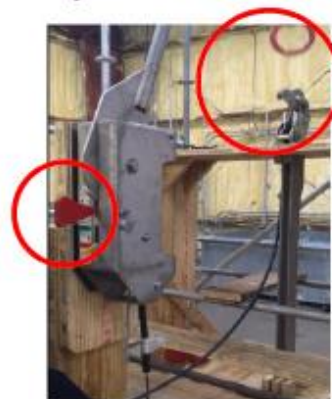
Image 4: If the locking shaft turns enough, the hook will release, even as the release handle stays locked.

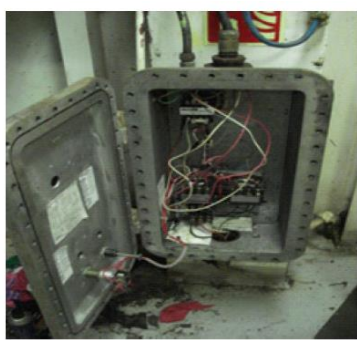
Improperly Modified & Maintained Certified Safe Junction Box

- ◆ Port State Control Officers (PSCOs) have found certified safe equipment improperly installed or identified missing components, which compromises the certification of the system and nullifies this critical protection in a flammable environment;
- ◆ In other cases, PSCOs found degraded components and evidence of equipment not being maintained or inspected;
- ◆ Additionally, USCG personnel have discovered instances where individuals responsible for the installation, maintenance, and oversight of this equipment onboard foreign and domestic vessels were unfamiliar with the appropriate standards to follow.

- ◆ Implement an appropriate periodic inspection and maintenance program by competent personnel;
- ◆ Ensure that any repairs are made by a competent technician or repair facility. When in doubt, a representative of the equipment manufacturer should be consulted. Any modifications to existing systems must be discussed with and approved by the appropriate regulatory authority.

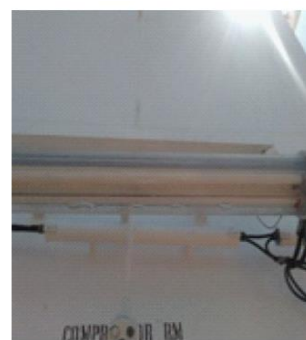
Standing Water in a Certified Safe Flameproof Light Enclosure Indicating Failed Ingress Protection
