IMCA Safety Flash 29/20

October 2020

1 Crane hydraulic hose caught on protruding grease fitting

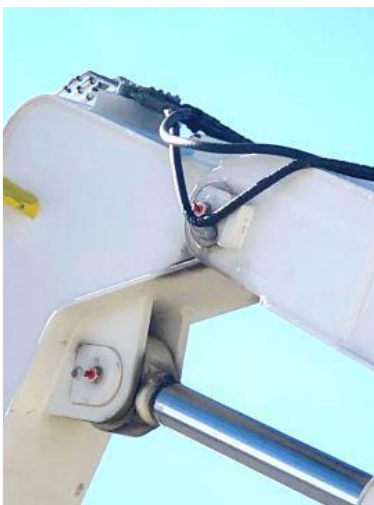
While retracting the outer jib of the boom during crane operations, one of the hydraulic hoses caught on the protruding grease fitting of the boom bearings, which could have led to a failure of the crane and hydraulic oil spill due to hose rupture.

Hydraulic hose caught on the protruding grease fitting

The hydraulic hose routing on the crane boom was incorrectly lined up allowing the excess of the hose to catch the grease fitting – there was insufficient pre-use inspection of the crane.

- ◆ Stop Work Authority was used by Master and crane operations were suspended until a fix could be arranged;
- ◆ The hose was fixed in a correct way to prevent it catching;
- ◆ Proper pre-use inspection should be conducted before each crane operation;
- ◆ Check your own cranes for the possibility of snagging or catching of this sort.

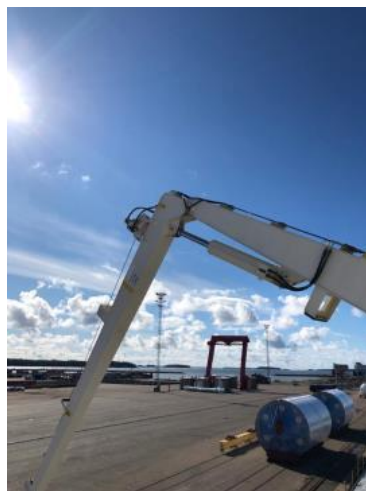
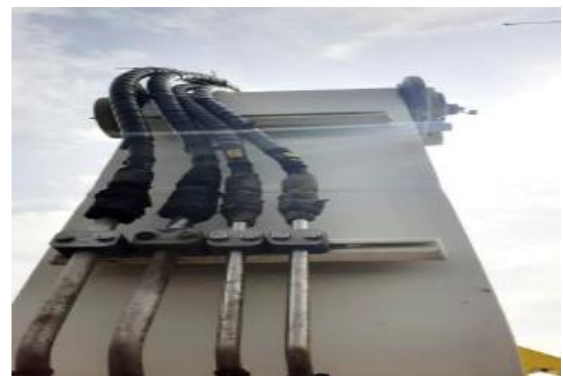
Correctly secured hydraulic hoses

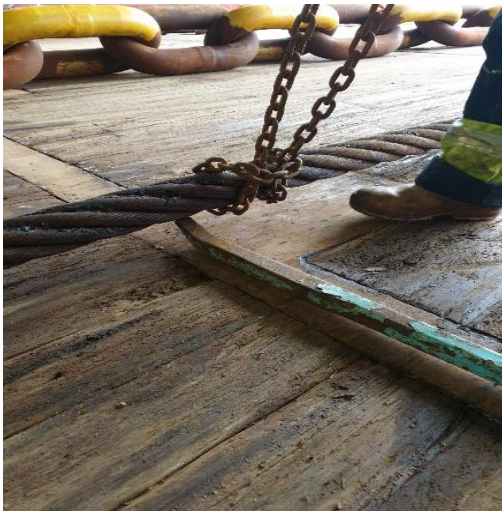
The crew then used a crowbar to try and free the stopper chain from the wire. This was done by inserting the crowbar underneath the wire to lift it up from the deck. One of the AB's was removing the stopper chain whilst the crow bar held it up. Unfortunately, the crowbar was removed too early resulting in the wire falling to the deck whilst his hand was still underneath it. This resulted in a crush injury to the left index finger.

Crowbar used to support the tow wire

- ◆ The size of the chain stopper wrapped twice around the tow wire made access difficult for removal without placing a hand underneath the wire;
- ◆ The tow wire was heavy and difficult to move;
- ◆ There was no alternative means available to move the tow wire;
- ◆ Complacency – “task seen as routine”:
 - It was not foreseen that the tow wire would move;
 - This was a routine activity completed many times before;
 - This method was viewed as “standard practice”;
- ◆ The risk assessment was not reviewed:
 - It did not identify that there should be verification of ‘hands clear’ before the crowbar was removed;
 - There was “normalisation” of the perception of risk of finger entrapment not identified;
 - A failsafe for the tow wire slipping was not identified.

- ◆ Ensuring that where hazards for hand entrapment exist, a suitable assessment of the risk is completed and communicated to all parties involved;
- ◆ Re-emphasise the importance of ensuring that hand and fingers remain out of the line of fire.

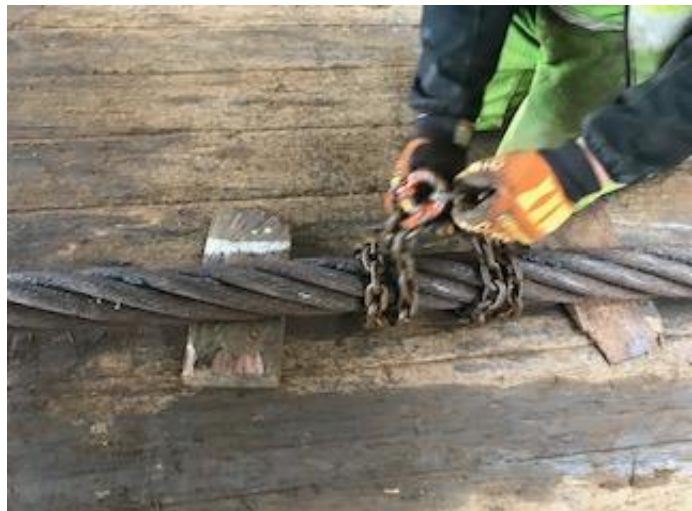
Disconnection of the chain (post-incident solution)

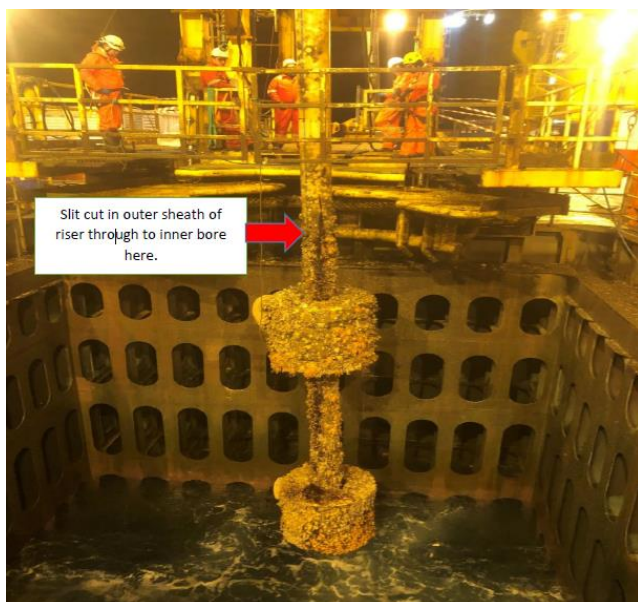
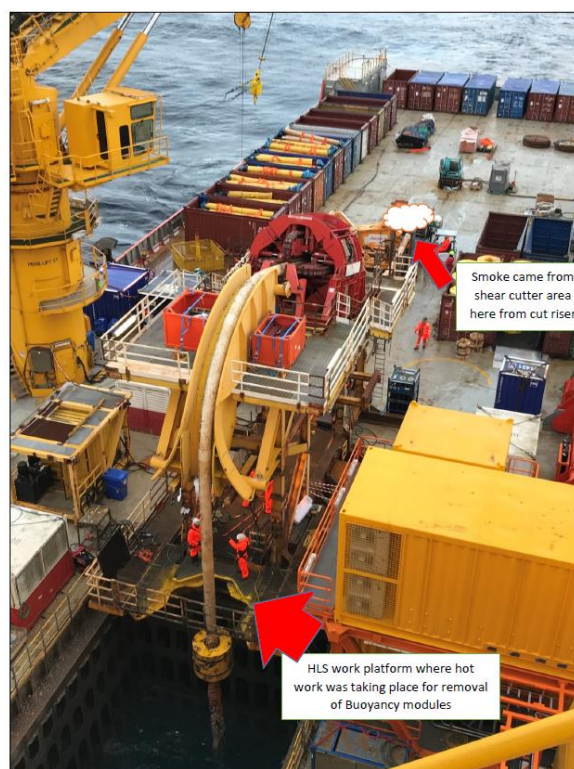
During recovery of a 10” oil production riser at an FPSO, gas in the riser bore ignited and a smoke cloud was seen on deck in the vicinity of the shear cutter. The vessel Master was on the bridge and saw the occurrence. Crew were working nearby on the HLS (horizontal lay system) and work platform removing buoyancy modules and inner clamps.

- ◆ **Underlying cause:** A slit was completed to mitigate an identified hazard, however it also introduced a new hazard that resulted in current incident. This hazard was not identified in HAZID or HAZOP & Risk Assessment sessions onshore. New elements were introduced to the procedure without identifying the new risk. When introducing new elements to a procedure, all consequences (if any) must be investigated
- ◆ **Immediate cause:** Ignition of gas in riser bore with smoke exiting at shear cutter end due to spark from hot work being carried out at the HLS platform – opposite end
- ◆ **Root Cause:** Slit in riser outer sheath through into riser bore allowed air ingress and gave a path for any hot sparks to ignite any residual gas in the riser bore

- 1.Keep area around shear cutter well clear during all cutting operations , on both sides;
 - 2.Do not bag ends of cut sections to avoid being in the riser cut section area (the bags serve little purpose as they rip when the riser is pushed along the chute);

- 3.Readings to be taken before and after cuts and at HLS platform and report on any combustible levels, with any further action as required.
 - 4.Attempt to always use low pressure air-driven tools [“windy gun”] for removal of buoyancy modules and inner clamps, and avoid hot work. If hot work required attempt to use a grinder (this type of cut can bring its own hazard to manage as the clamp bands can spring when cut)

- 5.Shear cutter “water mister” to be engaged when cutting.
- 00:05 Client rep. notified on plan ahead and revised risk assessment/job safety analysis reviewed with all nightshift deck crew.

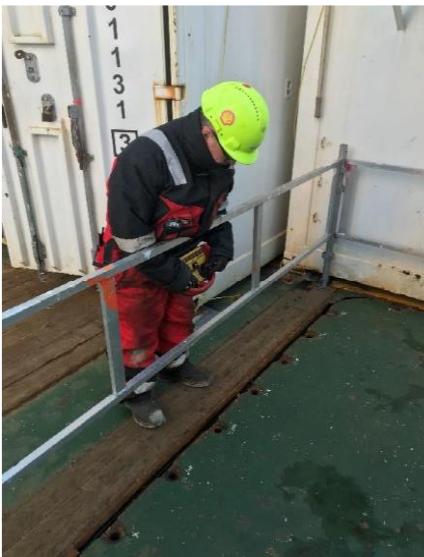
A dropped object event occurred when a crane wireless remote control unit fell from the main deck to the ROV winch room deck below. An operator was controlling a 3 tonne crane with a wireless remote control unit (1.5kg) strapped to his waist. As the operator stood at the edge of the hatch to view the crane hook, the belt buckle failed, and the remote-control unit dropped almost 7 m to the ROV winch room deck below.

Position of the operator at the hatch

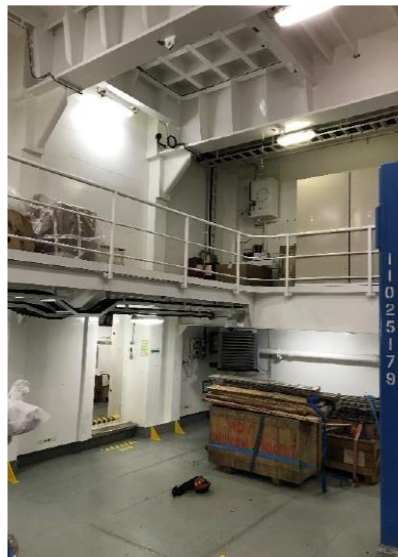
Fall path and final position of the wireless crane control unit

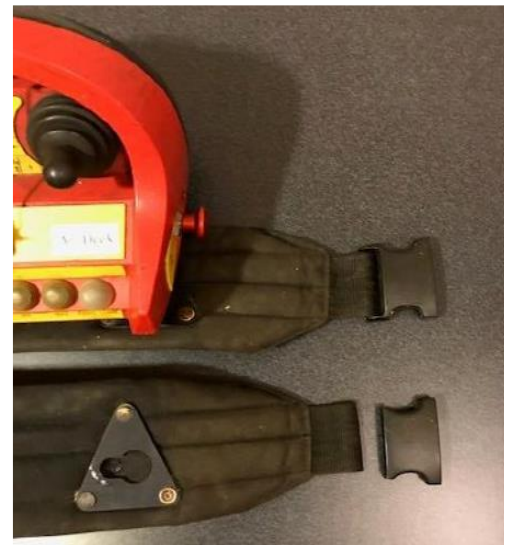
*Upper: undamaged belt buckle
Lower: belt buckle post-incident*

The wireless remote controller was secured around the waist of the crane operator by a belt with a plastic side release buckle clip (securing mechanism). The original manufacturer's securing mechanism was used. Given the age of the crane, it was estimated that the belt was approximately 10 years old. The service logs did not indicate any changes, replacement or repairs to the remote unit or the belt.

- ◆ Include inspection and replacement of securing mechanisms within PMS (planned maintenance systems);
- ◆ Inspect securing mechanisms of wireless remote-control units and consider the use of a secondary retention strap such as a DROPS lanyard;
- ◆ Review the application of kick boards around hatches and areas with the potential for dropped objects;
- ◆ Reinforce the importance of pre-use visual inspections of equipment.

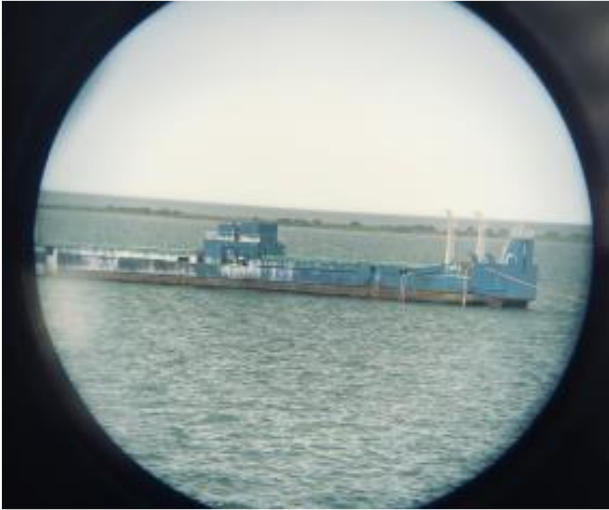
Two barges were tied up and moored at an anchorage. Crew were working on a third barge when they spotted the unusual position of another barge, and suspected that a mooring line had parted.

Mooring line broke

In this particular anchorage there were a number of unmanned barges all tied to mooring buoys. Noticing that there was a serious problem and spotting the damage required a sharp eye and more than that, a high sense of responsibility. The unsafe condition reported to the office; the damage to the mooring line damage was confirmed by one of the company's tugs, and the damaged line replaced.

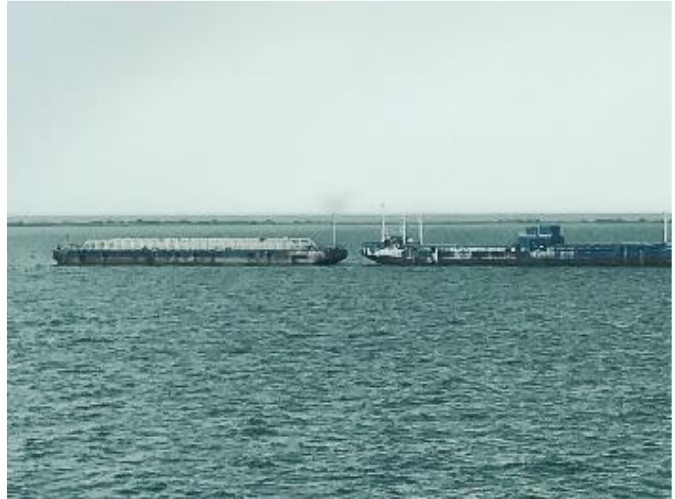
Barges untied
