IMCA Safety Flash 30/20

October 2020

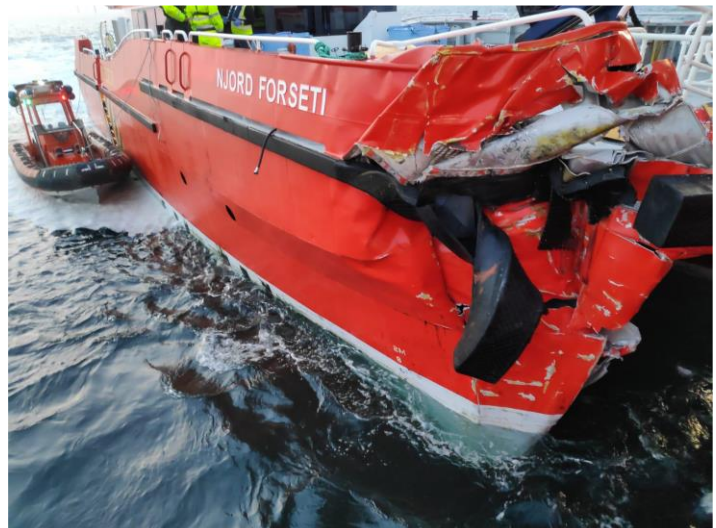
Whilst transiting between windfarms at approximately 20 knots, *Njord Forseti* hit a turbine tower. The impact resulted in serious damage to the vessel. Two crew members were evacuated by air to hospital, and the third was required to have a subsequent medical examination. Immediate assistance was provided by a nearby offshore construction vessel. The *Njord Forseti* returned to port under her own power with temporary crew members provided by a sister vessel.

- ♦ For an indeterminate period between departure from the windfarm until the incident occurred, the vessel crew were not keeping a proper look out as required by Rule 5 of the International Regulations for Preventing Collisions at Sea (COLREGS);
- ♦ The primary reason why a proper lookout was not being kept was because the Master was distracted from his primary role;
- ♦ It is possible that the Master was distracted from his primary role as he may have been adjusting of settings on the VHF radio which is mounted immediately to starboard of his seat. However, this has not been positively determined and distractions caused by other means cannot be ruled out;

- ◆ At the time of the incident the vessel was not following the established passage plan from the windfarm to port, but was undertaking an alternative route. Whilst this route was safe, ineffective monitoring of the vessels track, position and proximity to navigational hazards contributed to the incident.

- ◆ There should be renewed emphasis on the importance of compliance with COLREGS, and particularly Rule 5;
- ◆ Identify tasks, equipment and functions that may give rise to possible distractions for the person having the conduct of a vessel whilst underway, and implement measures to ensure that the safe conduct of the vessel is not impaired by these or other factors;

- ◆ Review the methods by which Masters monitor the safe progress of a vessel's passage and make changes as necessary, including where necessary, additional training;

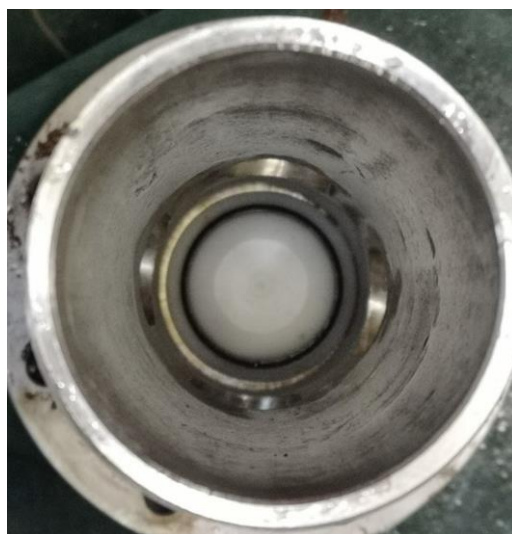
The endcap plug unscrewed itself over time and eventually detached from the float. Because the endcap plug is heavier than water it sank to the bottom of the guide tube and blocked the tank outlet.

Figure 1 - Endcap Plug detached from float and blocked tank

That would result in no water being supplied from the tank, and therefore it could have **life-threatening repercussions in the event of an emergency**. In normal circumstances it would only be detected during routine 6 monthly maintenance. (IMCA emphasis).

The floating plug assemblies were removed from all 6 x FiFi tanks on the vessel and the endcap plugs were permanently bonded to the floats to prevent this failure from happening again.

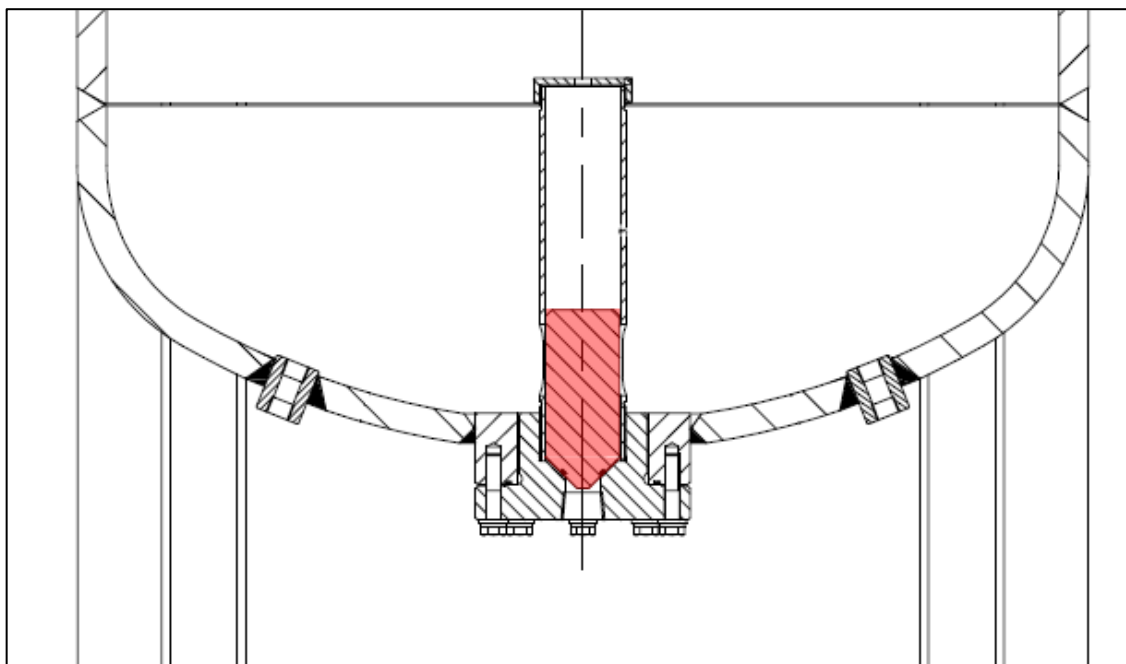
On this particular DSV the saturation diving chamber complex has six firefighting water tanks. Each tank has a water outlet at the bottom with a floating plug that blocks the outlet if all the water drains from the tank. See line drawing of the bottom of one of the FiFi tanks.

Figure 2 Drawing showing bottom of FiFi tank

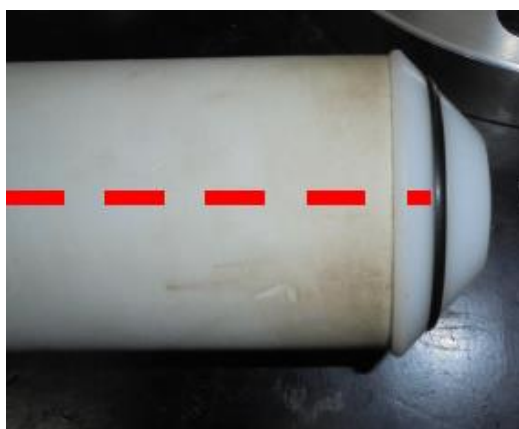
The floating plug assembly consists of a buoyant float and a nylon conical endcap plug with recessed O-ring, which sinks in water. The floating plug assembly is highlighted red in the line drawing. The float is connected to the endcap plug with a threaded rod through the centre, as shown on Figure 3. The floating plug is retained in the tank by a guide tube.

Figure 3 – Floating Plug with threaded rod position shown in red

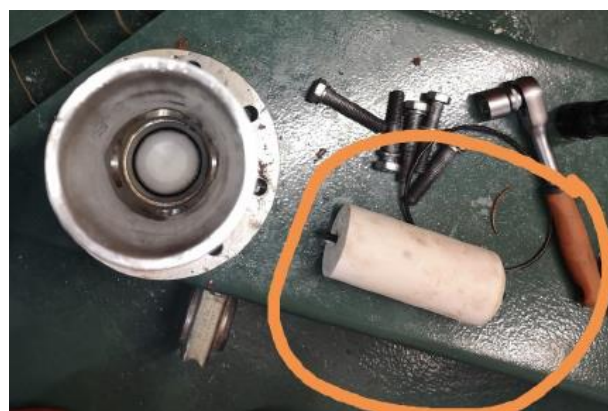
Figure 4 – Blocked Guide Tube Float
