IMCA Safety Flash 31/20

October 2020

1 Main crane hoist wire damage

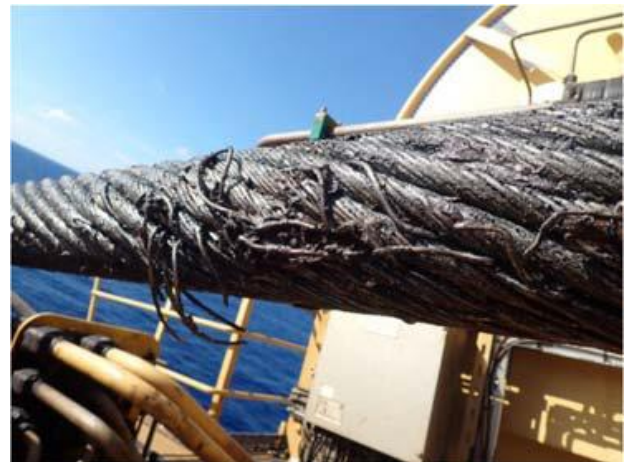
A 70-centimetre length of main crane hoist wire was found to be damaged during an inspection. During pile installation operations, small plastic items were observed to be attached to the 400te crane main wire. The plastic was identified as ducting, a protection barrier from water/grease spray when recovering or paying out the crane wire within the crane pedestal.

- ◆ A contact/rubbing point was identified on the knuckle aperture where the crane wire passed through the knuckle boom;
- ◆ The crane operator struggled to engage the Active Heave Compensation (AHC) and proceeded to disengage the auto knuckle function to activate AHC;

- ◆ The crane operator ignored the angle deviation alarm and did not notify the lay technician of any issues;
- ◆ The resultant knuckle position extended beyond the working parameters of the special lift mode which caused the crane wire to contact the knuckle aperture. When AHC was activated, it created a sawing motion against the inner side of the aperture which over a period of lifting operations damaged the wire rope and cut a groove into the aperture structure;

After internal consultation with both company technical specialists and the offshore management team, it was decided to cut 1,410 meters of wire rope from the hook subsea using an ROV. The crane wire re-socketing was then performed onboard the vessel main deck. This work cost 71 hours of downtime.

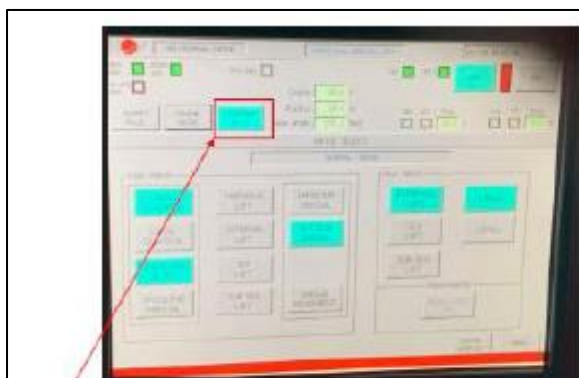
- At the time of the incident, the crane operating system displayed a KN-Boom Auto virtual button with no other information when selected. The crane manufacturer subsequently recommended to upgrade the system to enable a pop-up screen showing the limits in special lift mode when the KN-Boom Auto virtual button is selected.

Photograph #3 shows the system configuration at the time of the incident which displayed the KN-Boom Auto virtual button with no other information

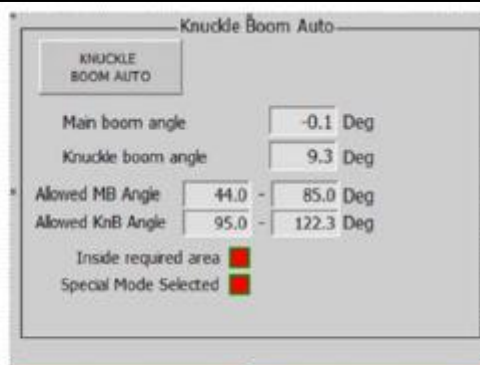
Photograph #4 shows an example of pop up screen with the limits displayed when the KN – Boom Auto virtual button is selected

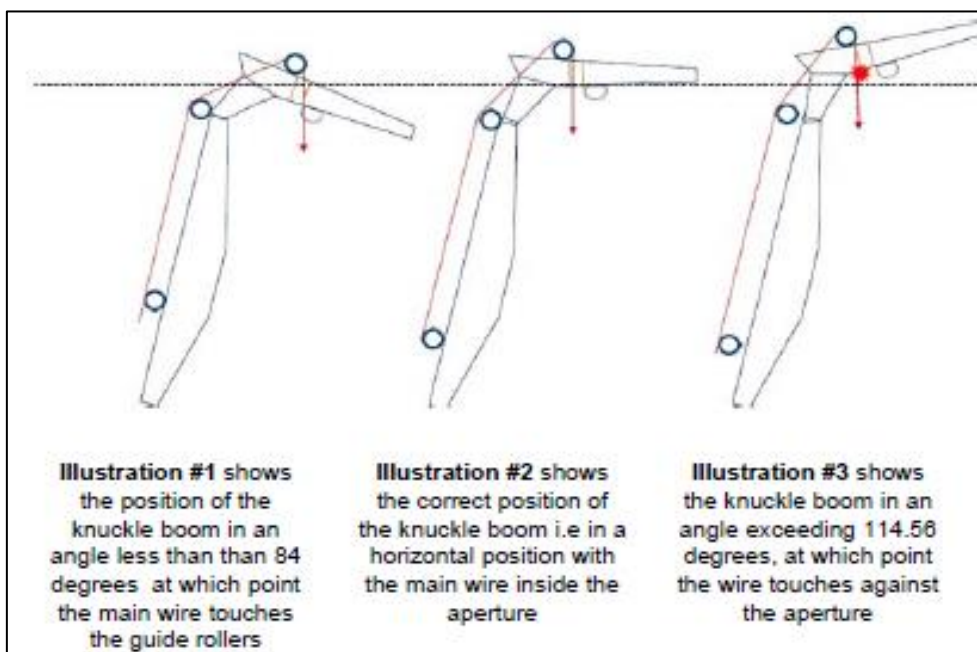
Illustration #1 shows the position of the knuckle boom in an angle less than 84 degrees at which point the main wire touches the guide rollers

Illustration #2 shows the correct position of the knuckle boom i.e in a horizontal position with the main wire inside the aperture

Illustration #3 shows the knuckle boom in an angle exceeding 114.58 degrees, at which point the wire touches against the aperture

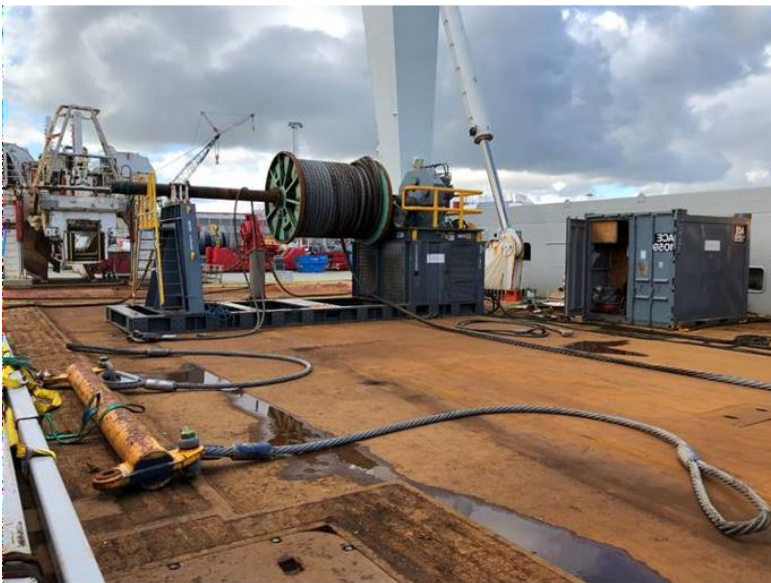
Back deck - 64mm wire rope slings connected to the spreader beam

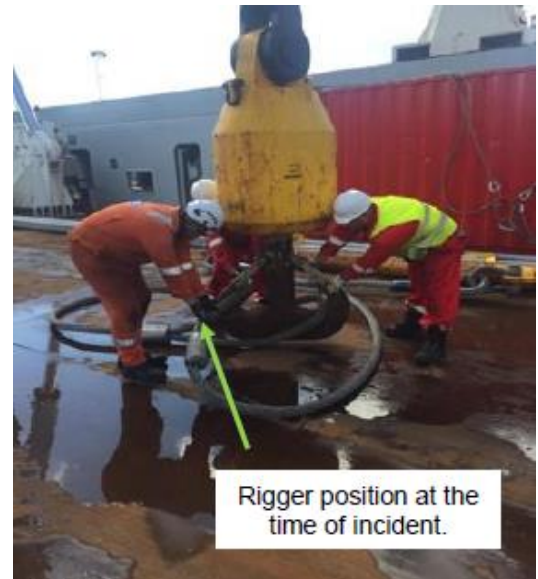
Post incident - disconnecting wire rope slings with the crane hook lowered to the deck. Note, crane was positioned at waist height at the time of incident.

- ◆ There was no Task Risk Assessment and Toolbox Talk for what was a non-routine lift;
- ◆ The crane hook was at waist height and kept in proximity to the spreader beam to assist manual handling; this introduced a bend in the wire rope sling with possible torsion which introduced an unknown amount of stored energy;
- ◆ During the task, the rigger acknowledged the advice from the Deck Foreman to watch out for stored energy but did not appreciate the potential risk from this and continued working.

- ◆ Raise awareness of the critical need for a time out before starting non-routine activities;
- ◆ Ensure that Task Risk Assessments and Toolbox Talks include everyone involved in the lifting operation and that they are fully aware of the inherent risks;
- ◆ Whilst removing wire rope slings from crane hooks, it is recognised that there will be many different situations. In most cases, however, the crane hook should be landed on the deck before disconnecting the slings;
- ◆ Reinforce with riggers and personnel involved in lifting operations the need to remain aware of the potential hazard of stored energy in large steel wire rope slings when disconnecting them from the crane hook and during general wire rope handling activities.

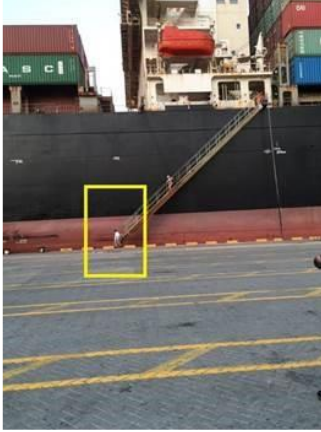
Pilot jumping from vessel

The very next day after this injury was reported, local port staff reported an unsafe act involving another pilot who disembarked from a vessel before berthing was finalized and the gangway adjusted for his safe egress. He “jumped” from the gangway onto the jetty. That pilot was also not wearing a lifejacket whilst disembarking – another significant concern. Given the known potential for injuries, this event was recorded and investigated as a ‘Near-Miss’.

- ◆ Remind pilots and all personnel that disembarkation from the vessel is only to take place with the gangway fully flat on the jetty and vessel crew in attendance. When time pressure is an issue, communicate the cause for delays – don't take shortcuts!
- ◆ When possible and available, use available persons on the jetty to assist safe egress from the gangway;
- ◆ Vessel mooring must be complete before the pilot disembarks ashore;
- ◆ Lifejackets, like all other PPE, should always be worn for safe access and egress.

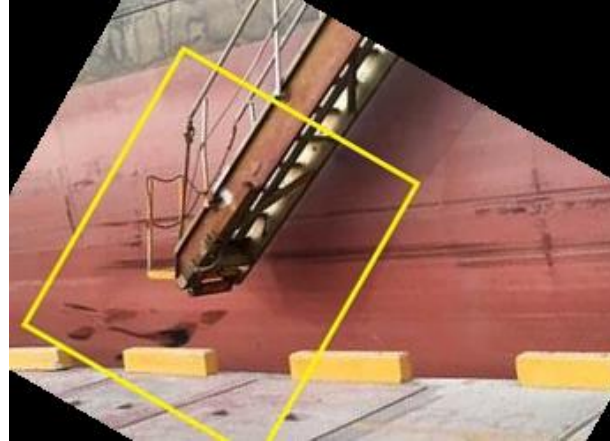
Gangway not rigged at the correct height for safe transfer of personnel

The personal injury was sustained while the gangway was not higher than 0.5 meters from touching the jetty; the injured person judged the situation to be safe for his transfer ashore. He fell and hurt himself. The injury did not require him to be away from his duties, but the potential was high, and still resulted in stitches on his face, caused by broken eyeglasses as a consequence of his fall.

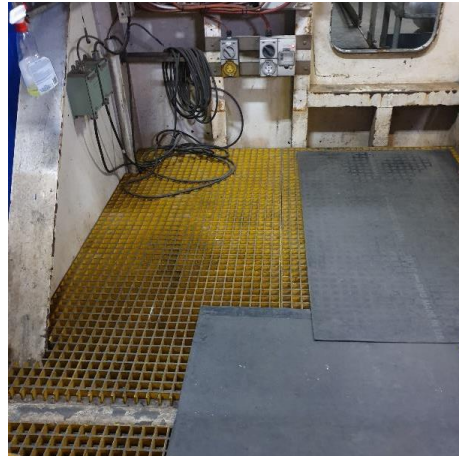
- ◆ He did not check for safe securing of portable ladder;
- ◆ The uneven levelling of the deck was not considered prior to ladder use.

Uneven levelling of deck

- ◆ Risk assessment and toolbox talk before working on ladders;
- ◆ Routine inspection of ladders, and procedures that identify the quarantining of damaged ladders;
- ◆ Inspect your ladder before you start work!
- ◆ Make sure you're familiar with the hazards and risks before using a ladder;
- ◆ Position the ladder on a stable surface, where it won't wobble.

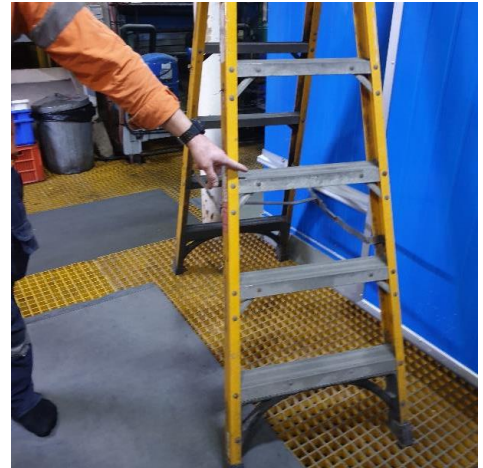
Placement of ladder

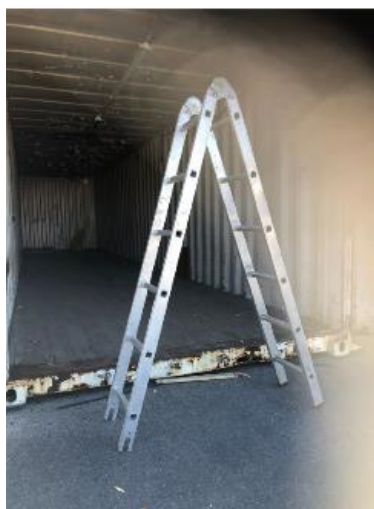
- ◆ No risk assessment, permit to work or procedure was in place for the task or for the lifting of the container;
- ◆ There had been no check of the ladder before he started going up it – otherwise he might have noticed it was damaged;

Ladder involved in incident 2

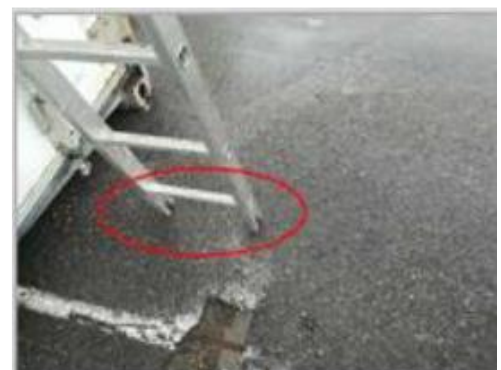
Damaged rubber feet on ladder

- ◆ The broken ladders shouldn't have been there at all: there was no routine inspections of ladders, and no quarantining of defective ladders;
- ◆ He was not wearing safety boots at the time of the incident;
- ◆ There was no training or awareness methods in place for the safe use of ladders.
