Fires and fire risks on vessels

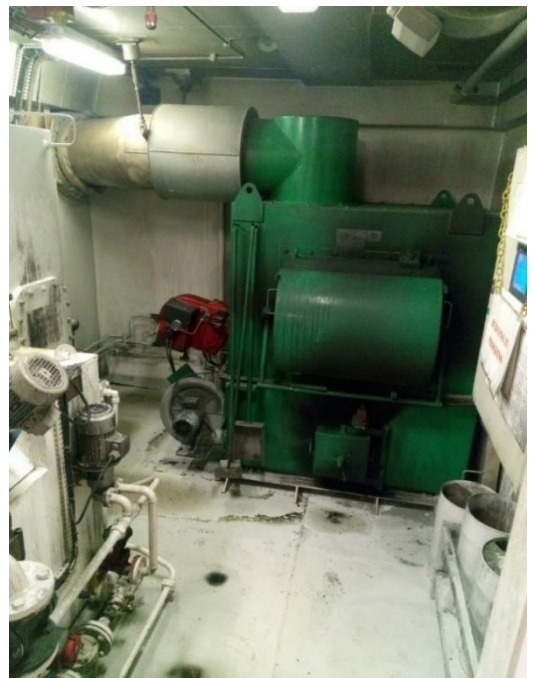
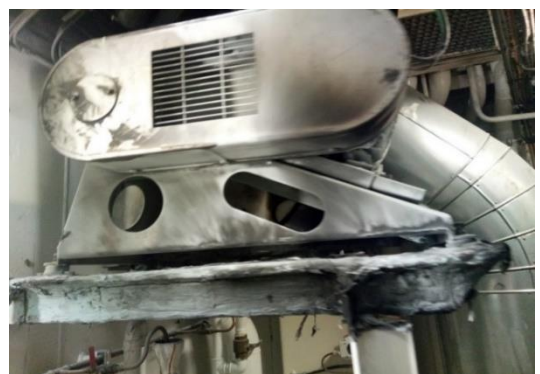
An incinerator was being routinely operated by its designated operator. After the last garbage parcel was inserted into the chamber, the operator noticed flames and smoke coming out of the exhaust pipe and ash removal door. The bridge was immediately informed via radio. The operator left the room, and activated the emergency stop and the hi-fog system. The fire alarm was sounded and the crew mustered. While the fire teams responded to the fire in the incinerator, multiple fire sensors located in the casing and engine room were activated automatically. Fire fighters went to the engine room and found the exhaust fan motor from the incinerator on fire. The fire was extinguished by dry powder extinguisher.

The exhaust fan holding bolts were found broken inside the casing.

Investigation confirmed that the fire was caused by overloading the incinerator with plastic and thereby creating excessively high temperatures. This led to overheating of the exhaust fan which created an imbalance of the fan and consequent failure of the bolts.

- ◆ The manufacturer's recommendations for maximum loads for the incinerator chamber, in terms of type and amount of waste, should be displayed at a conspicuous place near the incinerator;
- ◆ Further documented training/familiarization for the operators;
- ◆ Segregation of waste as per garbage management plan.

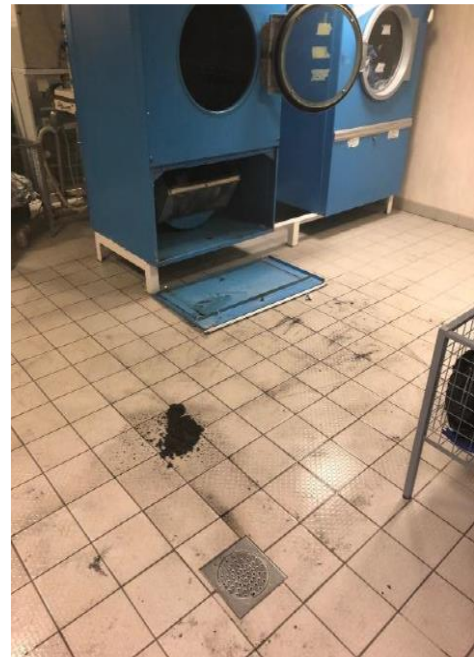
The fire was due to a build-up of dust/residue inside the exhaust ducting between the tumble dryer and secondary filter, causing the safe operational limits of the machine to be exceeded.

Further investigation established that the heat sensor, a safety feature designed to protect the machine from overheating, had failed.

Laundry Room with tumble dryer in the background (Dust from smouldering laundry can be seen on the floor)

- ◆ **If you see or detect a fire, raise the alarm! Never investigate further or tackle the fire unless it is safe to do so;**
- ◆ Ensure that all tumble dryer filters and exhaust systems are regularly cleaned;
- ◆ Ensure that the design of the tumble dryer filters and exhaust ducting enable full access to the tumble dryer and exhaust ducting. Consider whether additional access hatches need to be installed to improve access;
- ◆ Check of the safety sensors within the tumble dryers and consider installation of a secondary safety sensor as back-up;
- ◆ Confirm that heat and smoke detection in laundry rooms is suitable and sufficient.

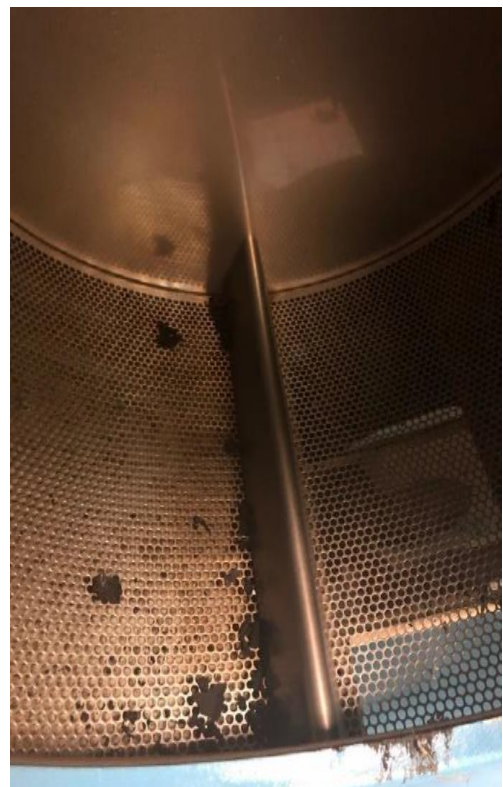
Inside tumble dryer (Dust from smouldering laundry can be seen inside)

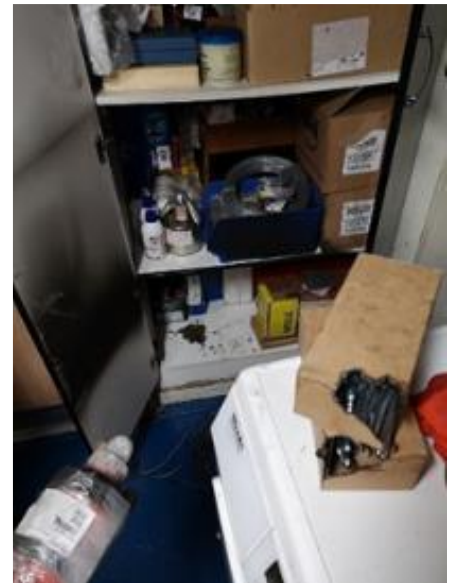
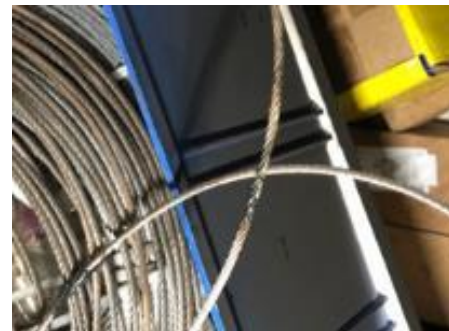
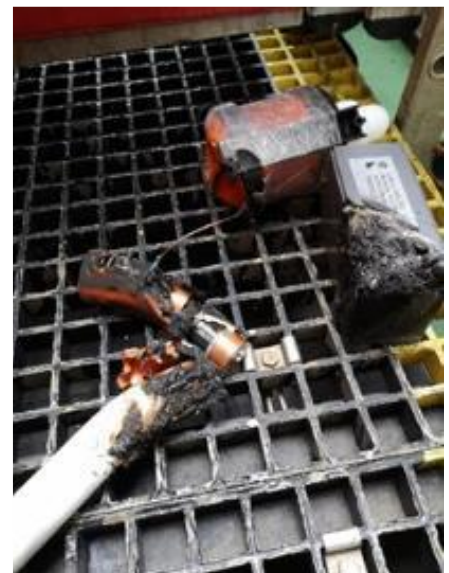
A small fire occurred in the safety locker of the changing room. The safety locker was used to store various safety items including among others: an Aldis-lamp spare battery in its carton packaging, a spare stainless steel wire coil for the rescue boat, a Holmes (lifebuoy) light filled with regular batteries and various other safety items packaged in carton boxes. During rolling of the vessel, the steel wire fell from its position and came in contact with the spare Aldis battery. This created a short circuit and caused high temperature/sparks. As a result the Aldis battery and the steel wire coil were damaged and some of the carton boxes were slightly burned. The smoke triggered the fire alarm and the fire team responded immediately. Although the damage was limited to the above, the consequences could have been much more serious under slightly different circumstances.

The materials within the safety locker sparked a fire in combination with each other. The specific combination and cause of the fire is quite unusual but it can still cause a fire.

The storage of the materials, although at first sight was safe and sufficient, did not take fully into account the fire triangle principle.

- ◆ The surroundings of stored materials should be taken into account when considering fire risk;
- ◆ Beware of the combination of stored items which may cause development of sparks and/or heat;
- ◆ As far as is practical, always remove batteries from any device in storage;
- ◆ Check existing stores in light of lessons learned here.

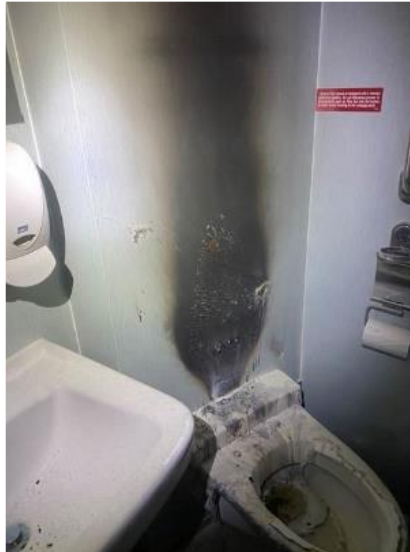
Showing damage to wall in bathroom

The fire started when the ceiling light fixture overheated due to an internal failure/short at the bulb connection point. Due to the overheating, the light's plastic cover melted and dripped onto the toilet lid, setting it on fire, which then scorched the wall.

- ◆ Inspect all cabin light fixtures by removing covers/shrouds to identify any noticeable signs of deterioration/corrosion, etc., or other issues of concern. Remedial actions should be left to the engineers; crew members should not attempt to remedy such concerns themselves;

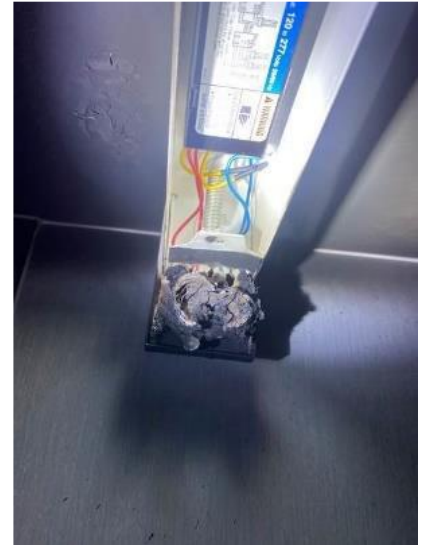
Bathroom ceiling light fitting

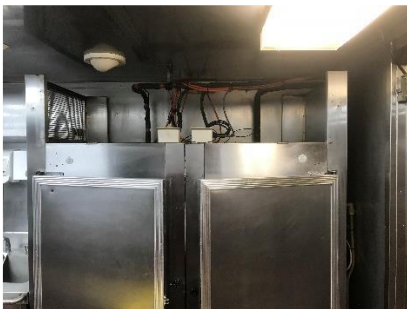
Whilst fault-finding an earth fault on the 240v mains system on a vessel, the engineers came across a pair of mains sockets installed above the galley fridge / freezer space. This space was not ventilated. These mains sockets were discovered to be heavily soiled by the fat residue that had drifted into this space from cooking in the galley.

Grate removed showing space above the unit

- ◆ The entire area was cleaned comprehensively once the sockets were isolated and locked/tagged out;
- ◆ The sockets were inspected and replaced if necessary, and testing conducted;
- ◆ Checks to be made of difficult to access areas, high up areas and such in galleys to ensure nothing similar could occur elsewhere.

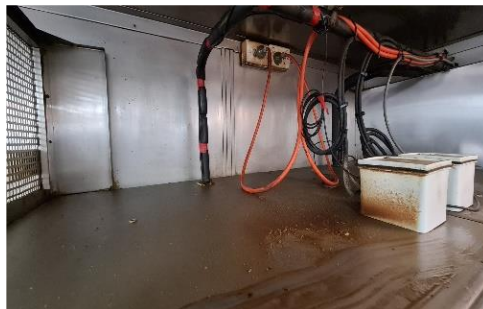
Fat residue on the top surface of the fridge freezer

The fat residue was the immediate cause of the earth fault. This was clearly a potential fire hazard caused by the fat dripping down into the mains sockets.

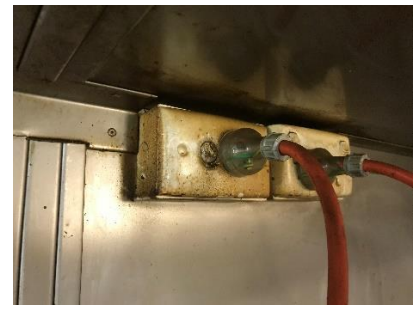
Fat residue accumulation on the power sockets

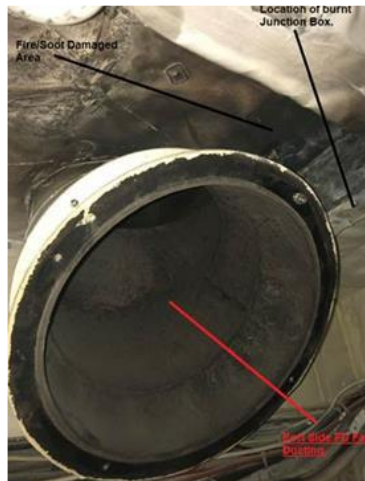
A fire alarm was activated from within the machinery space, and on investigation, a minor fire was noted on the deckhead at the port side exhaust fan junction box. Given the limited size of the fire, it was tackled with a dry chemical powder extinguisher.

Heating was caused by a breakdown in continuity in a terminal block inside a plastic junction box mounted on the machinery space deck head. The cable possibly suffered breakdown at the termination, or the connection in the terminal block joining the supply to the consumer had weakened, leading to reduced continuity (increased resistance) and consequent heating of the wires.

Port Side exhaust fan ducting

- ◆ Check physical and electrical condition of connections for high load or continuously running equipment;
- ◆ All terminations to be checked as a matter of routine during forth planned maintenance.

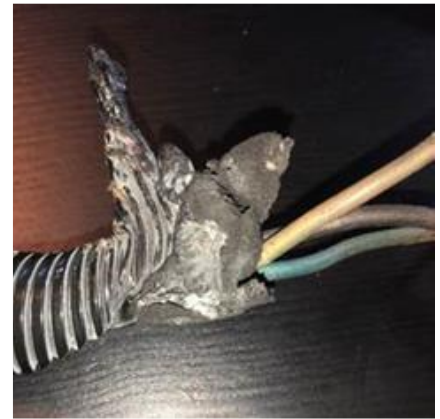
Fire spread to cable conduit
