## 1 Simultaneous activities on the bridge caused a DP Incident

## 2 Inadequate Position Reference Systems Caused DP Incident

### 3 Lack of Experience in Dealing with Environmental Conditions Caused Loss of Position

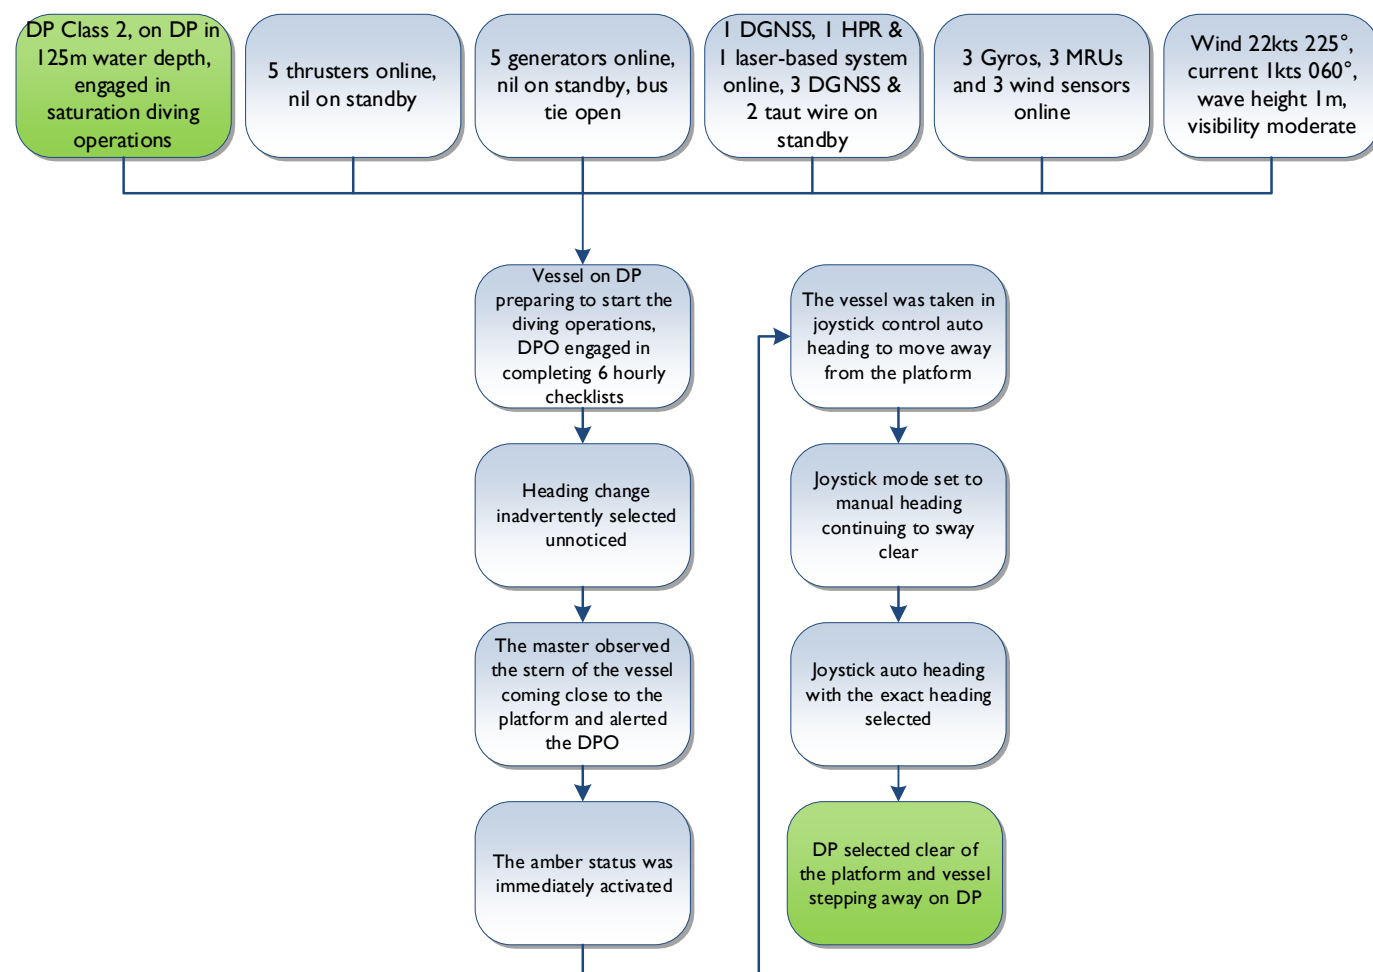
The DPO, though experienced, was new to the vessel and the DP system. He had undergone familiarisation of the system but misinterpreted 30° heading increment as being a 30° / min rate of turn. As the 6-hourly checklists were being completed, the vessel was making moves and deploying references. Multiple operations were initiated just prior to watch handover which could have been delayed by a few more minutes.

- ◆ Bridge resource management was not properly exercised. In principle, the second DPO should fill out the checklists and the DPO at the desk should concentrate on vessel position keeping only;
- ◆ The familiarisation process should be reviewed to be more robust to ensure new DPOs are completely familiar with the desk and functions;
- ◆ Reference should be made to [IMCA M 117](#) “The training and experience of key DP Personnel;
- ◆ It should be noted that a 30° per minute rate of turn was considered to be far too high whilst engaged in diving operations.

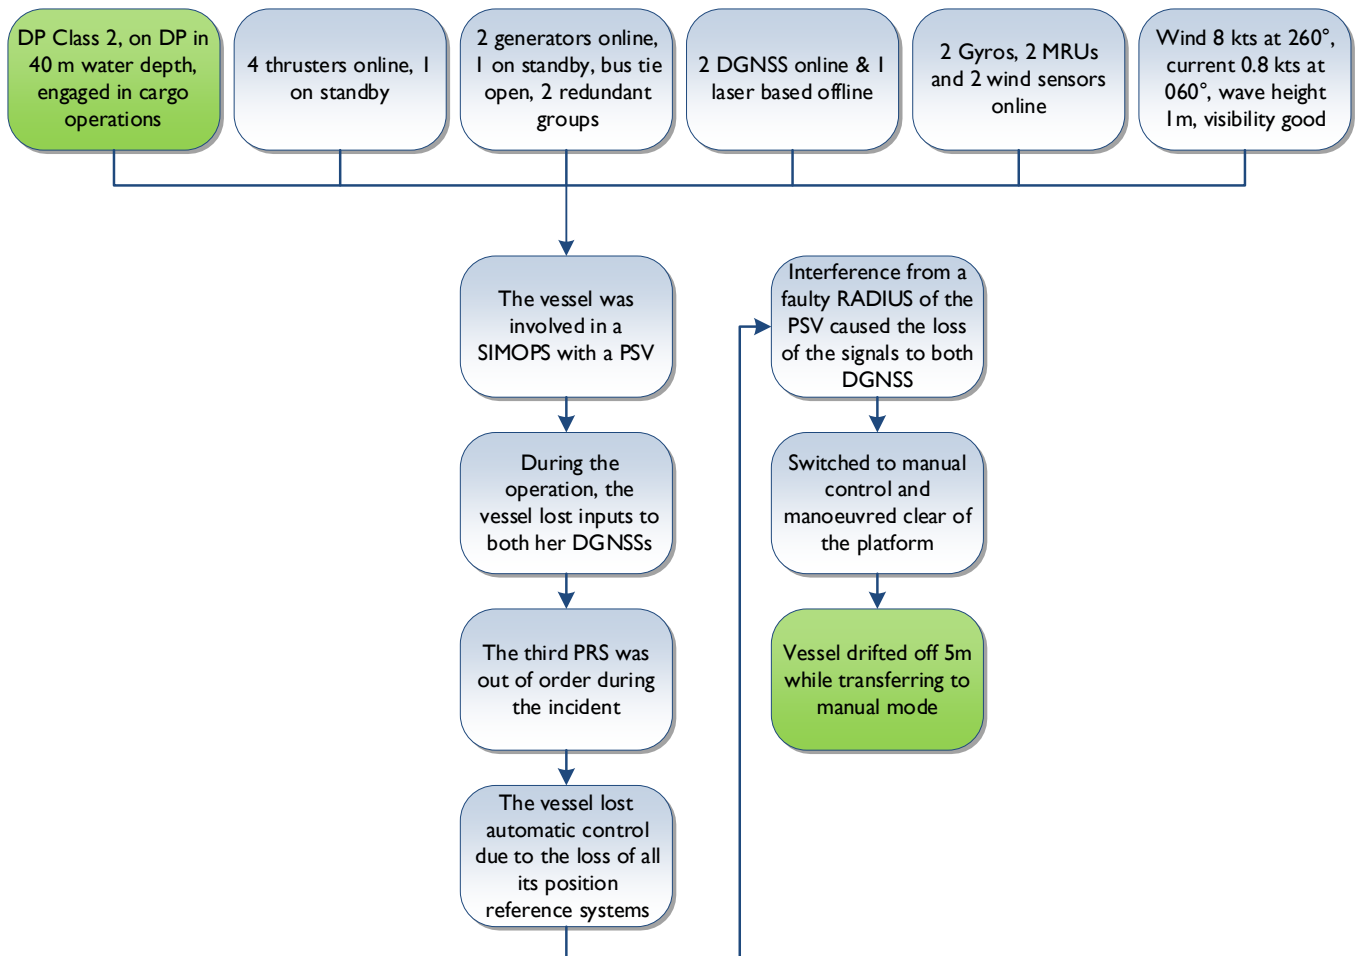
It is mentioned in the report that task appropriate mode (TAM) and activity specific operating guidelines (ASOG) were in use, with the limitation identified for 2 DGNSS subject to common mode failure.

- ◆ Use of only 2 DGNSS was contrary to the MSc.1 / Circ. 1580 requirements. This meant the vessel was not set up in accordance with DP class 2 requirements of 3 position reference systems based on at least two different principles;

- ◆ Vessel sensors selection did not appear to comply with DP class 2 requirements, though this non-compliance was not a factor in the incident;
- ◆ Task appropriate mode was in place, indicating that a loss of position was acceptable. However, the incident indicates that an adequate risk assessment was not done and TAM and ASOG were not thoroughly reviewed prior to their approvals;

- ◆ When the vessel lost its automatic DP control due to the loss of all its PRSs, the position could have been maintained for a period of time using the DP mathematical model;

- ◆ The report states that interference from a faulty laser-based system on the PSV caused the loss of signals to both the DGNSSs. However, this could have been caused by interference of the differential correction signal receivers caused by shielding or reflection;

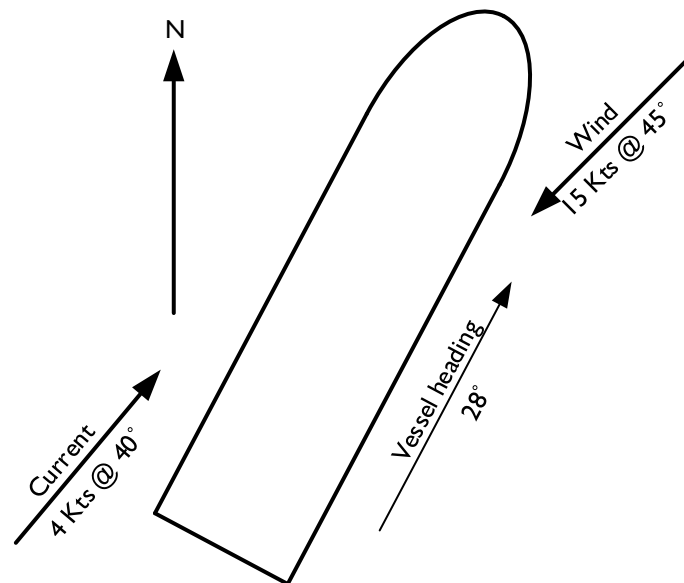
The vessel was encountering strong currents from the stern, as expected, and experienced by the DPO's during the earlier spring tides. For this reason, the vessel receives location specific current modelling from a remote centre during its operations. These models display peak marine current's direction and speed at any given time. During these strong currents, it is prudent to change the vessel heading regularly to follow the currents direction and to keep them at the stern.
