IMCA Safety Flash 04/14

April 2014

I LTI – Thumb Laceration

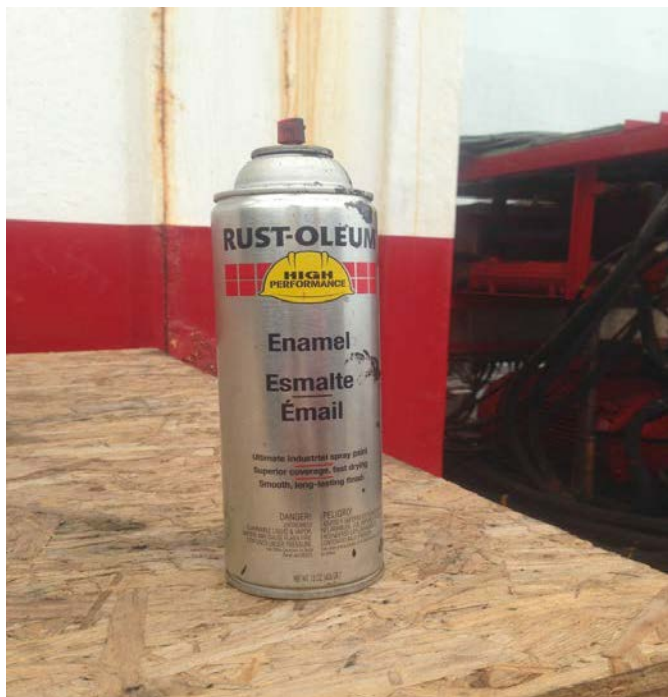
Figure 1: Aerosol Spray Paint can from same batch as ruptured can

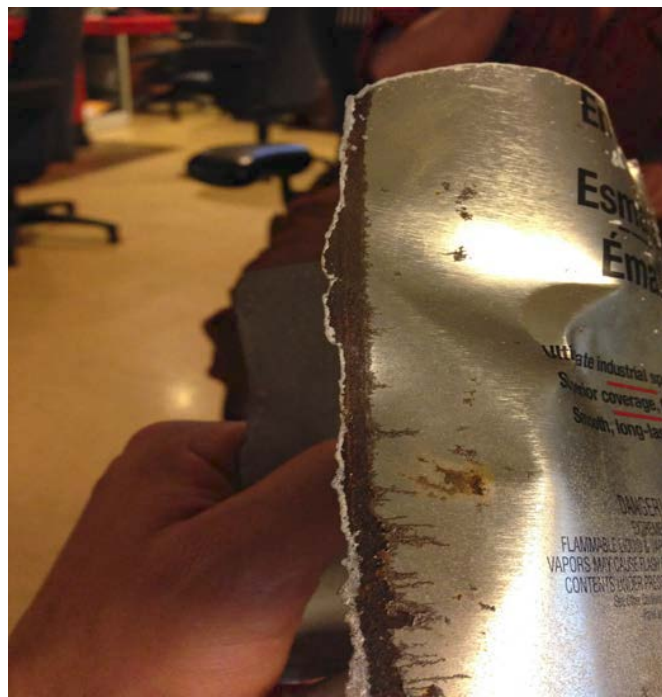
Upon inspection of the can, there were signs of corrosion along the seam of the can, which has caused the can to part unexpectedly under pressure.

Figure 2: Ruptured aerosol can showing evidence of corrosion along seam

- ◆ There was noticeable corrosion of the seam of the aerosol can;
- ◆ The vessel had been operating in humid tropical climates over the past 12 months, which may have caused more rapid corrosion and deterioration of the aerosol can;
- ◆ There was no system in place to monitor receipt of chemicals or the time the chemicals had been on board.

- ◆ Thorough visual inspection of all aerosol cans on board and also fleet wide globally;
- ◆ Amended procedures for dealing with chemicals and other substances hazardous to health, to record when chemicals are received on board and set a maximum usage period;
- ◆ Reviewed company list of approved chemicals and see if it was practical to reduce number of aerosols used;
