# IMCA Safety Flash 10/15

July 2015

## I Near Miss: Dropped Object Fell from Crane Boom

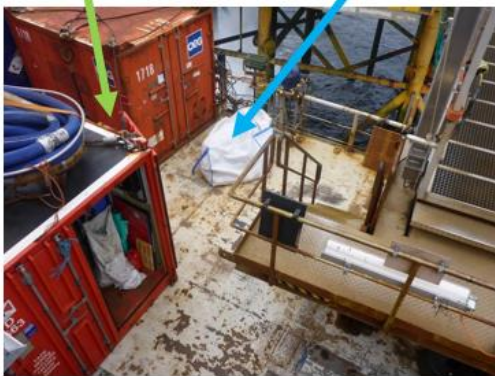
Location of Deck Foreman      Location of dropped object

A member has reported a near miss incident in which an object was discovered which must have fallen from the crane boom. It happened during crane operations when it was noticed that a piece of steel measuring approximately 70mm x 40mm and weighing approximately 300g fell from the boom tip area to the deck. It was assumed (and investigation clearly indicated) that the object came from the inside of the crane hook pocket. This means that the object fell from approximately 100 metres.

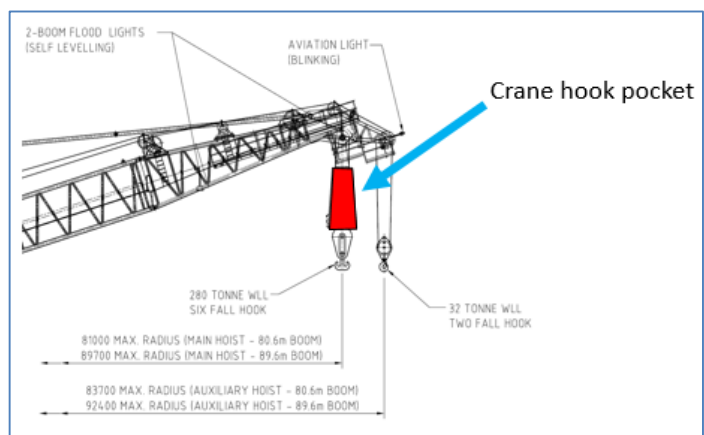
Internal condition of crane pocket

- ◆ Continuous movement of the main block inside the crane hook pocket caused damage to such an extent that a piece of steel broke loose and fell down;
- ◆ The crane hook pocket had been designed for storing the main block during transportation. The crane hook pocket could be locked against the boom using hydraulic pins;

- ◆ When using the auxiliary hook the crane hook pocket was locked against the boom. This caused steel on steel movement of the main block inside the crane hook pocket when booming up and down;
- ◆ Crane inspections only included load bearing parts of the crane;
- ◆ The crane hook pocket had been designed bearing in mind that the auxiliary hook would not be used frequently;
- ◆ No documentation was available on how this crane hook pocket should be used when using the auxiliary hook (locked against the boom or unlocked);
- ◆ An engineering bulletin from the crane manufacturer was not properly taken up by management.

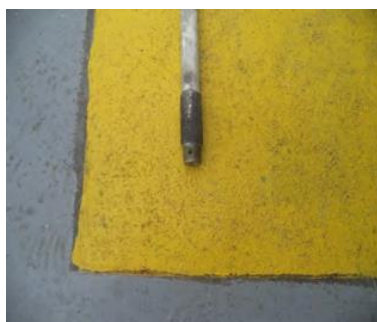
A member has reported a near miss incident in which part of a single side band (SSB) antenna fell off the mast to deck during bad weather. The antenna had three parts which were threaded and screwed together. The first part of the antenna was not fully screwed into the second part. In high winds, the antenna was waving back and forth in the wind which caused it to loosen and become detached. There were no injuries.

SSB antenna above bridge

- ◆ Damaged antenna was removed from above bridge and replaced with new one;
- ◆ Ensured correct practices were used for securing all navigation/communication equipment at height and/or on masts;
- ◆ Thorough check of all existing equipment above bridge or at height and/or on masts, most especially after installation or maintenance by a third party;
- ◆ Crew “time out for safety” carried out emphasizing hazards and risks of working at height and/or on masts, particularly the area above the vessel bridge (sometimes called the *monkey island*).

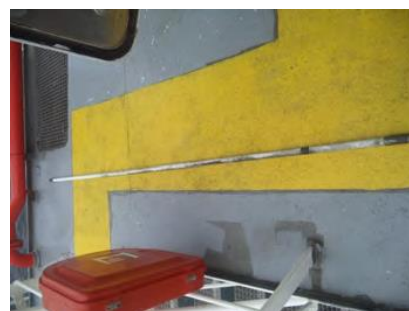
Detached antenna shown on deck afterwards
