## IMCA Safety Flash 17/17

July 2017

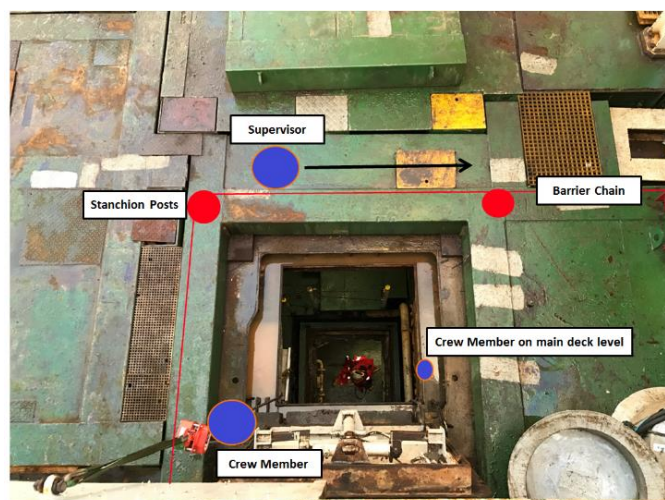
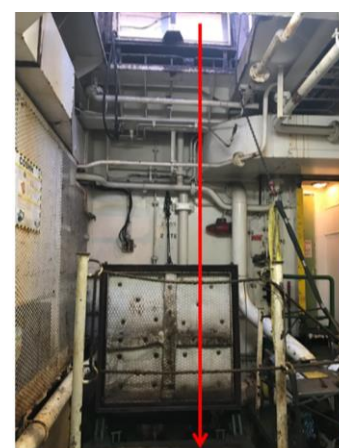
A portable barrier (two stanchions and length of chain) was put around the area to warn of a trip hazard. This was because although it was closed, the hatch was not fully sea-fastened.

Crew operating the chain pulls were stood inside the barriered off area, wearing fall arrest harness and inertia reel. Their supervisor was on the upper main deck outside of the barriered off area. As the equipment was being lifted using this technique, he moved to get a better look at what was happening. As he did so, he lost his footing and tipped forward toward the portable barrier stanchions and chain, and fell through the barrier and down the hatch.

- ◆ Fall prevention barriers that were around the upper main deck hatch were not suitable or sufficient. There was insufficient robust barrier hardware available on board;

- ◆ Several trip hazards existed around the area:
  - where the task was being carried out
  - where the Supervisor was standing
  - where the portable barrier was previously positioned – this was also close to the edge of the open upper main deck hatch;

- ◆ The Supervisor was too close to open hatch hazards without sufficient fall protection;
  - visual obstruction prompted the Supervisor to move to get a better look at the activities he was supervising. In so doing he knocked against the portable barrier

- the supervisor lost his footing/balance close to the edge of the portable barrier and open deck hatches;
- ◆ A generic or blanket Permit to Work was used for the recovery/lifting of this equipment using a working at height/chain pull method, rather than a specific Permit to Work.

- ◆ Time spent discussing the lift in detail, may have detracted from proper review of the suitability of the existing barrier, and possibly divided attention over risks from the lift versus that from the fall;
- ◆ Better management required of Permit to Work system for specific and non-routine tasks;
- ◆ A proper review of the barrier previously put in place, and its adequacy to protect against falls versus highlighting a potential trip hazard, seems to have been forgotten during the planning stages of the task;
- ◆ Lapses do happen – Comprehensive checklists to confirm specific actions required can help address potential lapses. These checklists could be included in pre-task dynamic/situational assessment, and standard pre-start checks made within the Permit to Work process.

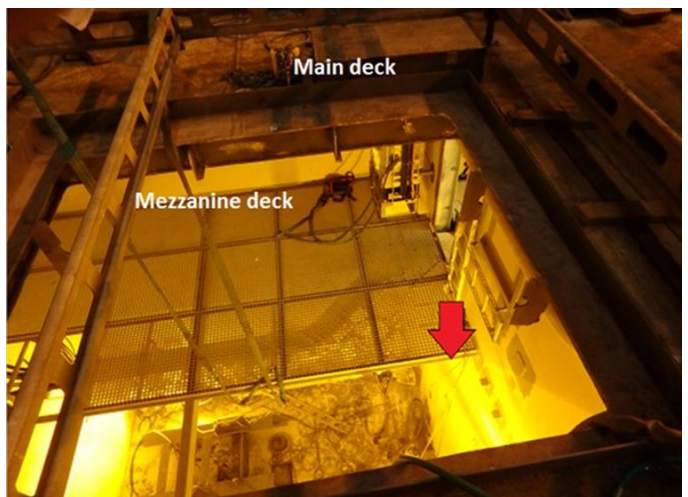
During a yard visit, pieces of grating were being manually lowered with a rope down through an opening on the main deck. The opening on the main deck was barred off by a scaffold. No fall protection was requested by the people on the main deck.

A piece of grating got stuck on an edge on the main deck. This was observed by a co-worker who happened

to be nearby. He intervened in the work operation. The workers on deck shifted the grating about 15 centimetres. As the grating shifted, the new worker continued to hold onto it, lost his balance and fell.

The injured worker was a part of the scaffolding team but was not a part of this planned operation. He decided to help his co-worker. He was wearing a fall arrester but did not clip into an anchor point.

- ♦ **Immediate cause:** the injured worker rushed into a work situation he was not supposed to be a part of. He did not consider the risk in the operation and did not secure his fall arrest to an anchor point;
- ♦ **Underlying causes** of the Incident: the injured worker did not comply with working at height standards and did not pay attention to the risks in the work situation;
- ♦ **Root Causes:** the investigation concluded that these were weaknesses in safety awareness and management of work in the actual situation.

- ♦ Ensure closer follow up of yard to ensure compliance to safety awareness;
- ♦ Executive (high level) commitment to safety is paramount for building a strong safety culture – particularly when multiple organizations are working together in a shipyard.

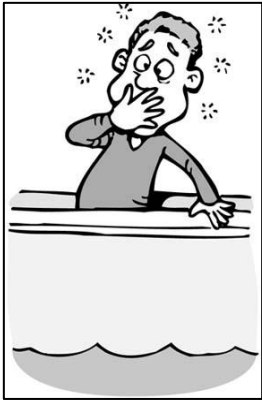
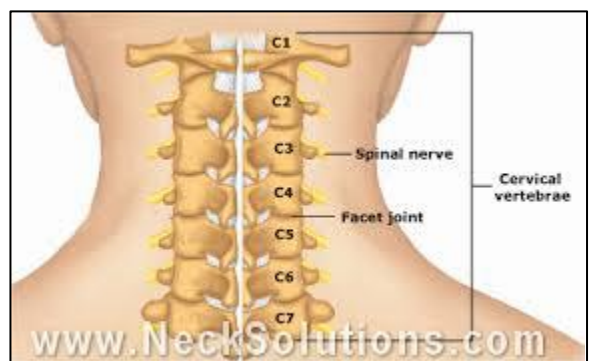
A trainee member of the crew was found lying unconscious on the deck between two cement tanks. In falling his left arm had twisted under him but there were no signs of physical injury at the time. The injured person suffered partial immobility of the left hand as a result of how he fell.

He had collapsed as a result of the combination of seasickness and medication he was taking to address seasickness.

- ◆ As a result of collapsing, this person suffered a potentially serious fall and injury which could have been a good deal worse;
- ◆ No account was taken of the fact that he was an inexperienced trainee. The likelihood of seasickness should be taken into account in risk assessment and informally, when inducting and training new personnel. A “buddy system,” or similar, to ensure new personnel are looked out for, may be beneficial.
