IMCA Safety Flash 24/17

October 2017

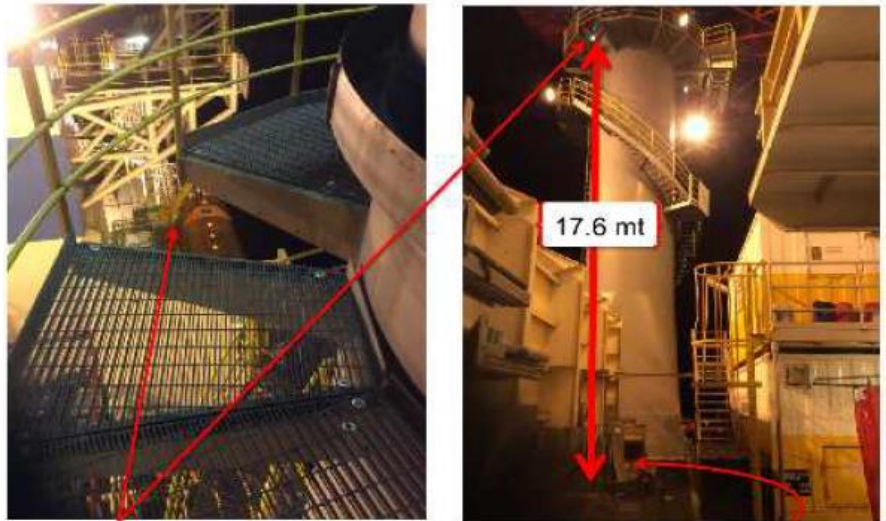
No solid structural support between the support arms. Kick plate is welded to grating and one side of kick plate is against the handrail.

- ◆ The grating was loose and fell:
 - the securing clips came loose as a result of the impact of the swinging crane block, and the loose grating was then dislodged
 - this piece of grating was fixed to the walkway structural frame in only two places
 - there was a kick plate welded onto the grating and not on the structure as on other cranes
 - the piece of grating had not been identified as potential dropped object;
- ◆ The crane was boomed up above the limit, and the crane operator did not deal properly with this;
- ◆ Changes had occurred which were not properly managed or controlled;
- ◆ The crane operator inspected the walkway looking at the guardrails, not the grating.

- ◆ Safety stand down held with all crew; grating replaced and secured;
- ◆ Engineering improvement of walkway design to be made, to prevent recurrence;
- ◆ Improvement of training for crane operators and lifting teams, particularly with regard to:
 - emergency procedures
 - handling unusual scenarios
 - management of change (MOC)/risk assessments/toolbox or pre-Job meetings.

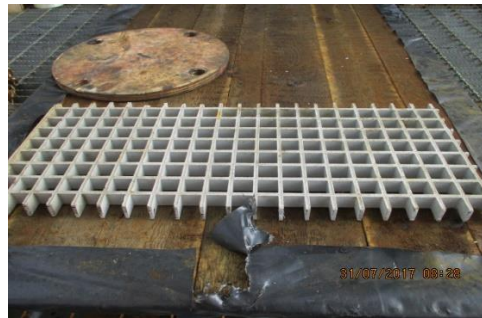
Piece of grating that dropped

It was assumed that the grating securing clips had come loose and fallen off, due to the flexing of the entire HOP during operations. There was no potential for persons to slip fully through the gap created by the dislodged grating due to the size of the gap.

- ◆ The rigging team held a time out for safety, then made a proper check of the security of all areas of the HOP;
- ◆ Before starting work again, the grating section was replaced and secured in place;
- ◆ The team members working on the flange were wearing full fall-arrest equipment and were clipped on;
- ◆ The surrounding area covering the HOP was completely barriered off;
- ◆ A subsequent ROV sweep grid survey was completed, and the grating section was located and recovered to deck by ROV.

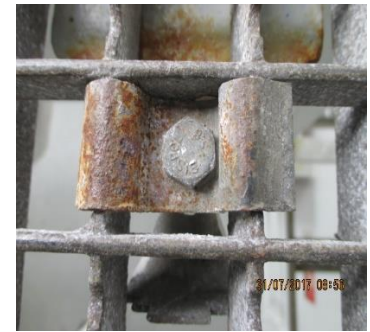
grating clip used for securing

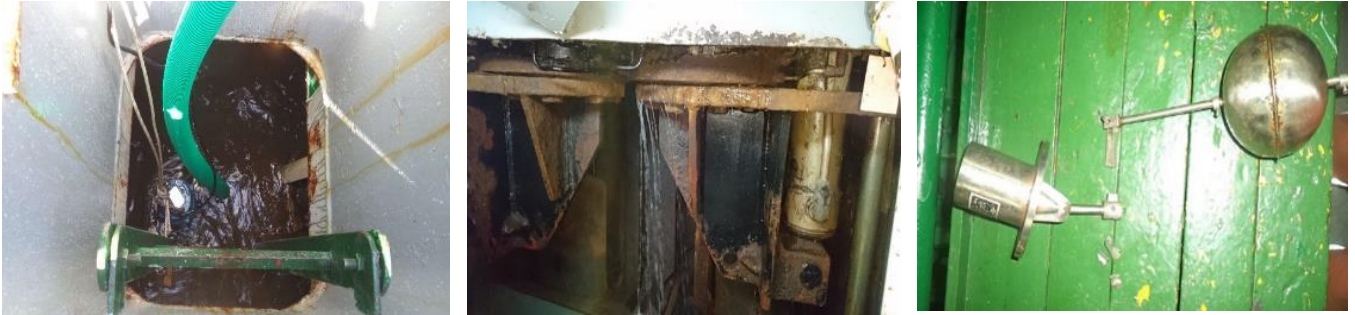
An announcement was made on the PA system regarding the steering gear failure; the client was informed and vessel assistance was requested. The Chief Engineer also found the bilge alarm float level-arms in broken condition (see rightmost image). A submersible pump was used to pump out water from the flooded compartment. Also, steps were taken to lighten the vessel by pumping out a number of freshwater tanks.

The main cause of the flooding was found to be the worn-out condition of the towing pin/Karm fork seal. Due to the rough weather, water was coming onto the deck and entered the steering compartment through the leaking seal.

- ◆ A thorough check was made of the condition of the covers of control panels, starters etc. in the steering gear compartment;
- ◆ A schedule of regular and logged checks was put in place for compartments below the waterline, with any deficiencies/observations reported to the office;
- ◆ The operation of the bilge level sensors was checked, as per PMS recommendations.

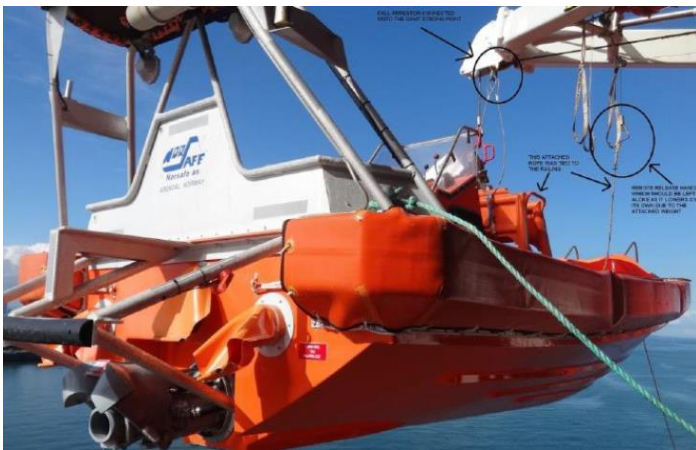
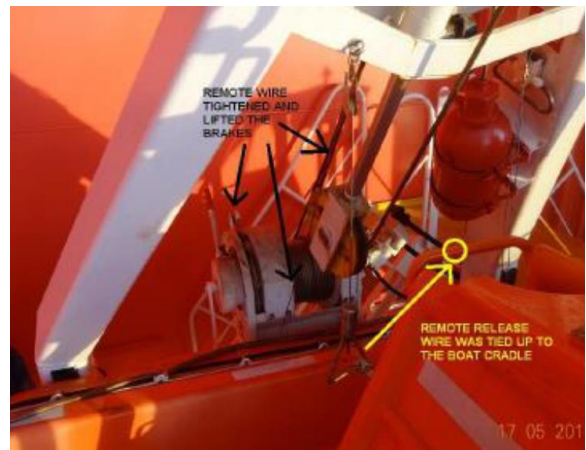
The remote-control wire was tied to the boat to prevent it from swinging during launching. The lowering of the boat was controlled by joystick from the control station. The remote-control wire became tight (since it was tied to the boat) about 5 meters above sea level and the electric motor tripped. This caused the rescue boat to descend under the influence of gravity until it was waterborne. As a result, the fall arrestors became activated and two crew members were left hanging 5 meters above the rescue boat. The third man followed the boat until it was waterborne.

The immediate cause of the incident was carelessness – the remote-control wire was tied up to the boat. A causal factor was that the correct launching procedures not followed. The root causes were determined to be:

- ◆ Crew to be trained in correct launching procedure as per manufacturer's instructions;
- ◆ All boat crew should be using fall arrestors if available on board during launching and recovery of rescue boat drills and training;
- ◆ Review of maintenance instructions and certification of fall arrestors;
- ◆ Review and update risk assessment for small boat launch and drill.

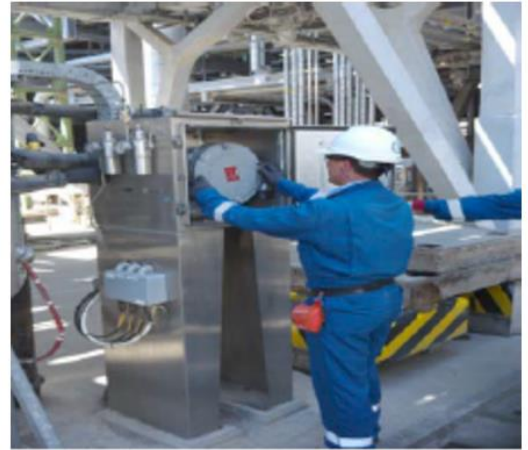
Figure 1: Re-enactment of cover removal

International Association of Oil & Gas Producers (IOGP) has published an alert regarding an incident in which an engineer was fatally injured. He was killed when he removed the cover on an explosion-proof enclosure, as part of a routine task. The threaded cover, measuring 35cm across and weighing around 6kg, was forcefully propelled from the enclosure as the engineer unscrewed it, inflicting fatal head injuries.

- ◆ Pressure built up inside the enclosure from leaking sample gas or instrument air components;
- ◆ The enclosure was not equipped with an external indicator to indicate the pressure inside;
- ◆ There was no means to relieve internal pressure in the enclosure.

- ◆ Recognize the potential hazard of trapped pressure in explosion-proof electrical enclosures from all sources of energy entering the enclosure;
- ◆ Identify explosion-proof enclosures which are susceptible to trapped pressure scenarios and do not have pressure indication or pressure relief protection;
- ◆ Work with equipment manufacturers to develop a mitigation plan that addresses the trapped pressure situation while still maintaining the electrical certification of the identified enclosures.
