1 Rigging failure - clump weight dropped to seabed

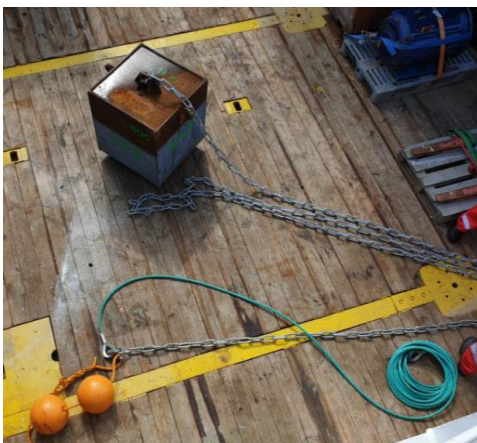
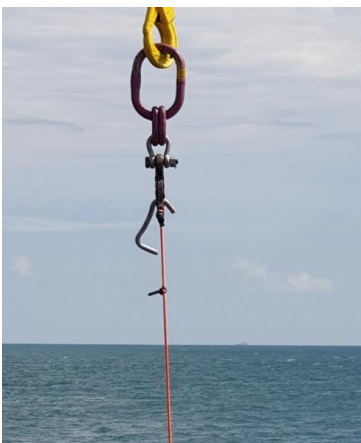
<p><i>Clump weight and the long link chain used for lifting</i></p>	<p><i>Chain link snapped on the quick release mechanism while deployed over the sea</i></p>	<p><i>Applicable Life Saving Rule: Safe Mechanical Lifting</i></p>

- The rigging failed because a larger clump weight (2.6t) was selected than the design allowed for (450kg). This decision was based on previous experience where the standard weight (450kg) did not adequately secure the weather buoy;
- The design and installation procedure were not revised to accommodate the heavier clump weight;
- The chain selected was not suitable for lifting. Declaration of conformity by the chain manufacturer confirmed that the working load limit was “2.5 Tonne Not for lifting”.

- All planned deviations from procedures should be subject to a formal Management of Change (MoC) process, the risk of the change adequately assessed and the change authorised by a competent person before the work proceeds;
- Reinforce to the riggers and personnel involved in lifting operations:
 - The need for thorough lift planning, and,
 - That they make a thorough check that lift rigging is certified, fit for purpose and appropriate for that specific lift.

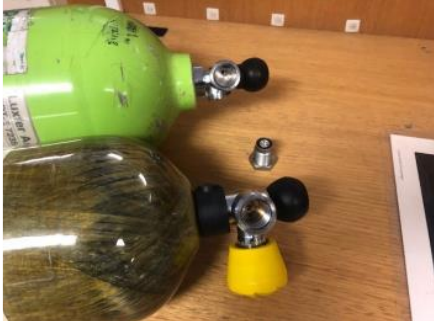
300 bar filler (from a compressor) will not properly fit a 200 bar cylinder vent valve, so a 200 bar unit cannot be over-pressurised. However, a 200 bar filler and SCBA backpack will fit a 300bar cylinder vent valve. This meant that the 6.8 litre cylinder could be filled to 200 bar (providing only 1360 litres of air rather than 2040 litres as designed).

Cylinder head v/v same size thread for both 200 bar and 300 bar

Ensure more thorough communication between procurement/purchasing department, vendors and persons actually generating requests.

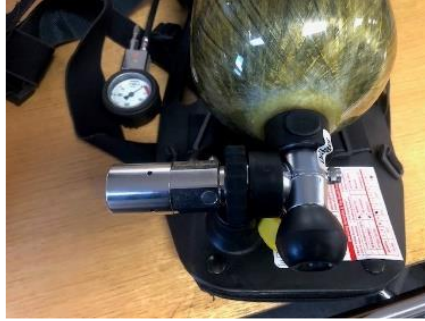
300 bar cylinder vent valve fits 200 bar SCBA backpack

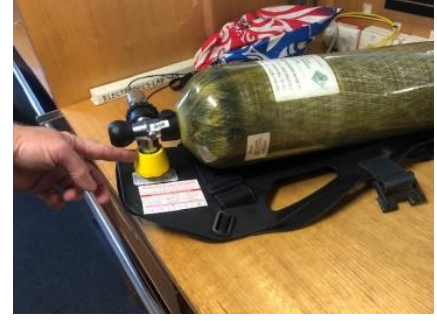
The wrong type of SCBA cylinder v/v were also ordered, the heads come in two types – an ‘in line’ type and a ‘90 deg’ type (see photo).

Incorrect orientation of vent valve head knob

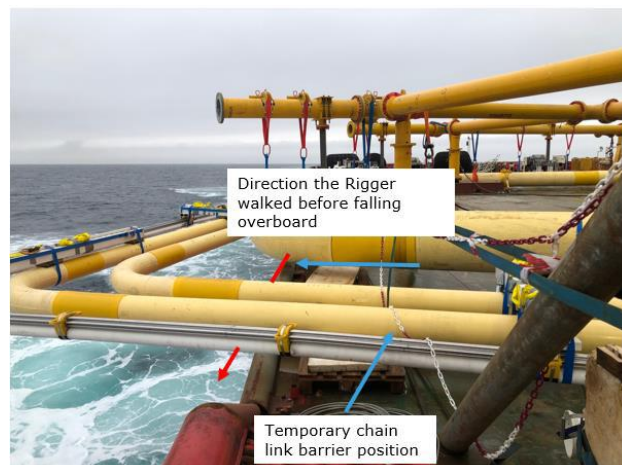
What happened? A man overboard incident occurred, in port at night. A rigger on the main deck, walking around spools secured to the main deck, stepped off the side of the vessel and fell to the sea. During mobilization of large spools, the vessel crew had removed a section of the starboard bulwark to accommodate the spools, for they were bigger than the main deck area - the spools extended over the side of the vessel. During sea-fastening of the spools a rigger decided to walk around the outside of the largest spool (see picture), without realizing this was over the side of the vessel. The rigger passed through a chain barrier and subsequently stepped over the side of the vessel. The rigger was not observed falling, but his calls for help were heard. He was rescued unharmed through the effective response of his colleagues, using life buoys and the pilot ladder.

- No rigid barriers were erected at the time of incident, only a temporary chain barrier, which the rigger passed through;
- Darkness, shadows, light transitions and poor weather (drizzle) made it difficult to see the difference between the deck and the water;
- The rigger had been on board for two weeks (with the bulwarks removed throughout that period due to multiple spool sets being mobilized) and had participated in the toolbox talk before he started work. He still did not understand the full hazard;
- There was no explicit specification that gaps should be barriered off on the starboard side (the task plan did specify a barrier for a similar situation on port side of the vessel).

- Verify that all temporary gaps and openings which create a fall hazard are equipped with rigid barriers;
- Never use access control barriers (plastic chain or barrier tape) as the single barrier for fall protection hazards;
- Review appropriateness of the use of access control barriers in particular:
 - Only using these barriers for access control and not for control of fall hazards;
 - Warning signs used with the barrier;
 - Authorization of access and egress from the barriered area.
- Check that back deck lighting is sufficient, with particular reference to areas of deep shadow;
- When project activities involve the removal or disabling of permanent safety equipment on a worksite, such as bulwarks, handrails and fire detectors for example, the project team has a responsibility to plan for an alternative and equally effective means of protection, confirming this with the worksite.

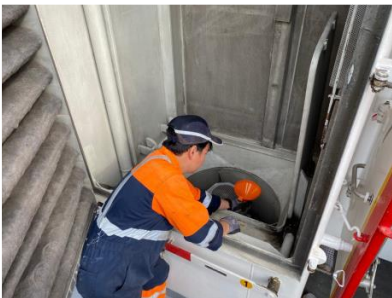
Position of crewman during incident (reconstruction)

The injured person filled the expansion tank in a way not detailed in procedures, via the filler cap from above, through the induction fan trunking. There was a company standard operating procedure for this and he did not follow it. The procedure for filling/topping up the high-temperature cooling system was via a portable pump with suction direct from a 20/25 litre drum. This system was in place due to the problematic location of the expansion tank filling cap in the engine room.

- Ensure no improvisations are replacing designed, approved systems on board. Where not functional, work orders/defects should be documented and if in doubt, assistance sought for clarification or suitable management of change process;
- Risk assessment should be conducted for non-routine tasks;
- **Don't cut corners** - crew should be reminded of the dangers of skipping or avoiding steps important to a task.

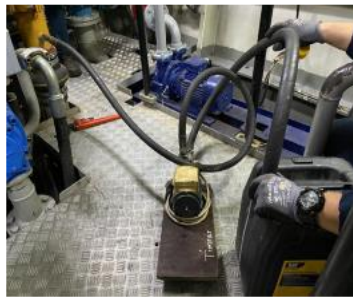
Pump rigged for procedurally correct transfer operation
