1 LTI Incident – Crew Struck by Cargo During Lifting Operations

2 Serious LTI - deck crew member struck by termination head/flexible

3 LTI: Person injured by a battery explosion on vessel deck

4 Unexpected truck movement caused rigger to fall off a ladder

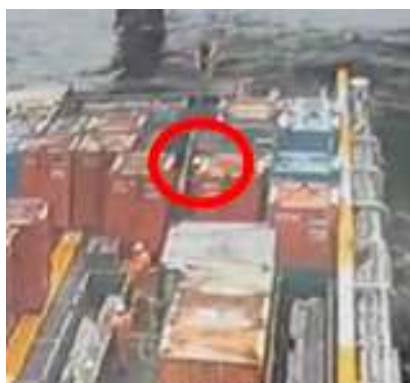
Injured person attempting to unhook load

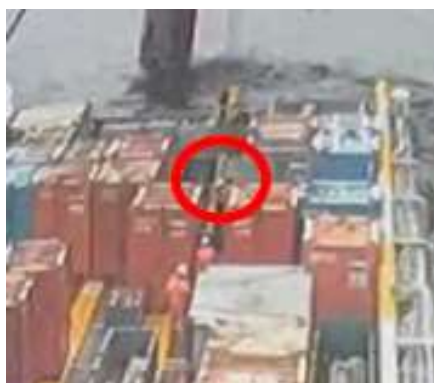
Injured person instructing crane operator to lower the boom

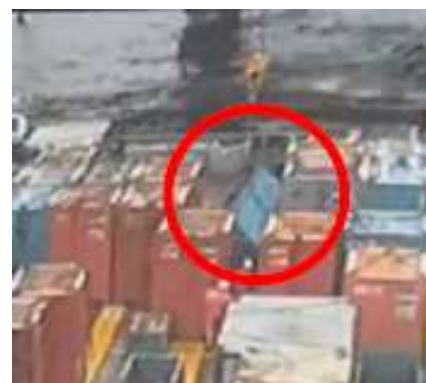
Crane suddenly lifted load striking the injured person in the chest

- The crane operator did not follow the instructions of the vessel lifting team;
- The injured crew member was in the line of fire during lifting operations;
- The vessel cargo plan not followed;
- Neither the other crew members or the crane operator thought to stop the job and use their Stop Work Authority.

- Immediate Stand Down for Safety and discuss the importance of crew members staying out of the line of fire during lifting operations;
- Reiteration of importance of Stop Work Authority which should be implemented if:
 - Crew see incorrect procedures being used or people working in unsafe manner

- Unsafe conditions are observed in the work area
- Crew are seen standing in a dangerous position
- Lifting operations should not be conducted unless clear communication channels are in place between crane operator and lifting team.

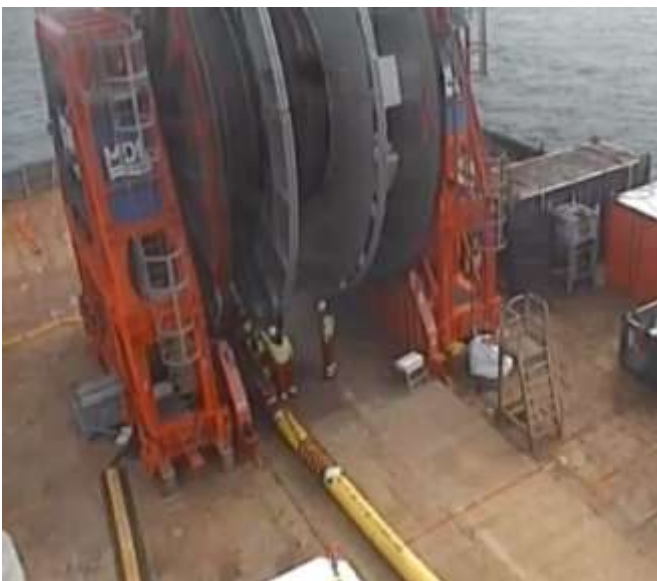
Fig. 1 - Image from CCTV 15s before the incident

The rigging team were removing plastic protection when the termination head suddenly moved downwards approximately 0.15 to 0.5 m, causing the termination head jumper to swing in towards the reel cradle. The injured party was struck by the jumper and squeezed towards the reel cradle and sustained life threatening injuries. He was med-evaced to the onshore medical facilities for immediate care.

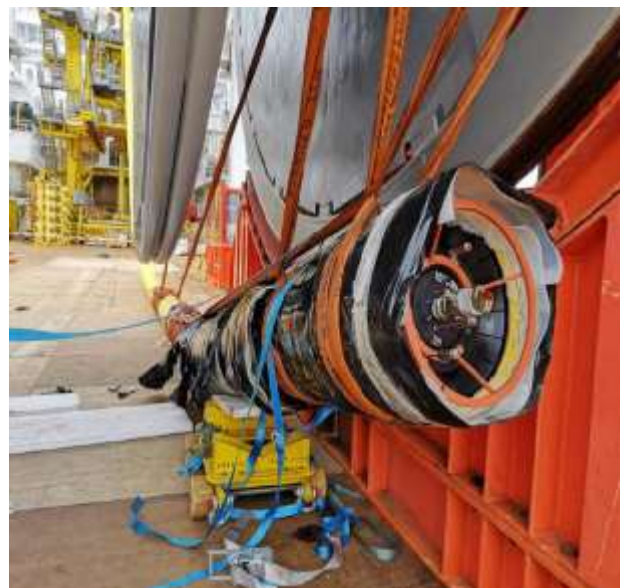
Fig. 2 - View looking forward (post incident)

- The sudden downward movement of the 2nd end termination head is believed to have been caused by slippage and reorganization of the rigging securing the termination head to the reel;
- Drawings and procedure did not have sufficient details related to unpacking of the reel.
- The line of fire was not identified prior to starting work.

- Termination heads on reels should be treated as suspended loads; with the potential to drop and swing.
- Drawings, procedures and risk assessments with sufficient detail are to be produced for unpacking of reels.
- Identify and discuss all possible line of fire situations and ensure personnel are in safe positions prior to starting a task.
- Slippage / reorganisation of the rigging is difficult to identify and can occur without warning;
- The potential for termination heads/suspended loads dropping and swinging should be mitigated. They should be treated as suspended loads with the potential to drop and swing;
- Unpacking of reels should be be proceduralised and risk assessed;

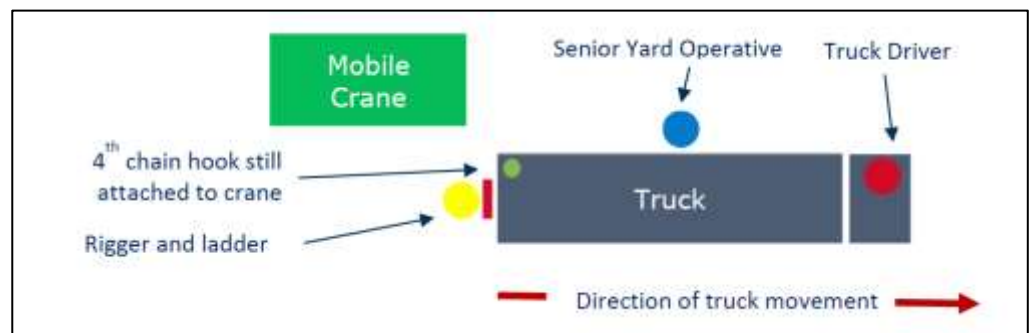
The rigger was approximately one meter above the ground and the 4th chain hook was still attached to the container and the crane, when the truck moved forward. The driver heard people shouting, and stopped the truck after it had moved

around half a metre forward. Due to the truck movement, the rigger slipped off the ladder, sustaining bruising to his leg.

- The supervisor did not provide the driver with an induction or briefing when he arrived at the yard.
- The Permit to Work for Working at Height indicated that a free standing work platform was to be used, but this was not used;
- The driver assumed that he was clear to drive forward;
- The Task Risk Assessment did not assess the risks introduced by or to the driver.

- Ensure clear and fully understood communication with third party plant operators – the truck driver in this case – before starting work;
- Ensure formal control of work, instructions, risk assessments and communications protocols are in place for third party drivers and other personnel;
- Consider keeping the driver away from the job completely until the lifting operations is complete. This prevents drive off and protects the driver from potential lifting issues impacting the driver's cab.

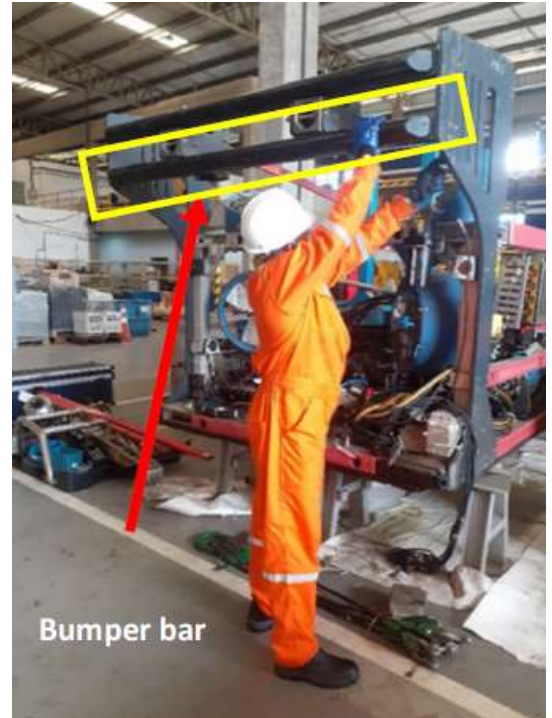
A worker broke his finger whilst working on an ROV. The incident occurred during ROV maintenance when he was single-handedly removing a bumper bar located above head height. During the process, the bumper bar snagged on the ROV structure. This required the injured person (a short service employee) to free it by hand. The weight of the bumper bar (approximately 29kg) was more than the employee had anticipated, therefore he was unable to support it. His right hand ring finger was bent backwards by the falling bumper bar, resulting in a metacarpal fracture.

- Ensure your tasks are sufficiently risk assessed and planned – have you got the right people tools and equipment available? Are the work instructions clear?
- Ensure the task is adequately supervised to ensure it happens safely and under control;
- Ensure that everyone involved – especially short service employees or third party contractors are competent: fully inducted, supported and mentored, even if they have previous industry sector and/or company experience;
- **Communicate!!** task specific toolbox talks should be carried out before starting work.

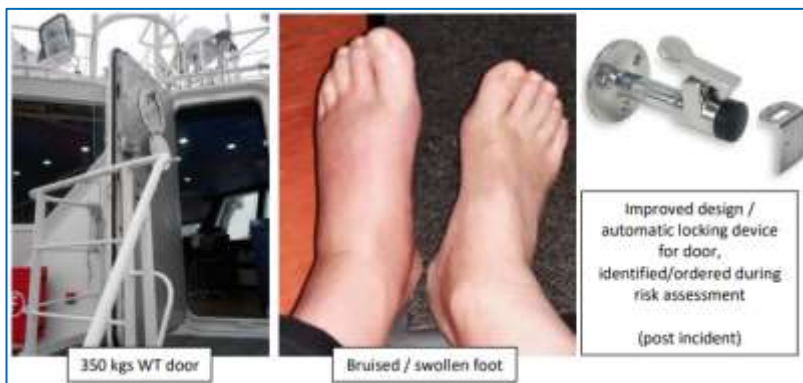
The injured party stepped outside during his watch to investigate an error. On his return he entered the wheelhouse from the outer bridge deck through the weather tight door. At the time of entering the bridge, the vessel made a slight roll. Due to the weight of the door (approx. 350 kg), and holding the door while passing through, he control of the door, which trapped his foot as it slammed shut. He sustained some bruising, which was treated with a cold ice pack.

- While the weight of the door was widely acknowledged as a hazard, no risk assessment was in place;
- The IP was not wearing safety boots or safety shoes at the time.

- Wear safety boots or safety shoes when at work – even on the bridge;
- Conduct risk assessment on hazards and implement all reasonably possible preventative measures, including correct PPE;
- Improved design / automatic locking device for door, identified/ordered during subsequent risk assessment.
