IMCA Safety Flashes summarise key safety matters and incidents, allowing lessons to be more easily learnt for the benefit of all. The effectiveness of the IMCA Safety Flash system depends on Members sharing information and so avoiding repeat incidents. Please consider adding safetyreports@imca-int.com to your internal distribution list for safety alerts or manually submitting information on incidents you consider may be relevant. All information is anonymised or sanitised, as appropriate.

1 NTSB: Flooding, sinking and loss of tugboat *Mangilao*

2 NTSB: Overturning of the Liftboat *Kristin Faye*

3 MSF: Cargo snagging

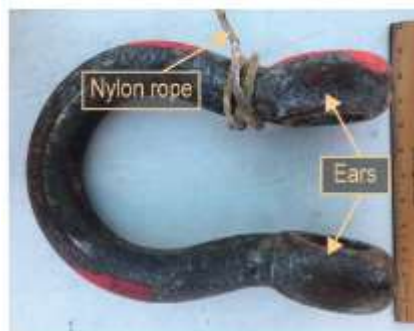
Investigation determined that the probable cause of the sinking was the failure of the towing arrangement due to the loss of a towline shackle pin, which left the towed vessel adrift and resulted in the ingress of water from boarding seas in a developing typhoon.

Recovered 50-ton shackle with nylon rope, bent ear, and missing pin. (Source: Coast Guard, annotated by NTSB)

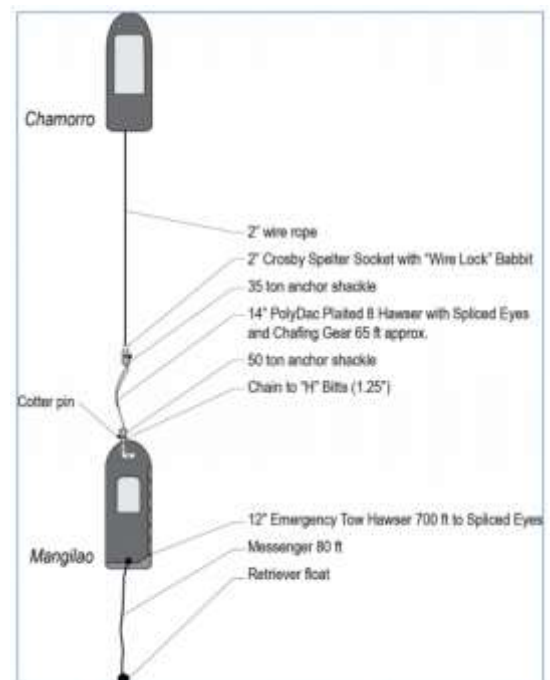
Representation of tow plan based on interview with Chamorro captain.

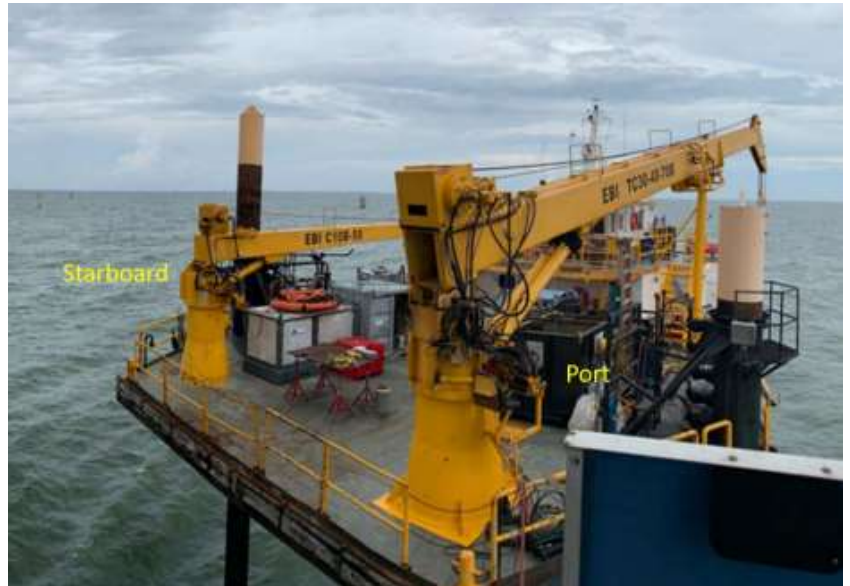
On September 8, 2019, about 1015 local time, the liftboat *Kristin Faye* overturned while preparing to conduct work alongside a platform in the Gulf of Mexico, about 18 miles east of Venice, Louisiana. All three crewmembers abandoned the vessel and were rescued. One person suffered minor injuries during the evacuation. An estimated 120 gallons of diesel fuel were released. The vessel was declared a constructive total loss at an estimated US\$750,000.

The probable cause determined by the NTSB was the company's **inadequate preload procedure** that did not account for crane movements or the planned loads (weights) to be lifted, resulting in a "punch through" of one of the vessel's three legs.

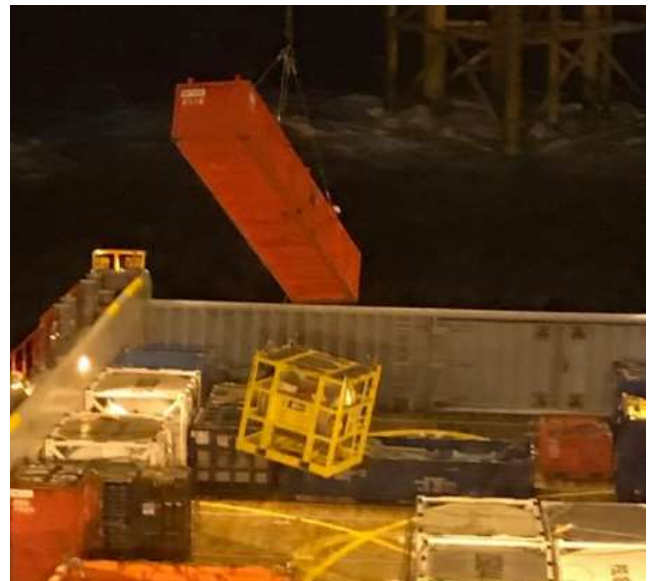
A vessel was engaged in deck cargo operations at an offshore location. A number of lifts had been successfully discharged and backloaded which led to limited space on deck. The crane operator advised the next lift would be the 25ft basket on the starboard side which was duly connected to the crane hook. The vessel deck crew moved to a safe place and confirmed to the crane operator that he was clear to hoist. As the crane operator began to lift the basket off the deck, the vessel bridge team noticed a corner of the basket had become snagged on a heli-tank and called an ALL STOP.

The call was not acknowledged, and the crane operator continued to hoist. As the 25ft basket was raised approximately 3m above the deck, the snagged lift was suspended approximately 0.5m and the 'Stop' call was given again by the bridge team. The crane operator continued to hoist causing the basket to rotate over the adjacent cargo and a third 'Stop' call was issued by the bridge team. The crane operator acknowledged the third stop call and began to take avoiding action. The crane operator was able to

- The vessel deck crew did not ‘tuck in’ the heli-tank bridle on completion of backload;
- The crane operator missed two opportunities to stop the job when the call was given;

- Reinforce the need for good communication between vessel and platform crew during lifting operations, particularly in relation to ‘stop the job’;
- Improve deck space management and planning. Vessel crew are encouraged to pro-actively give feedback in this area where possible;
- All crew are reminded to always be aware of potential snagging hazards and proactively take avoiding action where possible;
- Where possible, containerised cargo bridles should be stowed or tucked into the framework or basket to prevent snagging.

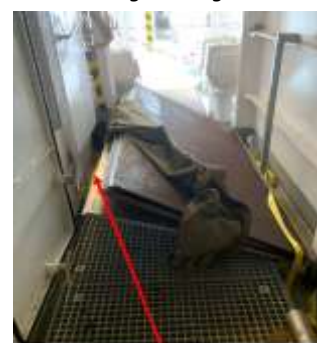
Injured party location
location of injured person

The sheets of material were secured with two webbing cargo ratchet straps hooked onto the surrounding ship's superstructure. In the process of removing slack from one of the webbing straps, the other loosened, resulting in both straps disengaging. At that point, movement of the vessel caused the unsecured rack to fall towards the crewman. He was unable to prevent the rack from falling on him and became pinned under the sheet material with most of the weight being taken on his right thigh. He called for help from a nearby colleague and was rescued. The following day he was able to visit a hospital ashore for X-rays to his leg, where no fractures of bones were detected, and he returned to his duties on board.

- Storage of such material
 - Ensure appropriate risk assessment is developed;
 - Consider whether or not sheet material, particularly metal, needs to be stored onboard;
 - Develop new and improved safer securing arrangements.
