1 Dutch Safety Board: fatality when mooring line snapped

2 Near miss: uncontrolled movement of mooring chain

3 Lifeboat Wire Rope Failure

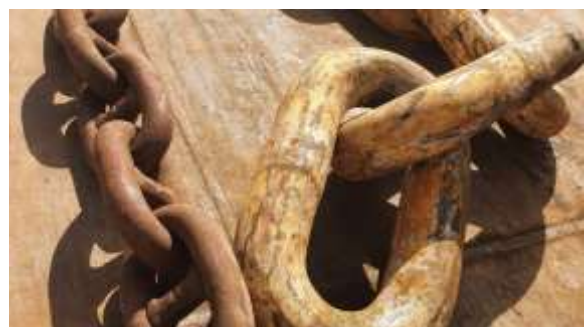
There was a sudden and uncontrolled movement of very heavy mooring chain during chain laying operations. A vessel was laying a 170mm diameter bottom chain from a suction anchor towards an FPSO. When the chain end was approaching, the shark jaw was engaged onto the chain to remove tension, in order to enable handling of the chain end from its chain locker. The last few chain links of the bottom chain then moved uncontrolled over the chain handling unit and rolled/dropped on deck, under its own weight, in between the chain lifter and the winch hangar. The bosun was located close to where the chain dropped and moved away when he noticed the uncontrolled chain movement starting.

The circulation pump on the chain handling unit tripped, causing the chain lifter to lose its holding force, and hence the chain catenary forward of the unit pulled the tail end over.

- This was a new vessel with as yet, a lack of full implementation of required safety systems;
- There was insufficient job safety preparation and risk management in place;
- There was inadequate understanding of the failure modes for the system;
- The vessel's generic procedures & job safety analyses were not re-visited with respect to project-specific loads and factors;
- The chain handling unit was not included in the vessel anchor handling and tow manual.

- Implement additional physical barriers on deck;
- Update vessel documentation including SJA's and manuals.
- Assess need for additional technical barriers on chain handling unit and circulation pump (including upscaling of pump and set-up on alarm);
- Formalise training and familiarisation.

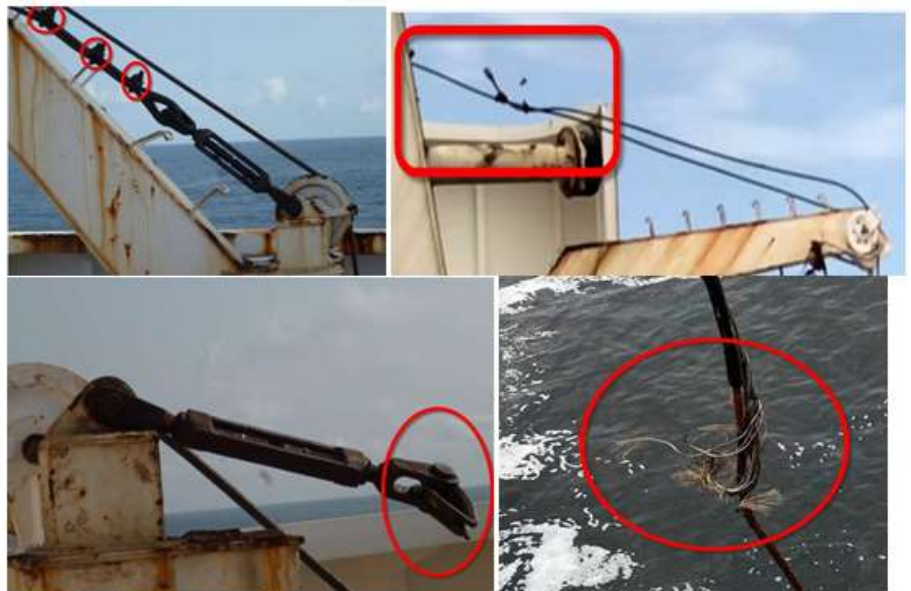
Our member's investigation noted that during maintenance of the lifeboat davit sheaves, the fall wire was removed by disassembling the three existing bulldog ("Crosby") clamps on each wire termination on the davit. Once all maintenance works were completed, the fall wire was reinstalled using the original bulldog clamps, which were clamped in the same position as the original termination.

indicated that the fall wire had slipped through the bulldog clips and released from the thimble on the turnbuckle because:

- The grips were torqued in the exact same position they were before, therefore compromising the structure of the wire which was already flattened/deteriorated;
- The bolt grips were tightened without making reference to any minimum / maximum torque value specification.

- There had been inadequate preparation of the wire for termination;
- Bulldog clips had remained in use since the installation of the lifeboat, as there was no regulatory or mandatory (Flag state) or company procedural requirement to perform replacement;
- There was no evidence that the bulldog clips were inspected prior to refitting.

- Checked fleetwide to see whether any similar terminations existed - any lifeboat falls which were found to be secured with bulldog grips were renewed and replaced with the asymmetrical wedge socket type by a competent third party and subsequently certified;
- Flag State was notified at the time of the event, and updated with the outcome of the investigation.

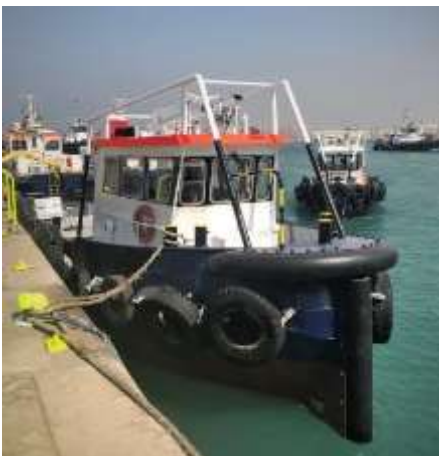
area to the original vessel design with additional stringers and stanchions added. Bow fendering enhancements were also made during this modification with heavy duty 500mm 'D' fender installed around the radius of the new platform for enhanced asset protection.

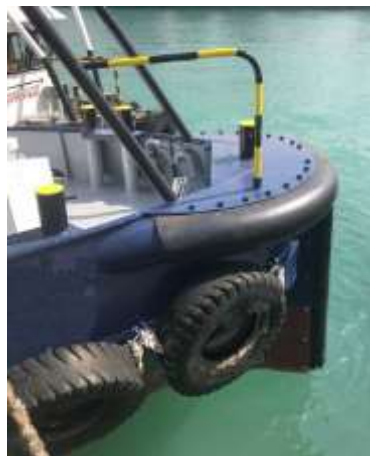
Photo showing obstruction free bow

The tug involved went to dry dock shortly after, and it was decided to remodel the bow area to provide an obstruction free bow embarkation/disembarkation platform at bulwark top height, with vastly increased landing
