IMCA Safety Flashes summarise key safety matters and incidents, allowing lessons to be more easily learnt for the benefit of all. The effectiveness of the IMCA Safety Flash system depends on Members sharing information and so avoiding repeat incidents. Please consider adding [safetyreports@imca-int.com](mailto:safetyreports@imca-int.com) to your internal distribution list for safety alerts or manually submitting information on incidents you consider may be relevant. All information is anonymised or sanitised, as appropriate.

## 1 Hand injury when caught in machinery

## 2 Injury to Fingers During Grinding Activity

### 3 LTI: Stored energy – rigger injured leg working on quayside

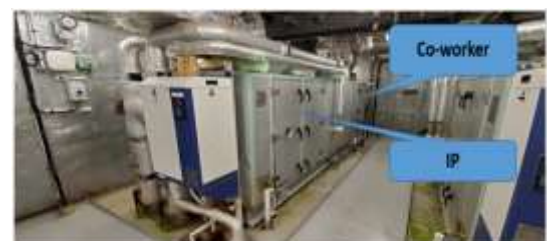
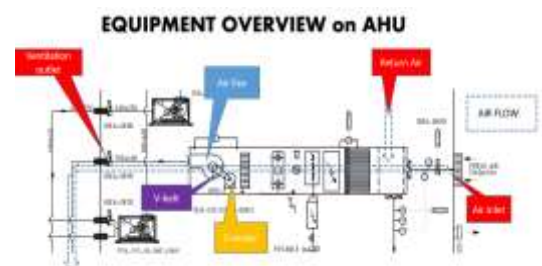
A crew member sustained injuries to his hand and arm when his hand got trapped by a moving belt. The incident occurred during routine maintenance of an Air Handling Unit (AHU) Humidifier. The AHU was confirmed as electrically isolated and the worker visually checked that the belt was completely stopped. The worker began the maintenance task as required, and happened to touch the belt with his right index and middle finger to check the tension. At this point an unexpected airflow within the ducting caused the air fan to rotate which caused the belt to move. This event led to his glove getting caught by the belt which in turn caused his right hand and forearm to be pulled towards the machine and caught between the belt and pulley. The movement caused his right forearm to get caught between the metal guard and fixed structure around the belt.

By opening the doors of the AHU humidifier an unexpected airflow was created by a vacuum from inside the AHU, that consequently rotated the air fan which then drew air from outside the AHU causing the belt to move. This previously unrecognized hazard was found only to happen when the ventilation outlet from the AHU to the accommodation E-deck is still in the open position. This scenario was re-enacted with several other AHU's on board and only the 2 Top-deck AHU's (#2 and #3) were found to have this unplanned event when the ventilation outlet was still in the open position.

- A review and update of procedures taking into account the previously unrecognized hazard, providing clear instructions;
- Expecting the unexpected – particularly with any kind of large rotating machines, and when there is a great deal of potential energy that can be unexpectedly released.

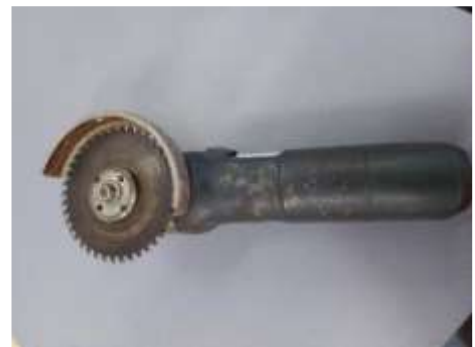
- Poor selection of the proper tool for the job, and the grinder was not compliant with the company’s own standards for such equipment;
- Not following manufacturer’s instructions – there was a toothed saw blade fitted which was not recommended for use with this grinder;
- The injured person picked up the grinder in an unsafe way whilst it was still powered;
- The injured person was not wearing the required PPE - safety gloves.

*Grinder equipped with toothed saw blade, no handle and no paddle switch*

- Removed all button-controlled grinders and replaced with paddle switch grinders with handles as per the company’s existing standards;
- Reissued good practice guidelines in the use of grinders;
- Began programme of refresher training on the use of rotating hand tools;
- Reviewed and update maintenance risk assessment for rotating machinery.

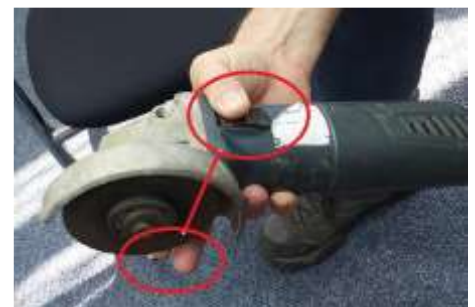
Someone was performing maintenance activities with a grinder, using the grinder to cut and shape wood. When he finished, he switched off the grinder and placed on deck. He removed his gloves and then proceeded to pick up the grinder so that it could be unplugged from the wall. When picking up the device, the injured person inadvertently pushed the on-switch and the blade cut two fingers of his right hand. When he then attempted to switch off the grinder he also cut a finger on his left hand. He managed to disconnect the tool from the socket.

*Showing **INCORRECT** way in which injured person picked up the grinder*

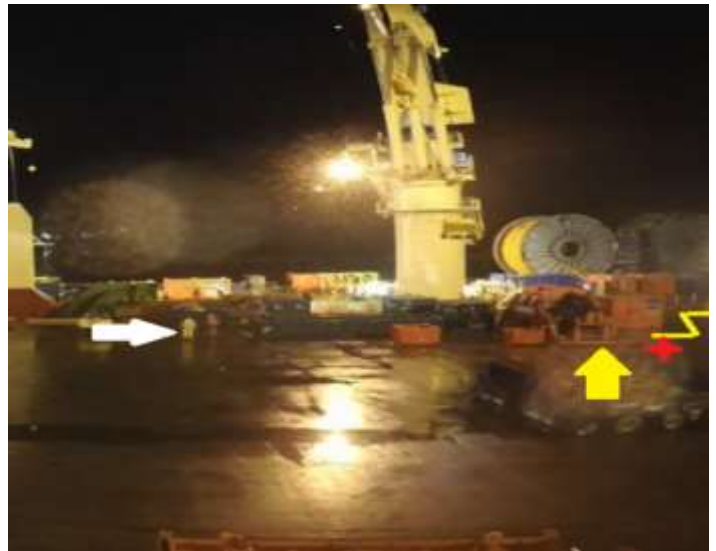
A set of slings 15m long were draped over the forks (not coiled or palletised) of a forklift truck. As the slings were lowered to the quayside, the steel eyes overhanging the forks made contact with the ground before the forks did, and they “kicked” off the forks. When they hit the ground they straightened out, in the process moving violently towards the rigger, causing injuries to his leg and breaking his foot. Injuries to his lower left leg needed seven stitches and there was a multiple fracture to his upper left foot requiring surgery to repair. A recovery time of six weeks was estimated.

The picture shows the quayside prior to the incident. The white arrow shows the rigger in full hi-viz clothing. The yellow line shows the route taken by him from aft of the vessel, with the red star indicating the location of the incident. The yellow arrow denotes the location where he awaited medical attention.

- A known risky technique (this method for moving slings with a forklift) had been accepted as the norm;
- There was no port induction for vessels coming into port, explaining quayside safety requirements including hi-viz and safe walkways;
- Containers removed from the vessel blocked the safe walkway;
- The forklift driver had to take a route which gave restricted visibility of personnel;
- The rigger had removed his hi-viz jacket further reducing his visibility;
- There was reduced lighting on the quayside;
- There were simultaneous activities occurring in the area which were not properly controlled.

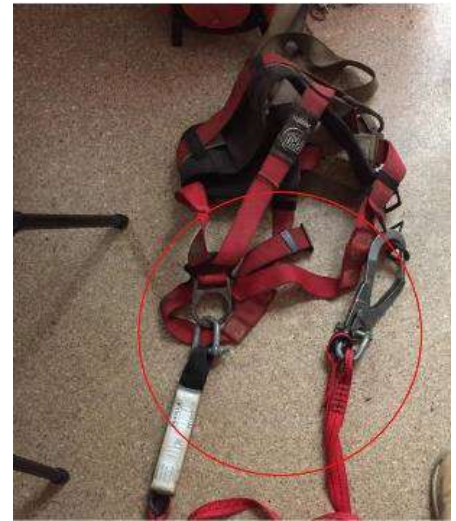
During a site visit, a third-party owned safety harness was found inside a container of the barge. The harness was without the manufacturer's tag and with cargo D-shackles on the lanyard instead of proper carabiners. The safety harness could potentially have been used, posing risk to the crew members who used it. The safety harness was immediately taken out of service.

- Ineffective checks on safety harnesses;
- Crew members did not quarantine or properly label defective safety harness;
- There was no designated quarantine space on the barge.

- Crew on board reminded of the need for regular inspection of the safety harnesses;
- Defective safety harness removed from use immediately – remove and quarantine any defective equipment immediately. **Any doubt at all about the safety of the equipment, don't use it!**
- Dedicated quarantine spaces (boxes) for defective equipment and tools to be arranged on board barges.
