1 Service letter from Palfinger Marine relating to Davit types NPD 11300H and NPD 14800H

Subject: Davit type NPD 11300H and NPD 14800H

2 Crane whip line parted during hook stop testing

5 Rigging failure during riser recovery – soft slings parted

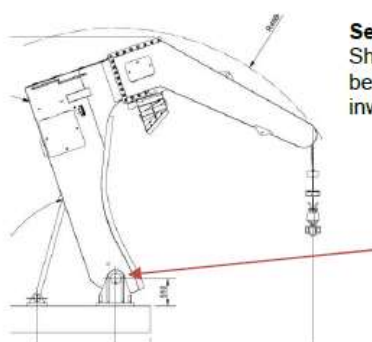
Sketch 1

A defect (see picture 1, sketch 1) was found during the annual maintenance of a lifeboat davit on a vessel. During scheduled maintenance it was discovered that one of the davit arm pivot pins had become detached from its retaining plate which allowed the pin to work its way out of its position. Palfinger Marine has found out that alignment of the pivot points between deck and davit can become fundamental in case of deck misalignments which can have an effect on the aligned pivot point positions during regular operation of the davit system.

Sequence of events as reviewed:

Shaft started to rotate due to increased friction of the misalignment, bearing broke, bolts of shaft securing plate broke as a result, shaft moved inwards.

Due to the design and functionality of the davit system the davit stool is attached with two hinges to the deck, turning via their shafts, if one became loose the davit might collapse during operation!

It is mandatory to stop an operation of the davit if a detached or loose securing plate has been detected! The root cause must be evaluated, and a repair must be carried out! In case a certified technician is requested, Palfinger need to be informed!

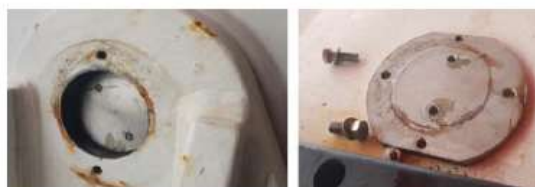
Picture 1: Pin retaining bolts sheared, Pin has moved 30mm into 50mm foot plate.

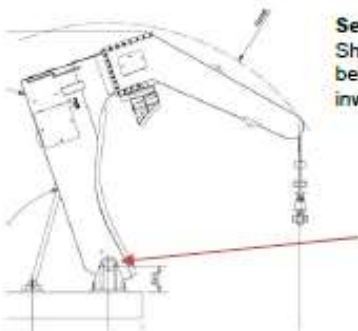
Sketch 1

A defect (picture 1, sketch 1) was found during the annual maintenance of a Lifeboat davit on a vessel. During scheduled maintenance it was discovered that one of the davit arm pivot pins had become detached from its retaining plate which allowed the pin to work its way out of its position. Palfinger Marine has found out that alignment of the pivot points between deck and davit can become fundamental in case of deck misalignments which are having an effect on the aligned pivot point positions during regularly operation of the davit system.

Sequence of events as reviewed:

Shaft started to rotate due to increased friction of the misalignment, bearing broke, bolts of shaft securing plate broke as a result, shaft moved inwards.

Due to the design and functionality of the davit system the davit stool is attached with two hinges to the deck, turning via their shafts, if one became loose the davit might collapse during operation!

It is mandatory to stop an operation of the davit if a detached or loose securing plate has been detected! The root cause must be evaluated, and a repair must be carried out! In case a certified technician is requested, Palfinger need to be informed!

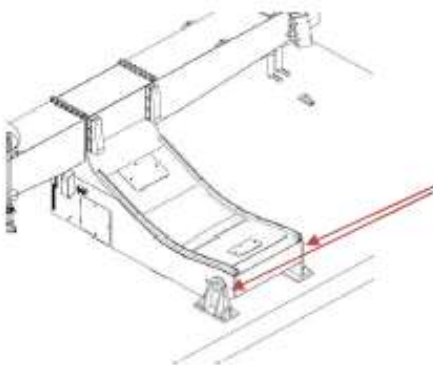
Sketch 2

The shaft (sketch 2) is locked with a locking plate (right side, sketch 2) towards the plate on the deck.

When the shaft is **not flush** with the davit side, the securing bolts are stressed due to the alignment between deck and davit is not constantly within tolerances during operation of the davit.

- Remove the locking plate.
- Check if shaft is completely flush with plate → see sketch 2.
- Put back locking plate.

If the shaft is flush with the plate, there is no reason to do any modification, provided that this check is done regularly.

- a modification can be done on the locking plate: *drill a hole in the locking plate for easy visual inspection*, when in doubt about this option, contact your local Palfinger Marine Service Station
- an upgrade kit can be ordered via your local Palfinger station, containing a new type of shaft which has a welded securing plate already installed.

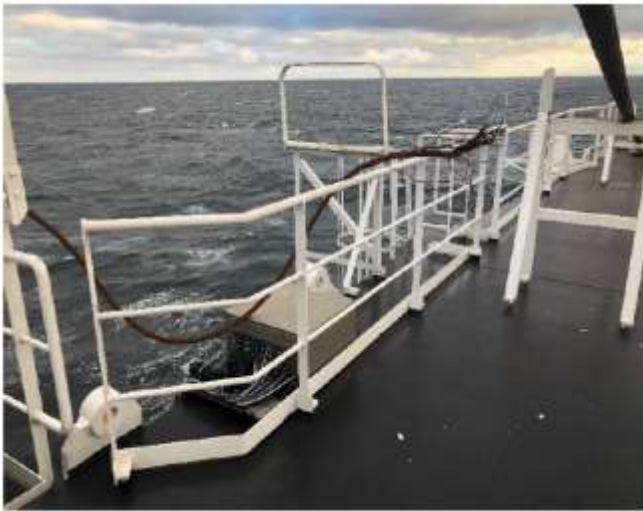
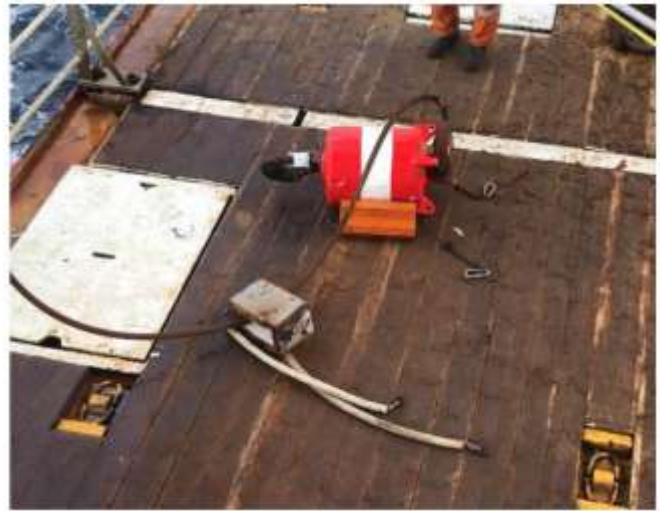
The crane was positioned in the rest while the Crane Operator carried out hook stop testing of the auxiliary winch. An uncontrolled hoisting movement resulted in the headache ball striking the jib and falling with the hook stop rigging assembly back to deck.

The Crane Operator was testing both the main winch and the auxiliary winch. The main winch was tested and operated normally. When the Crane Operator started to test the auxiliary winch, the winch accelerated to full speed pulling the headache ball into the sheave. The headache ball collided with the jib and the wire snapped, approximately 19 meters from the headache ball. The headache ball (500kg) and the hook stop rigging (25kg) dropped 4.2 meters to deck. There were no personnel in the vicinity.

- The winch was actuated by two hydraulic motors and the speed of the motors measured by encoders. The encoders were badly corroded inside and within the circuit board which resulted in erroneous signal being sent. Both speed encoders required replacement. The crane software was updated to include a second barrier preventing wrong signals from the encoder;

- The winch wire was in poor condition, corroded and dry. The investigation identified deviations from the wire rope management requirements of both the company and the owner of the vessel;

- The auxiliary winch wire was the original wire installed on the winch and had been in service for approximately 7.5 years. Magnetic Rope Tests (MRT) were performed every second year with wire cut-back completed in accordance with the recommendations from the examination. The latest MRT was not completed successfully due to failure in the test equipment and was overdue at the time of the incident. The wire used was 2160 grade which is vulnerable to brittleness; the company does not accept this grade if it is avoidable;

- Check and see if this same encoder component fault can occur on your worksite and check the maintenance routines for encoders;
- Further assure the integrity of wire ropes by carrying out a thorough visual examination combined with either annual Destruction Test or MRT Traces;
- Identify the age of the wire ropes and confirm appropriate in-service reviews have been carried out;
- Ensure formal MoC process is followed where compliance with existing procedures is not possible;

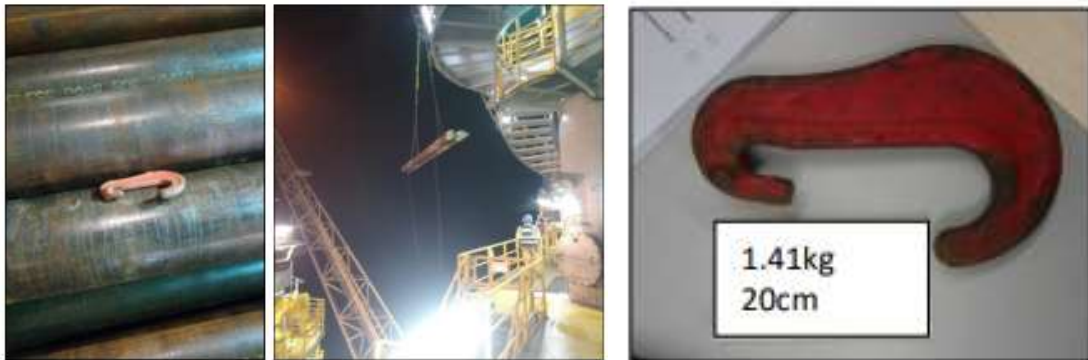
The Marine Safety Forum published [Safety Alert 20-11](#) relating to a potential dropped object in a load. The near miss incident occurred during offloading of casing from a supply vessel. The rig crew spotted a hook resting on the bundle. The load was set down and the job stopped.

The hook was later identified as part of the vessel’s cargo securing equipment which had been found defective before use but had not placed in the quarantine area for damaged lifting and securing equipment.

The weight of the hook was 1.4 kg. The hook could have fallen 19m on the rig and significantly higher (70m +) to the supply vessel deck.

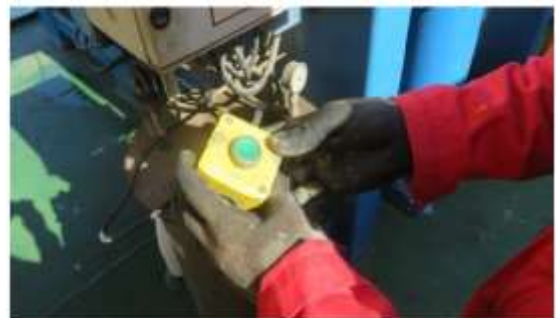
Remote control which failed

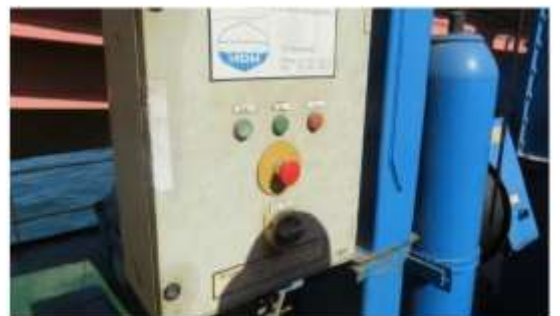
E-stop which failed to stop the winch

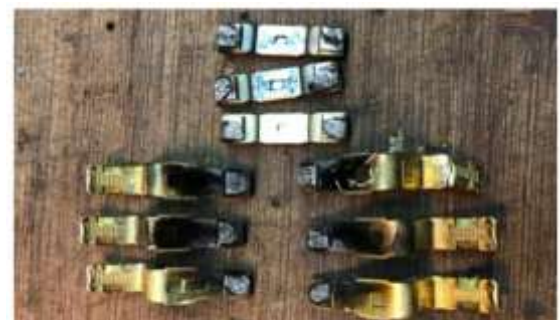
Testing revealed that the control circuitry for davit recovery was fully operational. However, the recovery was not automatically stopped by the limit switch. On inspection and disassembly of the contactor, it was found stuck, with contacts in the closed position. The system had undergone annual inspection by an approved independent inspector three weeks previously with the following notes:

The most probable cause of failure was frequent intermittent use of the winch for fine adjustment of boat level to make it easier for crew to get into and out of the fast rescue craft. The davit winch was being repeatedly switched on and off for very short time intervals, which can cause the contacts to burn out.

Failed breaker

- Ensure correct retrieval procedure is practiced by all winch operators - limit switches should not be relied on to stop the recovery of craft;
- Confirm correct installation of components including limit/proximity switches for davit systems.
- Where limit/proximity switches have noted systems faults, inspection should be completed before further use;
- Ensure planned maintenance system covers regular function testing of emergency stop switches;
- Limit/proximity switches found to be at fault should be replaced. Replacement switches are not high cost items.

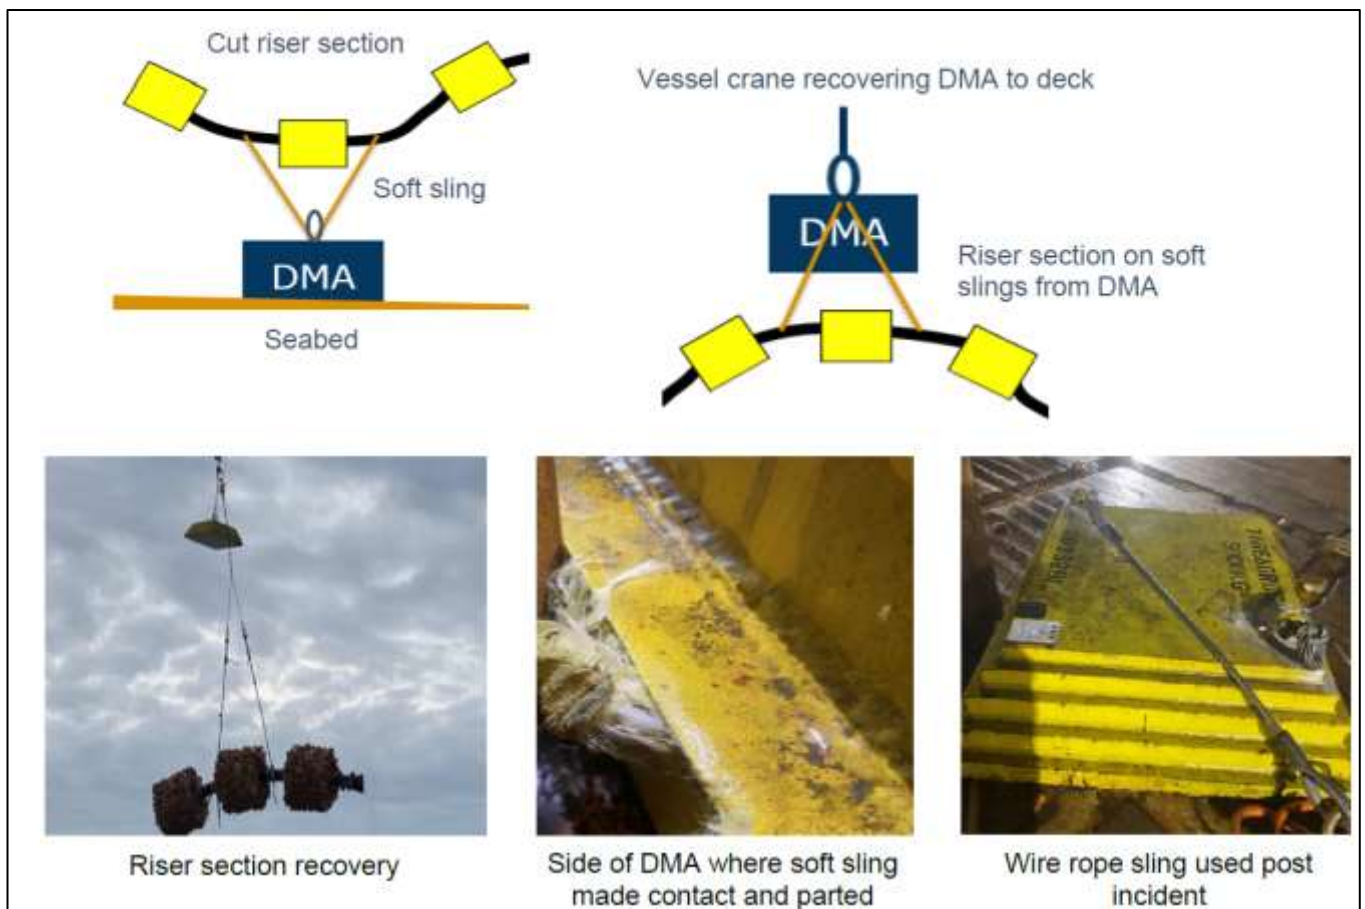
During recovery of a 10m riser section with buoyancy modules attached, the riser section dropped 2.5m to deck when the soft slings parted after rubbing on the sharp edge of the Deadman Anchor (DMA). During decommissioning activities, the riser was cut into approximately 10m long sections.

The section had been weighted down with a DMA prior to cutting. On completion, the DMA was recovered along with the riser section suspended below the DMA. When slewing the riser section inboard, the riser section (3.8Te) fell approximately 2.5m to deck when the slings parted after rubbing on the sharp edge of the DMA.

- A pendulum effect occurred whilst the product was draining before recovery onboard, which resulted in the riser section suspended below the DMA moving against the sharp edges on the DMA, and thus cutting the soft slings;
- The sharp edges of the DMA had not been identified as a potential hazard in relation to the use of soft slings.

- Wire rope slings should be used where slings connect with a DMA;
 - The exception would be, unless the use of soft slings has been fully risk assessed with specific consideration given to the possible contact with the edges of the DMA;
- Consider the use of rounded DMAs where there is a potential for sharp edges to connect with the rigging;

- Consider having pad eyes welded along the bottom profile of the DMA to mitigate against fouling with the rigging.
