## 1 MAIB: Fatal accident during cargo operations on *Karina C*

## 2 Disabled audible alarm on fire alarm panel

## 5 Lead-acid battery explosion

## 6 Sludge Accumulation in Fresh Water Tank

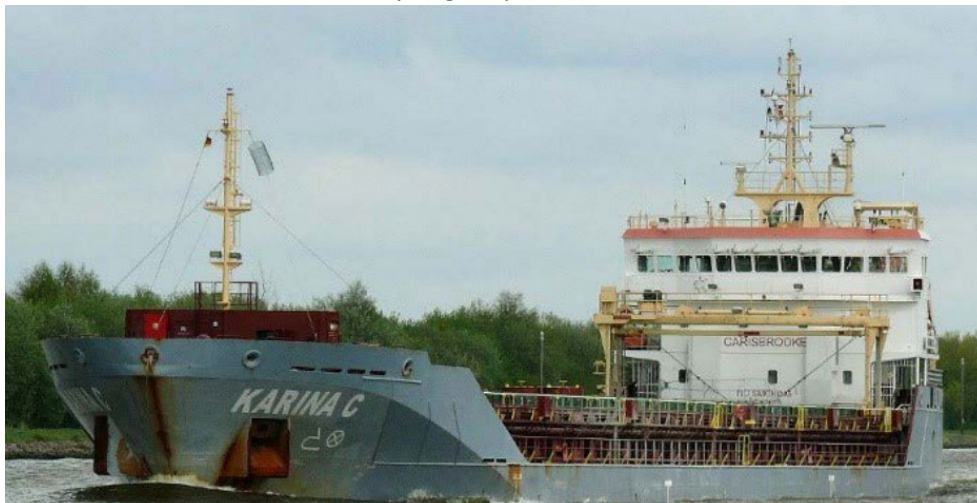
The second officer of the general cargo vessel *Karina C* was fatally injured when he was crushed between the vessel's gantry crane and a stack of cargo hold hatch covers during post-cargo loading operations. The second officer had been working at the aft end of the main deck and was attempting to pass between the hatch covers and the stationary crane. As the second officer climbed onto the hatch coaming, the vessel's chief officer drove the crane aft, trapping and crushing the second officer against the hatch covers. The chief officer immediately reversed the crane and the second officer fell onto the deck, where he received first-aid and cardiopulmonary resuscitation from the deck crew and shore paramedics.

- **Deck operations were not being properly controlled or supervised and the deck officers did not communicate with each other** - the second officer did not know the chief officer was about to move the crane and the chief officer did not know where the second officer was, or what he intended to do;

- The second officer’s judgment and perception of risk were probably adversely affected by alcohol;
- Tiredness might also have adversely influenced the second officer’s actions;
- The master did not adequately investigate or report the accident;
- **The safety culture on board was weak; company procedures were not followed, and several unsafe working practices were observed;**
- The company’s drug and alcohol policy was not being enforced.

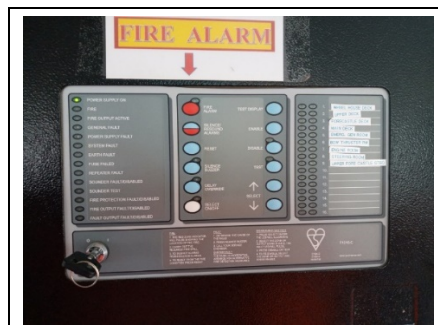
During routine testing of the fire alarm, it was observed that the Fire Alarm panel was not emitting an audible alarm – there was only a flashing light present. The Chief Engineer together with the ETO inspected the fire alarm panel and found that a cable had been disconnected from the panel.

How the cable came to be disconnected could not be determined. There was no proper testing of the fire alarm system, nor any oversight or recording of maintenance.

Disabled audible fire alarm

Members may wish to check fire alarm panels any similar alarm equipment or warning systems to verify that all alarms audible and visual are functioning.

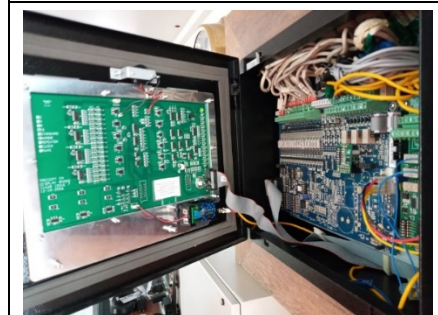
Disconnected cable

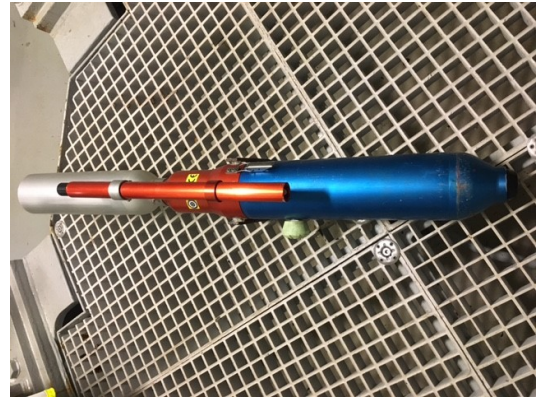
During mooring operations crew on a vessel used a pneumatic line thrower (PLT) to throw a mooring line. Several attempts were made, of which one was successful. Two of the “bullets” disappeared and a window was broken at a warehouse building, approximately 100 meters from the vessel.

- There was no toolbox talk before the mooring operation;
- There was a change of plan during the mooring operation: it proved impossible to get a heaving line to the quayside and so a PLT was used, which was not a part of mooring equipment;
- The PLT was not used according to manufacturers instructions or recommendations;
- The use of the PLT was not covered in the existing risk assessment for mooring operations;
- There was inadequate communication with the mooring team onshore;
- No-one stopped the job; no-one thought through or *assessed* the potential risks of using the PLT.

- Pneumatic line throwers ought not be used during mooring operation alongside quay, due to the increased risk to people and property;
- Develop a solution to get a heaving line ashore from vessels with a covered forecastle, without using a PLT;
- Ensure changed plans are managed using a Management of Change process; ensure appropriate risk assessment and toolbox talks are carried out before mooring operation;
- Reiterate duty to stop the job and intervene if unsafe work is taking place.

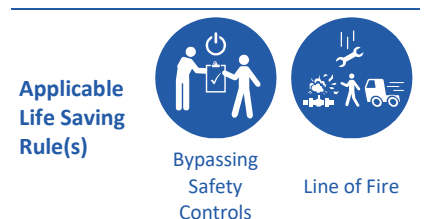
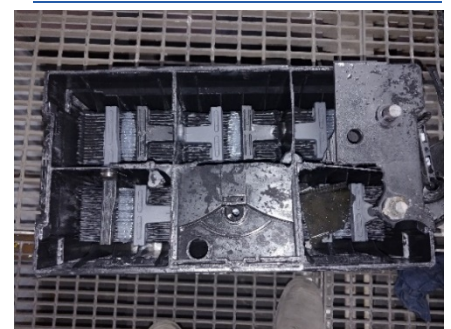
A lead-acid battery blew up when an engine was started. The incident occurred when, after conducting pre-start checks on a generator, the 2nd Engineer attempted to start the engine. As the lube oil pressure reached start pressure and the starter motor engaged, there was a loud bang from behind the engine in the vicinity of the port side battery box. The 2nd Engineer on investigating, found that one of the batteries in the bank for the generator had suffered a critical failure resulting in the top of the battery case being destroyed. He left the space immediately in case of release of hydrogen gas and woke the Chief Engineer to inform him of the incident.

- The battery tie connection on the negative terminal had formed a hot joint. This would have ignited any excess hydrogen built up inside the battery box when the generator started;

- The manufacturers instructions stated that the battery should not be used in hot environments (such as engine rooms).

- Consider replacing lead acid batteries with a type that does not release hydrogen when being charged, such as AGM (Absorbent Glass Mat) batteries;
- Check all battery terminals and connections;
- Follow manufacturers instructions when installing batteries.

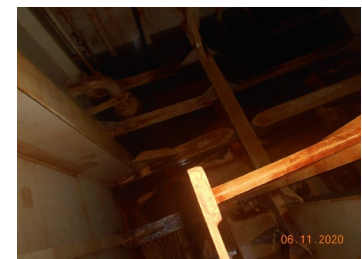
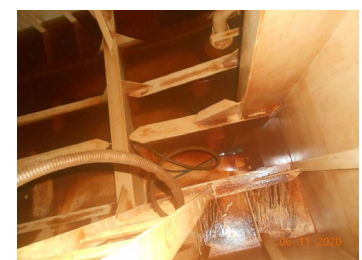
During inspection of a fresh water tank, it was discovered that there was significant sludge accumulation in the tank. Based on the condition of the tank, it was seen as more than likely that other tanks would be similarly affected and that the cause was due to a common source of water.

Our member understood that the condition was as a result of the quality of the water obtained from port. There was an accumulation of sedimentation and of organic and inorganic matter over a period of time.

*Sludge precipitation*

- Immediate inspection of other fresh water tanks to ensure potability of water supply, and subsequent maintenance (taking note of the requirement for Confined Space Entry permits to work) was arranged as soon as reasonably practicable;
- Internal tank inspection for signs of possible contamination and debris every 6 months for potable water and every 12 months for non-potable water;
- Disinfection of hoses as a routine measure every 6 months, or whenever any contamination is suspected. Our member flushed hoses thoroughly through and completely filled them with a solution of 50 ppm residual free chlorine, which was then allowed to stand for a period of at least 1 hour before the hoses were emptied and re-stowed.
