Palfinger Marine Service Letter

Subject: Davit type NPD 11300H and NPD 14800H

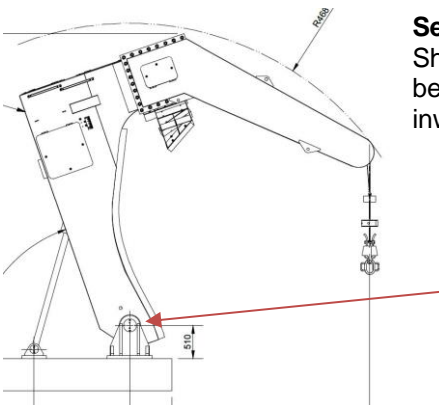
Sketch 1

A defect (picture 1, sketch 1) was found during the annual maintenance of a Lifeboat davit on a vessel. During scheduled maintenance it was discovered that one of the davit arm pivot pins had become detached from its retaining plate which allowed the pin to work its way out of its position. Palfinger Marine has found out that alignment of the pivot points between deck and davit can become fundamental in case of deck misalignments which are having an effect on the aligned pivot point positions during regularly operation of the davit system.

Shaft started to rotate due to increased friction of the misalignment, bearing broke, bolts of shaft securing plate broke as a result, shaft moved inwards.

- a modification can be done on the locking plate: *drill a hole in the locking plate for easy visual inspection*, when in doubt about this option, contact your local Palfinger Marine Service Station
- an upgrade kit can be ordered via your local Palfinger station, containing a new type of shaft which has a welded securing plate already installed.

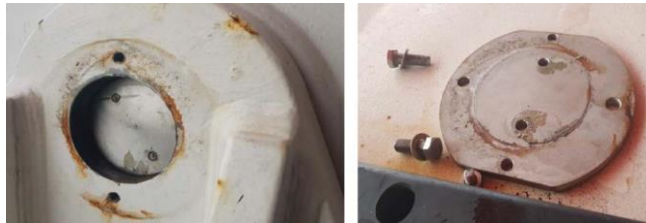
Picture 1: Pin retaining bolts sheared, Pin has moved 30mm into 50mm foot plate.

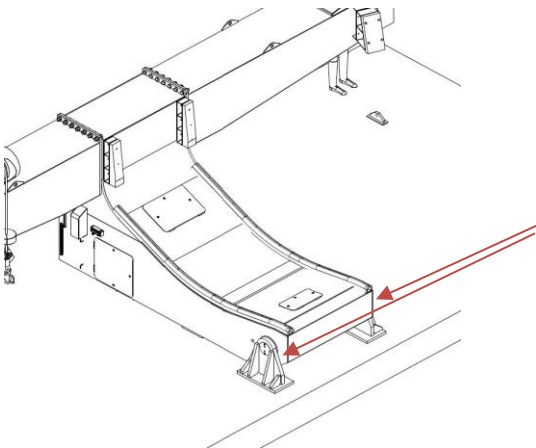
Sketch 2

The shaft (sketch 2) is locked with a locking plate (right side, sketch 2) towards the plate on the deck.

When the shaft is **not flush** with the davit side, the securing bolts are stressed due to the alignment between deck and davit is not constantly within tolerances during operation of the davit.

- Remove the locking plate.
- Check if shaft is completely flush with plate → see sketch 2.
- Put back locking plate.
