1 Dropped object during crane operations

2 Dropped Object – Steel deck plate falls from pipelay tower

3 Incorrect measurement and markings on divers umbilical

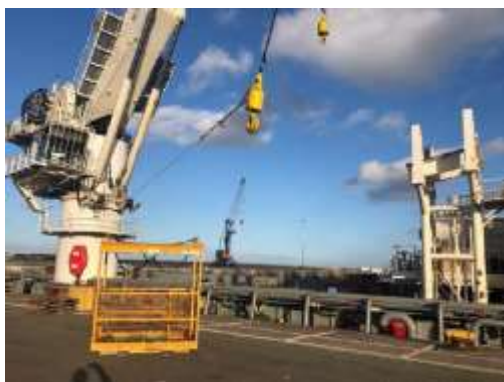
A piece of timber fell from a crane jib and landed on deck. The main crane on the vessel was being prepared for lifting operations by four deck crew and the crane operator. When the crane hooks were disconnected, the deck crew moved clear to allow the crane operator to start luffing the jib from the cradle. As the jib was slewing around, the crane operator observed an object fall from a height of approximately 10 metres to the main deck. No-one was nearby – the nearest crew were 15m away from where it landed. The dropped object was identified as a piece of timber, weighing 7.6kg. This had been used in a temporary repair of the dunnage on the boom rest.

Main crane and boom rest

- Initial design did not sufficiently address the lateral movements of the jib in the boom rest;
- Responsibility for the crane and associated equipment was not clearly understood;
- The temporary repair:
 - Several onboard inspections and third-party inspections were conducted which did not identify issues with the support dunnage and subsequent temporary repairs;
 - The damaged wooden packer was formally reported nearly a year earlier. This report had been closed out prematurely when a temporary repair was made;
 - The temporary repair was put in place using screws rather than bolts to attach a board over the damaged wooden packer. The screws corroded, causing the board to become loose and fall to the deck;
 - A work order had not been created for remedial works on the damaged support timbers;
- There was no checklist developed to include inspection of the boom rest.

- Review all lifting appliances, supports and cradles. Ensure that the equipment is maintained in its as built condition;
- Confirm that the boom rest is part of the vessel planned maintenance system;
- Ensure crane inspection checklists include inspection of the boom rest;
- Confirm areas around crane boom rests are included in hazard hunts for potential dropped objects.

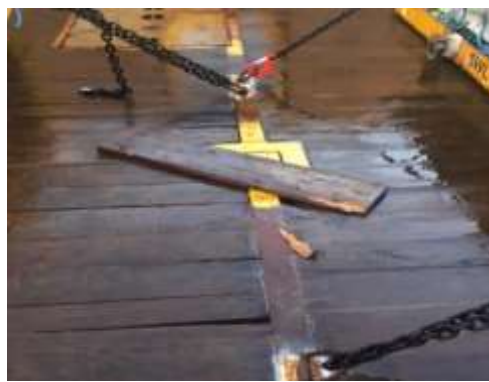
Section of timber landed on deck

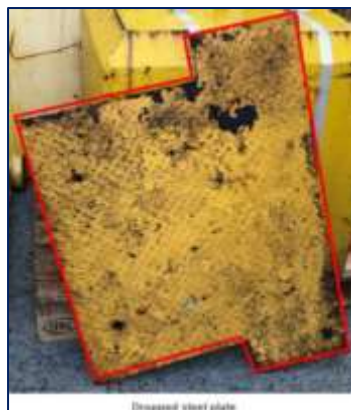
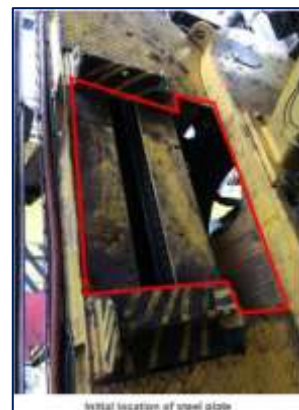
A large steel deck plate fell 9m from a pipelay tower to deck. The incident occurred on a vessel in dry dock, during which testing and inspection of the pipelay tower was taking place. A rope access technician stood on one of the steel deck plates located around the mid centralisers. The bolts securing the deck plate failed resulting in the deck plate upending and then falling to the deck below. The area below had been barriered off before work started. No-one was hurt. On inspection it was noticed that the deck plate fixings were heavily corroded, with three of the four securing bolts providing no support.

- This deck plate and others found were not part of the original pipelay tower structure, nor on any vessel drawings;
- No change management or design engineering was carried out;
- Incorrect size and material grade of bolts were used;
- The deck plate was only supported on the rear section, and no support bracket had been installed underneath the plate where the technician stood;

- Ensure all gratings, steel deck plates and their fixings installed at height are inspected as part of a routine inspection program;
- Ensure equipment modifications are controlled through the change management process.

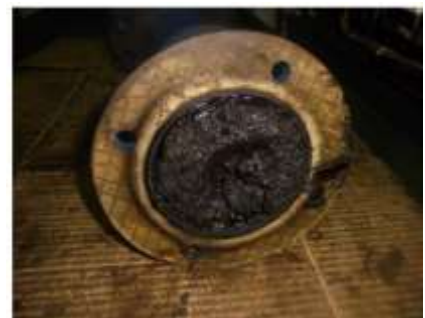
An engineer suffered severe burns when parts of his hands, arms and legs were covered with hot sludge from the sludge discharge line of a switched-off fuel oil separator. The incident occurred when he opened the inspection plug of the sludge discharge line.

- *The heating and pressurizing of the sludge in the discharge line in case of a complete blockade was not detected as a risk and so the inspection plug was opened very soon after the separator was switched off;*
- *Safety rules were not strictly followed outside the daily working hours in the engine room. The victim was not accompanied when inspecting the sludge discharge line and he was not protecting his skin with the necessary PPE. The hot and sticky sludge came into direct contact with the skin of the victim, aggravating the consequences of this accident.*

Completely blocked sludge discharge line

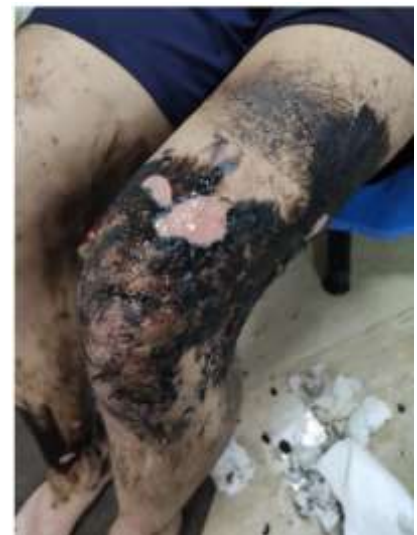
The engineer was wearing loose shorts and a t-shirt. The vessel was authorized to sail with an unmanned machinery space.

Legs of the engineer covered with sludge
