1 Three man overboard fatalities

2 Bypassing safety controls - violation of working at height requirements

3 Line of fire: deck tugger wire failure

4 Failure of natural fibre rope in embarkation ladder

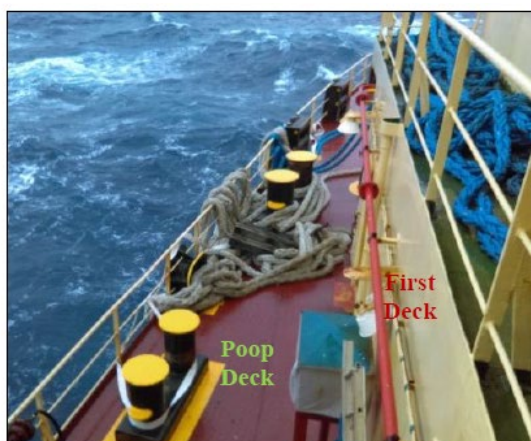
Figure 4: Situation on starboard side, two ropes secured to the railings of the poop deck, while the end of one of the ropes was hauled onto the first deck

Neither crew member was secured to the vessel, nor were they wearing life jackets, at the time of the incident. There were no inflatable life jackets on board the vessel. (IMCA red for emphasis)

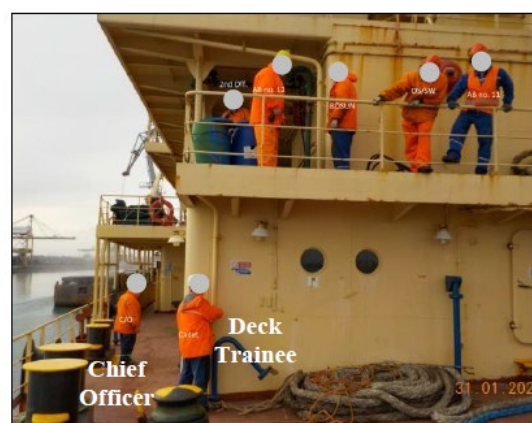
Figure 5: Simulation of the crew's location when the waves washed over the poop deck

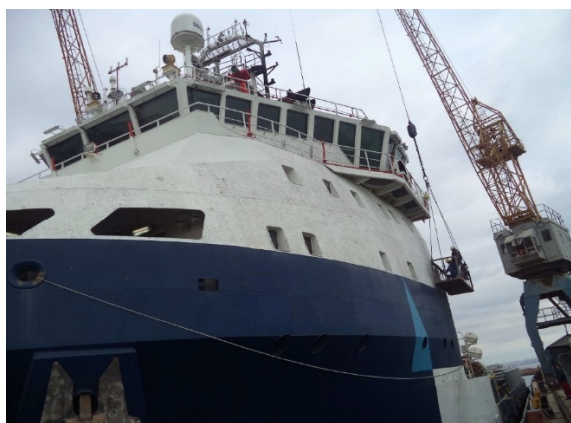
The shipyard representative was requested to provide certificates for basket in use, but it was revealed that neither basket nor fall arrest equipment had valid test certificates.

- Shipyard failed to follow agreed Control of Work process, or follow equipment certification & PPE requirements related to Work at Height activities as agreed by the contractor and the yard;
- It was *not clear* who was responsible for Control of Work and HSE oversight between the contractor and the yard. (IMCA italics)

Uncertified basket

- Revision of Safety Management System to include implementation of vessel pre-docking checklist to verify HSE readiness, including shipyard arrangements, cranes, relevant equipment and workforce certification prior to vessel docking;
- Arrange development of bridging agreements between shipyard and contractor, to specify Control of work responsibilities for any activities onboard of vessel, including external activities related to vessel hull.

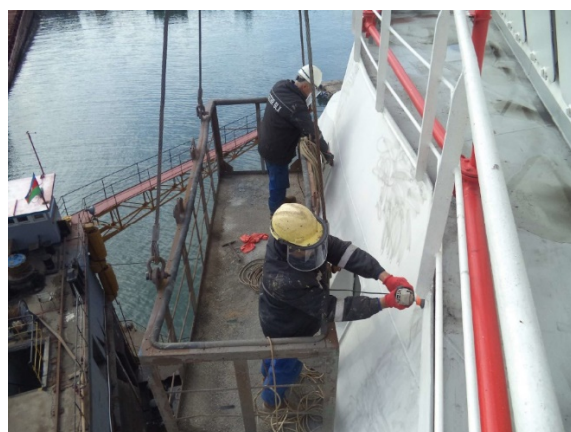
On a vessel in dry dock, painting of the hull was ongoing, using the shipyard crane and a personnel basket. During this work process it was observed that the workers in the basket were not provided with safety harnesses.

Working at height without a safety harness

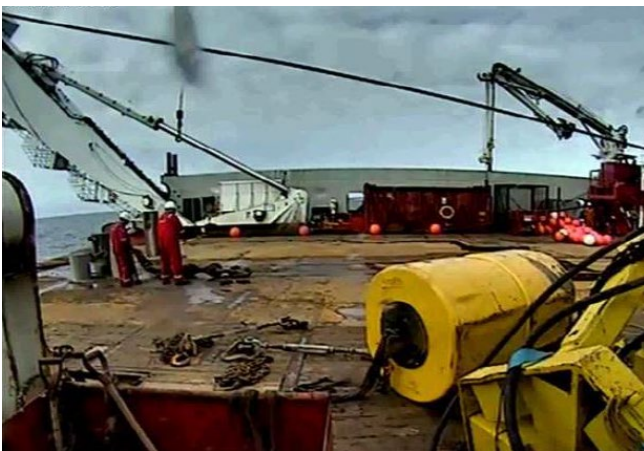
Personnel were standing in line of fire during recovery of a Back-Fill Plough when a chain sling failed, and the rigging recoiled across the deck. A tugger wire connected to a tow wire and chain sling, unexpectedly came under tension, the chain sling failed, and the rigging recoiled.

This intention was not clearly communicated to, nor was it understood by, the tugger winch operator or the deck crew. The tension on the chain sling rapidly increased, it failed, and the released rigging recoiled and narrowly missed the personnel in line of fire. The chain sling contacted a deck plate which dissipated much of the energy.

Deck crew immediately before tugger wire snaps (10:23 54'')

- Ensure a toolbox talk (TBT) is conducted when moving from one task plan to another so that all parties involved in the operation are aware of their roles and responsibilities;
- Supervise compliance with approved procedures or perform a Management of Change process before making any deviations from a procedure;
- Reinforce the need for clear, concise communication and always confirming everyone understands the next activity;
- Ensure personnel are fully aware of the risks from being **in the line of fire** of wires or chains under tension and that they are clear on the safe areas they must remain within. This should be a key part of the TBT.

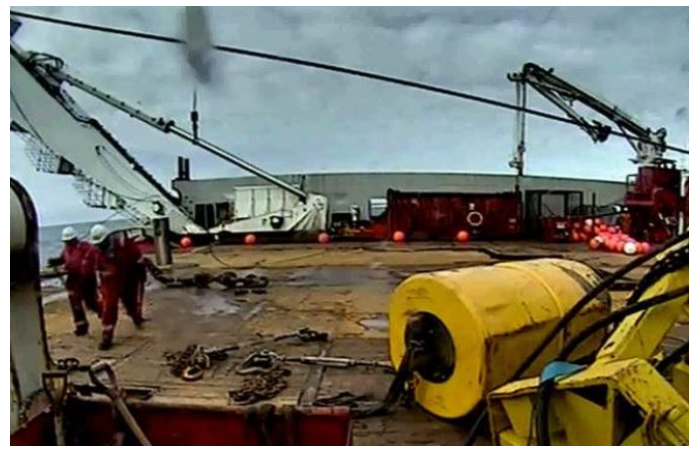
Deck crew getting out of the line of fire as tugger wire snaps (10:23 57'')

- There was no opportunity taken to have a time-out to discuss the change in task plans when moving from the launch of the plough to its recovery;
- There were inconsistencies between shifts, and inadequate documentation, between marine crew and project personnel, of who exactly was responsible for deck operations;
- The change in the “standard” practice of manually pulling the tugger wire up the deck was not communicated to all parties involved, and the consequence of the change was neither evaluated nor understood;
- There was a failure to follow the risk assessment which required a “Clear Deck Policy” when using tuggers and spooling with personnel positioned in a safe zone.

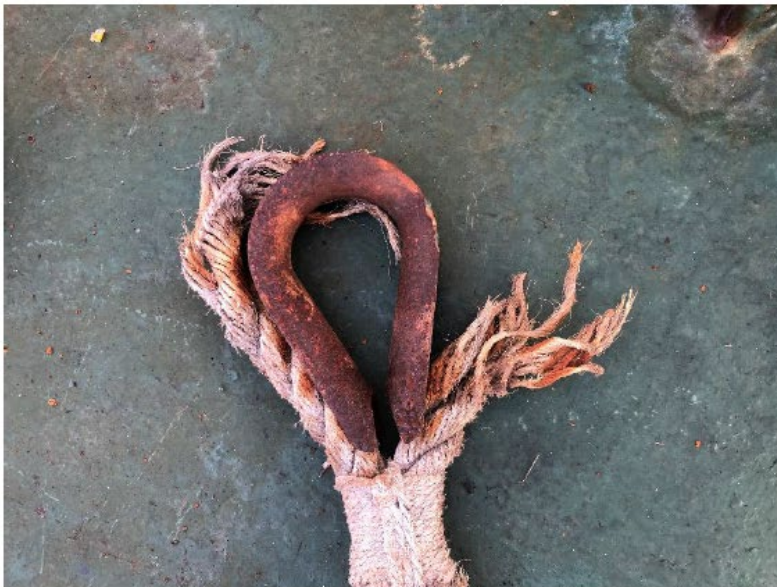
Planned inspection/replacement of a lifeboat embarkation ladder identified the total failure of the natural fibre rope at the securing thimble. The fibre rope at the anchor point securing thimble was worn through due to incorrect connection creating the potential for ladder failure on deployment.

Failure of cordage

Investigation found that the failure was caused through abrasion due to the back of the eye being in contact with the metal deck strong point. The anchor point was too small for the use of a shackle of enough size to provide clearance between the rope and deck strong point. The rope failed during removal of the ladder, indicating the extent of the wear.

The inspection and maintenance of rope ladders should be part of the vessel planned maintenance schedule. A thorough inspection should be undertaken on a regular basis, and a visual check before and after use. The entire length of the ladder should be examined including all fixtures and fittings, considering the following points:

Damage to or degradation of a natural fibre rope should be evaluated by an appropriately experienced crew member. If deemed necessary, or if any doubt exists, the ladder should be removed from service, repaired or replaced. Factors which may require such action could include:

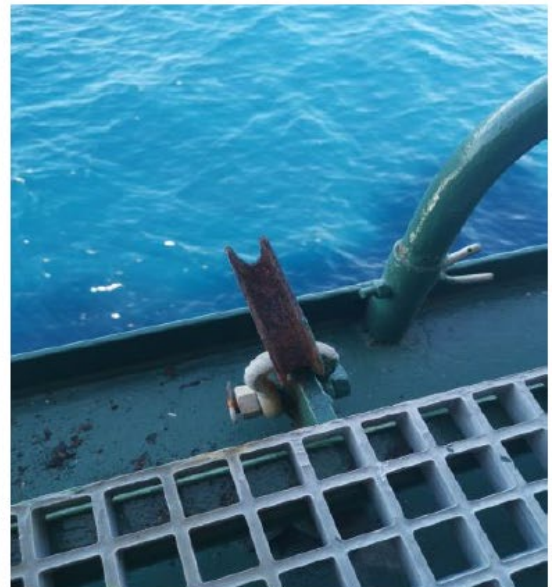
Lack of clearance (cordage – deck strong point)

Shackles should be replaced if wear or corrosion has reduced the diameter of the crown or pin by more than 10%. Pad eyes should be checked for cracks and excessive wear and be replaced or repaired in accordance with Class requirements.

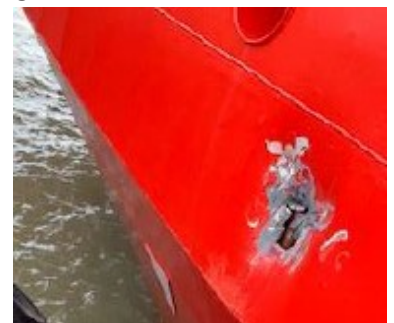
In one incident, a pad eye on the quayside edge made contact and penetrated the vessel hull plating. At the time of the incident, the vessel was experiencing strong beam winds gusting up to 47 knots, pushing the vessel onto the quayside. Contact with the furthest forward fendering squeezed it out of position and underneath the quay structure. This allowed the forward section of the hull to come into contact with the protruding pad eye. It has become apparent that the fender resting place on the quay structure must have been previously damaged, enabling the fender to slide around the quayside supporting column.

In the first incident, the securing arrangements (pad eye) for the Yokohama fender must have been damaged at some point, but this was not reported to the vessel. This resulted in the Yokohama fender being able to move away from the jetty column and thus offering no protection to the vessel's hull.

- Wherever possible obtain a berthing plan in good time so as to make a full appraisal of fendering, mooring and gangway arrangements and request any necessary changes or clarifications;

- Remain aware of the weather conditions when approaching the berth and if not satisfied with the situation, abort the approach and/or request tug assistance if appropriate and available;

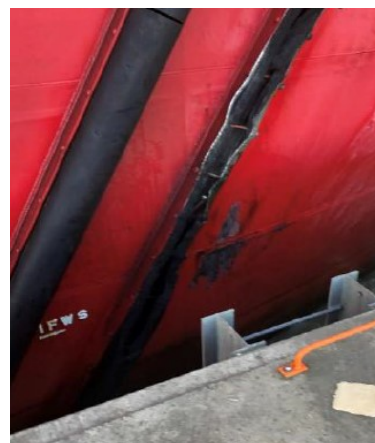
In the second incident, the vessel experienced damage to the hull fender and hull mounted fender frame. This was caused because there were no Yokohama fenders as expected, but instead large steel plates with sheets of rubber for the facing. The quayside location was exposed to the weather; the vessel experienced a heave of up to 2 metres, resulting in the wear down of the ship fender rubbing against the top edge of the quayside fender plate.

In the second incident, the vessel Master was expecting Yokohama fenders. Instead the berth was fitted with metal, rubber faced plate fenders, which were not suitable for the hull layout of the vessel and resulted in damage to the vessel's hull plating and fixed fenders.

- If it becomes apparent that the intended berth is not suitable, abort the approach and inform the Pilot/Port Authority and request alternative arrangements;
