1 Fatality: person crushed when secured material fell on him

2 Crane wire parted during offshore operations

3 Tumble dryer fire: lint ignition

4 Electric shock due to water in electrical equipment

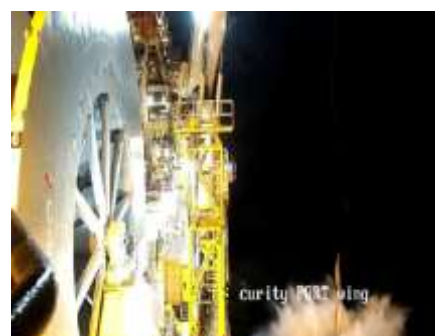
A concrete mattress was being deployed as part of the construction of a pipeline crossing. As the load was swung outboard and before it entered the water, the crane wire parted causing the load to fall to the seabed. The vessel was in a safe handling zone more than 5m from subsea assets. The mattress was overboarded when the crane was 17m from the nearest subsea asset.

During the lift, the load was swung outboard and before it entered the water, the crane wire parted causing the load to fall to the seabed. The mattress and lifting frame were found 6m away from the buried gas pipeline.

The moment the crane wire parted causing the load to fall to the sea

- Ensure full communication and engagement between shore-side experts and management on the one hand, and vessel team on the other;
- Any dispensation for wire ropes should be recorded in planned maintenance systems;
- Ensure that mattresses are moved into position from a direction that prevents the mattress being lifted over existing pipelines;
- Reinforce the requirements for the consistent application of the management of change, and technical management of change.

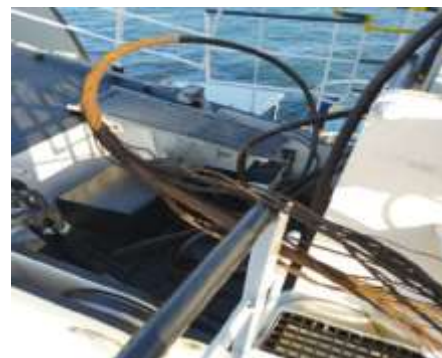
- The vessel main crane was in use during the period following the Magnetic Rope Testing (MRT) when the results were still being evaluated. The test results stated a clear recommendation to cut back the wire;

- The operational limit was set on using 30% of the crane capacity. There was a misunderstanding that the Safe Working Load (SWL) of the crane wire was 60Te;

Parted wire frayed end

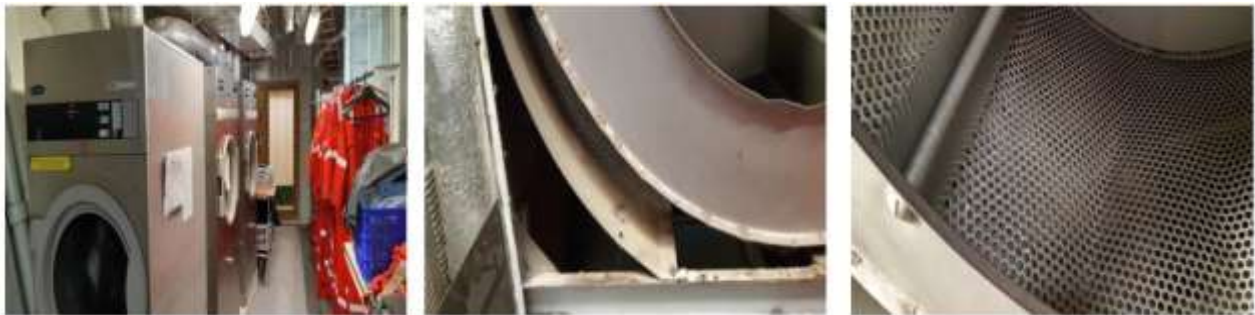
Accumulated lint trapped inside an industrial tumble dryer onboard a member's vessel, overheated and ignited. Whilst working in the vessel laundry a steward smelt burning coming from one of the three tumble driers. The steward stopped the dryer immediately, removed the contents and observed a flame coming through from the base of the rotating drum. He extinguished the fire with a portable fire extinguisher and immediately notified the bridge.

The other dryers in the laundry were subsequently isolated to inspect their filters which were found to be clean. A small amount of scorched lint was found trapped between the drum and the drum casing in the dryer: this lint had ignited. The gap between the drum and casing of the two other dryers was found to be clean.

- A review of manufacturer's user guides to support operation and planned maintenance of tumble dryers – assessing where appropriate additional measures required to reduce the risk arising from operational use;

- Take extra care when assessing the condition of filters within tumble dryers – it is more difficult to identify any passing or obstructions beyond filters;

- Ensure that the design of the tumble dryer filters, drums and exhaust ducting enable sufficient access to allow for cleaning and removal of build-up of material;

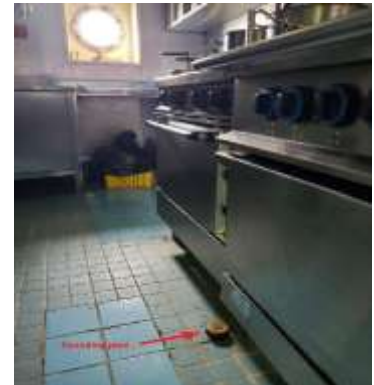
There was an uncontrolled spraying of fresh water from a sounding pipe in the galley, resulting in electrical equipment getting wet. As a result someone got an electric shock. The incident occurred during fresh water supply to a vessel, when the sounding pipe cap (located on the floor in the vessel galley) did not withstand the pressure, and so water sprayed out into the galley and onto the electrical stoves and deep fat fryer.

Location of sounding pipe cap

- The drainage system in the galley should be always kept open;
- Review, revise and update risk assessments as related to potential water flooding from the freshwater tank sounding pipes;
- Ensure the catering crew are kept informed of relevant inspection and maintenance requirements for their equipment.

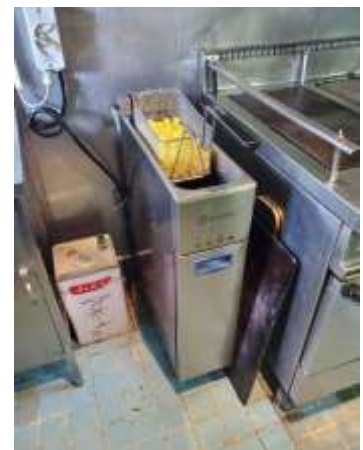
The flow of water was stopped and spilled water was mopped up, and the catering team continued to work. However, it appeared that water had penetrated the electrical circuitry of the deep fat fryer, and the steward received a mains electrical shock. This was reported, and the electrical equipment isolated. The steward was not harmed.

Electrical stove and deep fryer

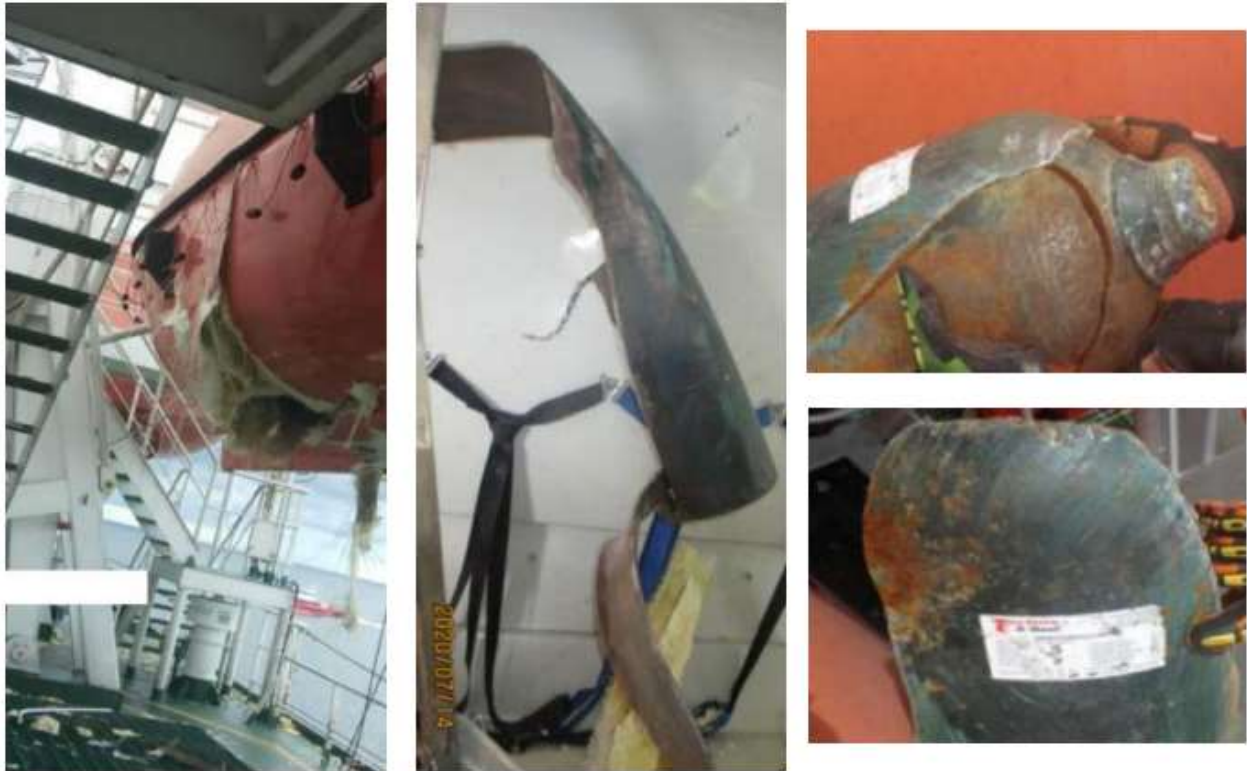
There was a structural failure of an air cylinder fitted in a lifeboat. It occurred without warning. No work had or was being conducted on or around the air cylinder. Three crew members working nearby were injured by the blast debris.

Two preliminary suspected causes of the cylinder failure have been identified:

- Galvanic corrosion between the cylinder material and the metal support frame leading to a weakness in the cylinder wall;
- Cylinders submerged in bilge water for extended period leading to wall corrosion which could have then affected the integrity.

- Inspected annually for corrosion or wall damage by service providers;
- Hydrostatic [pressure] tested at a required interval of five years.
