1 Human Factor caused a DP Incident

2 Human Factor caused a DP Undesired Event

3 DP2 Cargo Vessel DP Incident

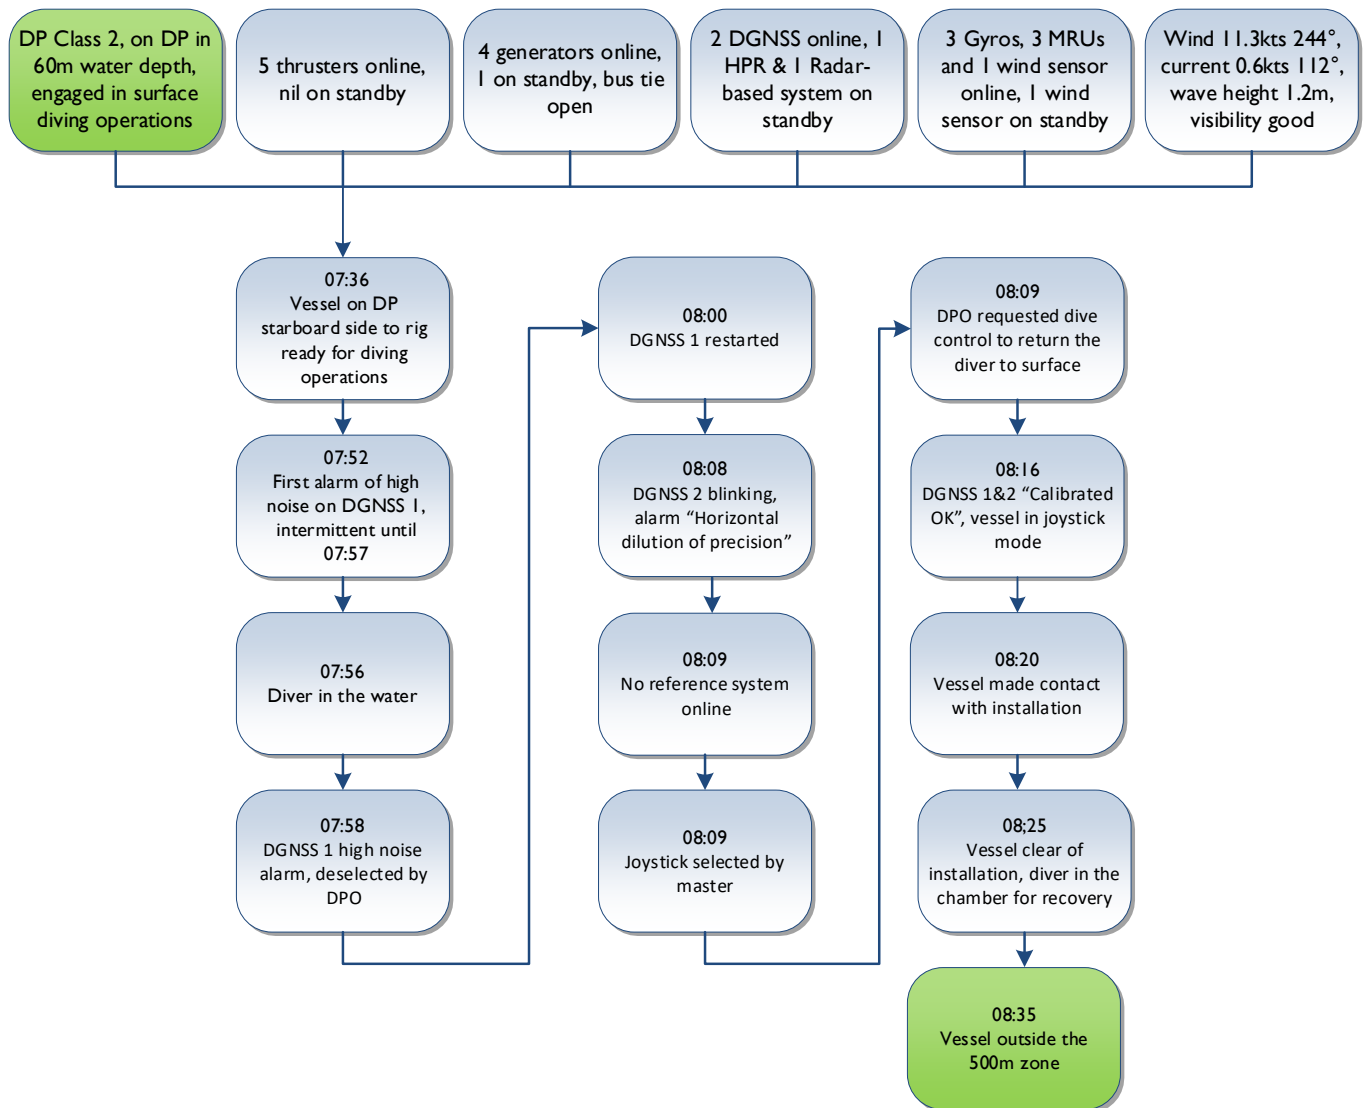
Human factor played a role here, checklists were completed but the minimum number of position reference systems (PRS) for a DP class 2 operation were not used. When both the DGNSSs failed due to high noise, other PRSs were not readily available for deployment.

- 1) The vessel was not being operated as a DP Equipment Class 2 vessel due to a lack of position reference systems in use at the time of the incident.

- 6) It is not clear from the events reported why the vessel made contact with the installation despite being in manual joystick mode for 11 minutes considering light weather conditions. In the absence of detail, it is assumed that those operating the vessel had inadequate manoeuvring competencies.

- 4) Operational planning and the effective use of decision support tools should have ensured the correct deployment of position reference systems and identified the risk of DGNSS interference, prior to the operation.

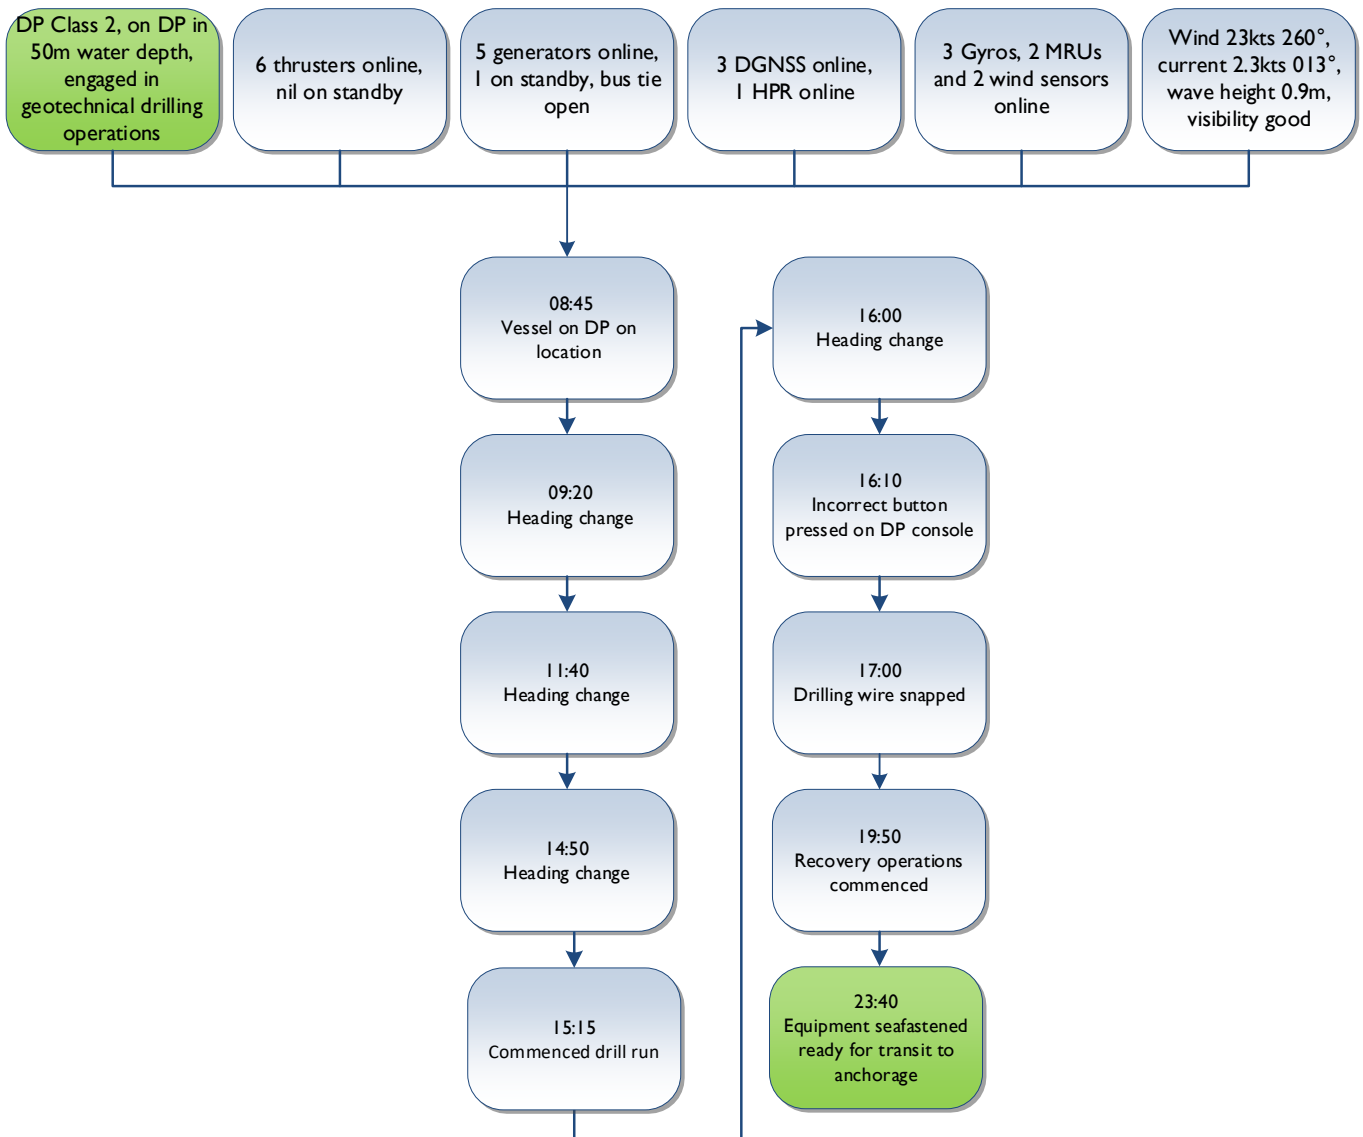
The vessel was operating in shallow water and a strong current. There were several heading changes prior to the event. It was noted that heading changes, particularly in strong current should be completed at very low rates of turn. In such a situation the report commented that the vessel position should be independently monitored, such as by a survey screen, to ensure the required position setpoint remains as required.

- 1) There is a lack of information available within the report however, it states that the drill string snapped 50 minutes after an “incorrect button” was pressed. It also appears that the ROT used for heading changes was too high for the operation and the offsets for the DGNSS were incorrect. Therefore, it is assumed that there was a position excursion.

- 3) Rapid heading changes in such environmental conditions may destabilise the DP model resulting in unpredictable behaviour with significant consequences. Heading and position changes should be carried out in small increments and with adequate waiting time to enable the model to stabilise between increments.

- 4) The use of three DGNSS is an over reliance on one PRS operating principle (DGNSS) at the expense of the other single PRS.

- CAMO updated, maximum Rate of Turn (ROT) & maximum allowance for heading change amended;
- Heading change procedure generated; inc position of personnel, drillers to be evacuated from Rooster box, checks to be performed and communication protocols;
- 6 hourly checklist revised: offsets of DGNSS added & tick box added for survey position;
- Revised DP standing orders: Offset of DGNSS to be checked after rebooting OS PC. Compare survey position with DP all times during operations.

- 2) Following the installation or relocation of position reference sensors, offsets should be permanently changed in the controllers. On at least one DP control system, position reference system offsets can be changed at the operator stations but revert to the original setting when the controllers are reset. Offsets should therefore be verified as part of operational planning.
