1 Near miss: vessel approach to wind turbine tower

2 Dropped Object – Crane auxiliary block dropped from crane boom

3 Shipyard worker receives electrical shock

4 SIMOPS - Smoke from hot work task enters confined space

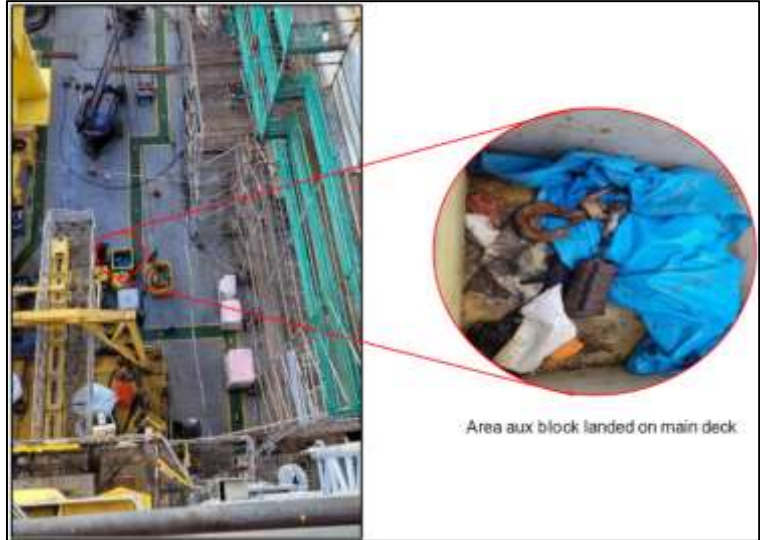
The crane operator was instructed by the banksman, who was situated on the main deck to extend the boom so it was positioned over the basket containing the water bags, sited on the main deck. It was during the extension of the boom that the auxiliary crane wire failed and the block, weighing 30kg dropped from crane boom to main deck (approximately 30 metres). The block landed directly into a steel container that was used for storing tensioner pads.

The cause of the failure was due to the double blocking of the auxiliary block and chandelier, also the interlock overload protection failed to activate.

- The following immediate improvement was identified:
 - Although a banksman was in place for this task, he was too far away to effectively monitor the full movement of the crane. An additional spotter should have been used.

- Further discussion points:
 - Ensure crane checks are carried out daily;
 - Ensure crane operators do not rely solely on their crane limits to stop a movement;
 - The banksman should at all times direct the crane operator when the crane is on the move, from start up when removing the crane from the rest, through to until it is parked and made secure.
 - Where applicable, additional spotters should be used to monitor positions of crane blocks.

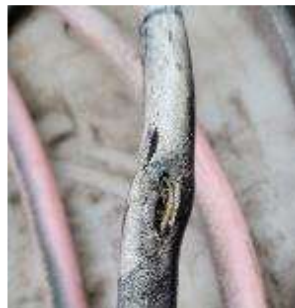
Damaged section of three-phase cable

As he routed the cable the welder had to walk through the pools of water which had gathered due to the inclement weather, to get the cable positioned correctly near his welding machine. Whilst carrying out this task, his hand came into contact with a damaged section of the extension cable which resulted in him receiving an electric shock.

- The electric cable outer sheathing was damaged with the inner cores exposed. The plug socket end cap was also broken off;
- The equipment was not visually inspected prior to use
- No RCD's (residual current breaker) were installed in the electrical distribution boxes. (The shipyard was unaware of the availability of RCD's that wouldn't 'trip' all the time during welding operations).
- The welders gloves were wet as a result of the inclement weather.

- Ensure daily pre-use inspections are performed on all work equipment;
- Ensure any defective equipment is immediately removed from site and quarantined;
- Ensure appropriate protection devices are fitted to electrical circuits;
- Emphasise the importance of knowing how to isolate equipment in the event of an emergency;
- Ensure risk assessments consider the effects of inclement weather and that suitable controls are identified and implemented.

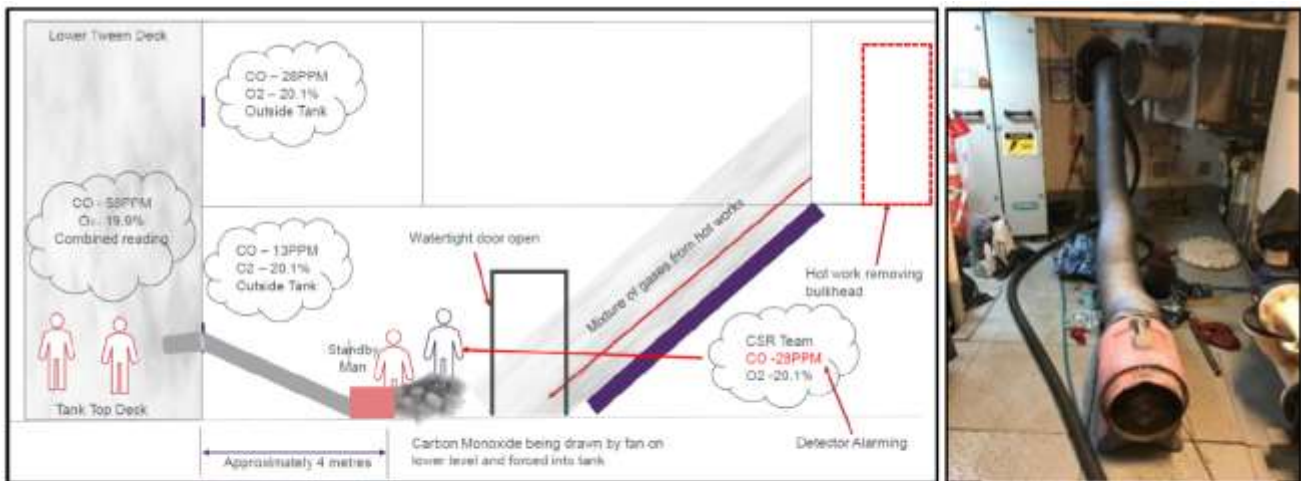
On a vessel in dry dock, confined space entry was required for the cleaning of the vessel sewage tanks. Nearby, shipyard workers were removing a section of bulkhead using oxy-propane cutting equipment. The smoke generated from this activity was being drawn down a stairway to the deck below by a portable ventilation fan. The fan had been set up to provide clean air for the sewage tank cleaning operation. The smoke was then sucked into the portable ventilation and forced into the confined space.

- The sub-contracted tank cleaning work party were wearing their gas monitors inside their protective oversuits potentially preventing them from functioning correctly;
- The work party was also unaware of the requirement to perform daily “bump tests” on their gas detectors, and the calibration for all their detectors was out of date.
- The hotwork work party and the tank sentry did not recognise the smoke to be a hazardous condition and therefore did not intervene.

Worksite layout indicating the different detector readings at various locations

- Additional focus to be placed on SIMOPS during the daily planning meeting;
- Onsite checks of all sub-contractor equipment and worksite layout to be performed by confined space entry rescue team before work starts in a confined space;
- More effective fume extraction should be used during hotwork activities;
- Ensure all tank sentries fully understand their role and responsibilities and the hazards associated with confined space entry;
- The sub-contracted cleaning company made the following changes:
 - Correct calibration and bump testing of gas detectors as per manufacturer’s instructions;
 - Required wearing of gas detectors outside of protective suits.
