1 BSEE: Crewman fell to his death through faulty grating

The United States' Bureau of Safety and Environmental Enforcement (BSEE) has published BSEE Panel Report 2021-001 into a fatal fall from a platform in the Gulf of Mexico in 2019.

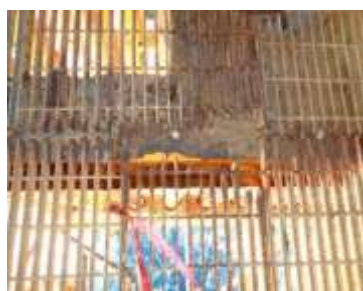
Less than 24 hours prior to the incident, a single section of severely corroded and deteriorated grating, posing a walking and working surface hazard, was identified on the north side of the well bay by a supervisor, who said that the grating section felt "spongy" underfoot. Upon examination, he found that bearing bars at one end of the grating section had deteriorated.

Pre-Incident photograph of hazardous grating section

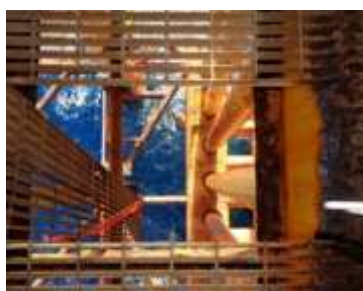
A night shift production operator died when he fell into the sea through a rusty grating on the platform. His body was never recovered.

Post-Incident photograph of hazardous grating section suspended in open hole

- There was a failure to maintain all walking and working surfaces on the facility in a safe condition;
- Supervisors did not fulfill their responsibilities within the relevant, established Safe Work Practices (SWPs) when they:
 - failed to promptly correct or prevent personnel from accessing the hazardous area;
 - failed to stop work and warn all personnel of the hazardous area.
- The operator and its contractors failed to follow the agreed upon terms and conditions within their respective Safety and Environmental Management Systems (SEMS) bridging arrangements.

- Ensure crew are informed about all identified hazards in a timely and meaningful way;

- When hazards are identified, fix them;
- Better understanding of and agreement between, operators and contractors in terms of safety management systems bridging arrangements.

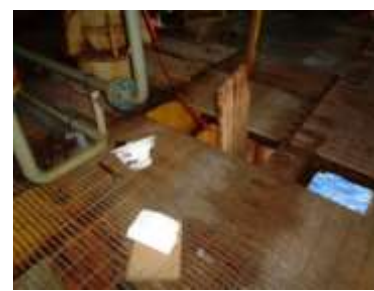
Post-Incident Photograph of hazardous grating section

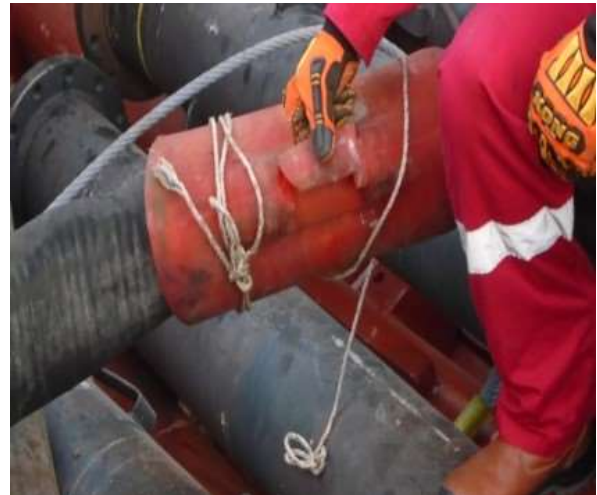
A lifting saddle broke, causing a hose to swing and hit a crewman, causing an injury to his hand. The incident occurred at completion of cement pumping between a vessel and a rig. During recovery of the cement hose, the saddle handle broke, and this caused the hose to swing and hit the AB, who at that moment was giving a signal to the crane operator. He was not under the hose or the load, but was approximately 10 meters away. Part of the hose was still in the water. He was in the line of fire when the hose swung in his direction and he braced using his forearm, resulting in an injury.

- The lifting saddle broke where the sling was incorrectly attached;
- The hose was lowered from the rig to the vessel deck only slinging the handle of the saddle and not passing it around the hose;
- The deck crew noticed this incorrect lifting arrangement but did not stop to correct or change it, and give the instruction to pick up.

Showing point where saddle broke and sling was connected

- **Stop Work Authority** should be exercised if incorrect procedures and unsafe conditions are noticed, particularly during lifting operations;
- Thorough and regular inspection of all loose lifting equipment.

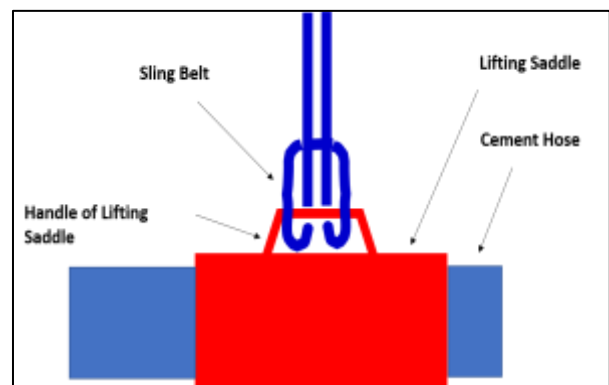
Diagram Showing Lifting Arrangement Used (Incorrect)

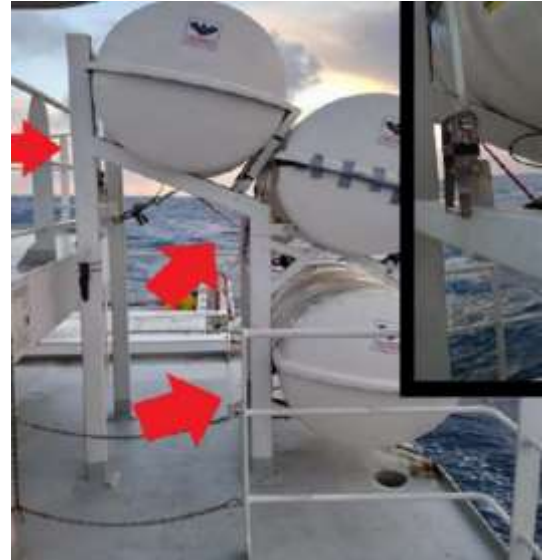
The life-rafts were individually secured by a crane while the straps were being replaced. When the crane was holding the topmost life-raft, one crewmember accidentally released the ratchet strap of the middle raft. The raft slid off the cradle and dropped approximately 10 meters to the pier. The life-raft container was damaged; no-one was injured.

- The risk assessment was not suitable or sufficient: the risk assessment used for this job was primarily intended for the tasks of lifting the life-rafts out of storage;
 - It did not identify the risk of confusing the straps; this particular risk was not discussed during toolbox talks beforehand;
- The straps were not identified nor temporarily marked before the task – the crewman took the wrong strap;
- The responsibility of releasing the strap was not clearly assigned to any one particular person, and who was going to do it, was not agreed beforehand.

- **Develop better situational awareness:** the person who released the wrong life-raft believed his action was correct;
- **Mistakes will be made:** the risks of human error occurring should always be taken into account;
- **Assign clear responsibility:** ensure that team members know which task is done by which person – before starting work;
- **Check the drop zones:** investigation revealed that the area on the quay underneath the life-rafts was not easily accessible because access to the gangway was restricted to comply with ISPS requirements.

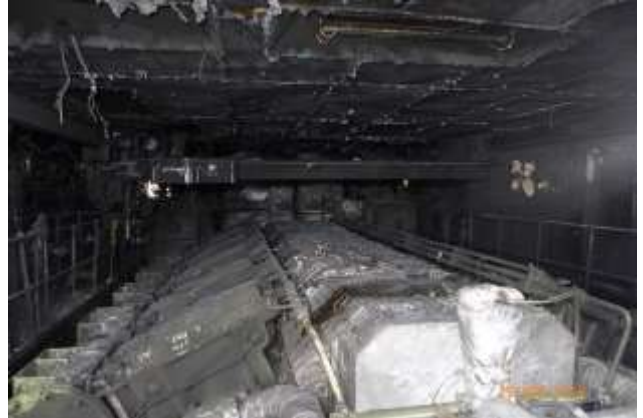
On 16 April 2018, the Lithuanian registered ro-ro cargo vessel *Finlandia Seaways* suffered a catastrophic main engine failure that caused serious structural damage to the engine and a fire in the engine room. The vessel's third engineer, who was on duty in the engine room at the time, suffered serious smoke-related lung, kidney and eye injuries during his escape.

A main engine connecting rod broke. Parts of the engine were thrown through the side of the crank case into the engine room, and a short but intense fire occurred. Within 20 minutes the crew had conducted a muster, sealed the engine room, activated its carbon dioxide fixed fire-fighting system and extinguished the fire. The third engineer was medevaced to hospital and made a successful recovery.

The MAIB investigation identified that the catastrophic engine failure had been initiated by the failure of a **single component** (IMCA emphasis) and found that the standard and management of maintenance carried out by the vessel operator's maintenance support contractor was a significant causal factor.

- Standards of maintenance management;
- Lack of appreciation of the importance of following the engine manufacturer's instructions for the removal and refitting of the piston pin bearing bushes;
- External oversight of the engine maintenance process.
