IMCA Safety Flashes summarise key safety matters and incidents, allowing lessons to be more easily learnt for the benefit of all. The effectiveness of the IMCA Safety Flash system depends on Members sharing information and so avoiding repeat incidents. Please consider adding safetyreports@imca-int.com to your internal distribution list for safety alerts or manually submitting information on incidents you consider may be relevant. All information is anonymised or sanitised, as appropriate.

1 Flood light dropped to deck - corrosion

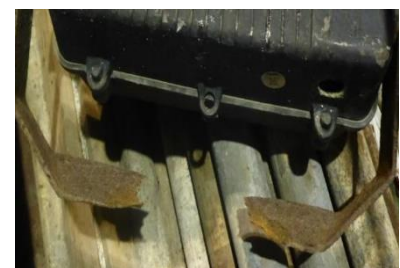
A floodlight weighing about 6kg was found on the deck, near to the scaffolding storage area, underneath the main crane boom rest. The flood light affixed to the main crane boom rest dislodged from its frame and dropped to deck, a distance of 4.5m. The electrical supply to the flood light fitting was immediately isolated.

- Hidden corrosion: The flood light mounting frame which remained affixed to the main crane boom rest, showed excessive wear and tear, and had completely corroded, leading to the flood light detaching from its mounting frame;
- There was no secondary retention;
- The flood light had not been identified as a potential dropped object;
- The advanced deterioration of the mounting frame was obscured by the paint work;
- Environmental conditions including vibration, humidity, wind loading, and sea salt corrosion may have impacted the mounting frame materials.

Dropped flood light

- Think carefully about what could become a dropped object - perform dropped object surveys;
 - Consider cross-departmental “hazard hunts” for drop hazards – get some “fresh eyes” in to spot what you may have missed;
- Ensure that everyone knows who is responsible for doing dropped object inspections;
- Make use of secondary retention where appropriate.

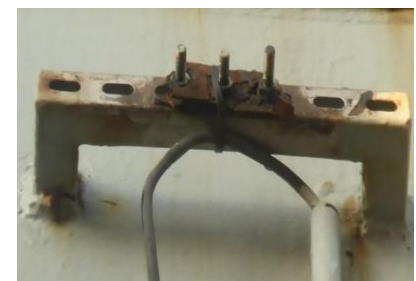
Flood light mounting frame

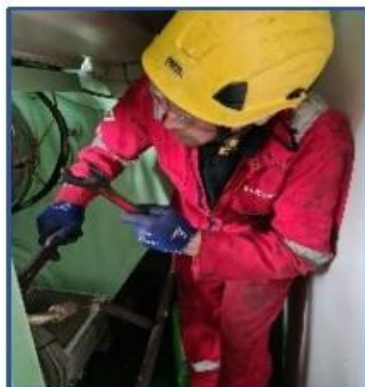
A technician was working on a hydraulic fitting with two spanners when one spanner slipped and struck him in the face. There was limited space available due to the position of the fitting. Holding one spanner in his right hand, he was loosening the fitting with a spanner in his left hand which slipped and struck his forehead causing the injuries. He was wearing safety glasses at the time but the struck safety glasses injured the bridge of his nose.

Technician workspace at cooler box

Work in the marine and offshore environment may require individuals to lift, stoop, kneel, twist, grip, stretch, reach overhead, or work in other awkward positions. In planning these activities, task risk assessments, pre-job planning and toolbox talks should consider and review the combination of ergonomic factors that could impact the task.

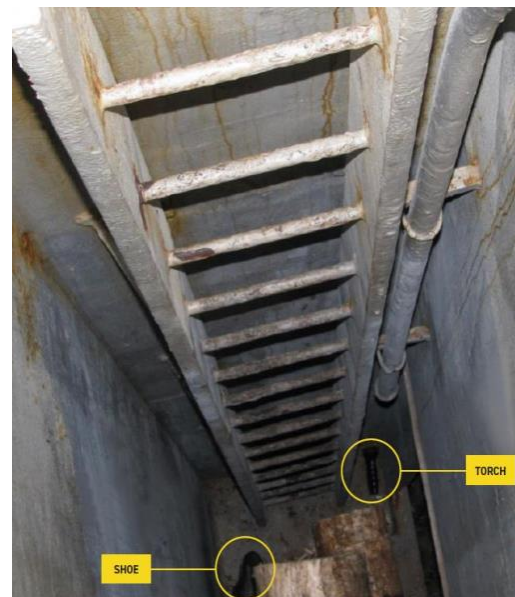
A bulk carrier was loading logs, and the Chief Officer entered a cargo hold which contained logs. Upon entry he rapidly lost consciousness and fell from the entrance ladder. A fellow crew member who tried to rescue the Chief Officer suffered the same fate. They were later both pronounced dead due to asphyxia.

It had been noted that a rubber seal on the hold access door needed replacing. The Chief Officer descended into the cargo hold and after only a few steps suddenly fell onto the logs below. The bosun immediately alerted fellow crew members standing at the gangway, then made his way to the aft mooring station to get a rope. The Second Officer was at the gangway and alerted the master by radio. He then fetched a breathing apparatus (BA) set and also oxygen from the ship’s hospital. An Able Seaman, having alerted the Third Officer, returned to the hold and started to climb down into the hold with another crew member about to follow. The Bosun managed to prevent the latter from entering but the Able Seaman collapsed and fell.

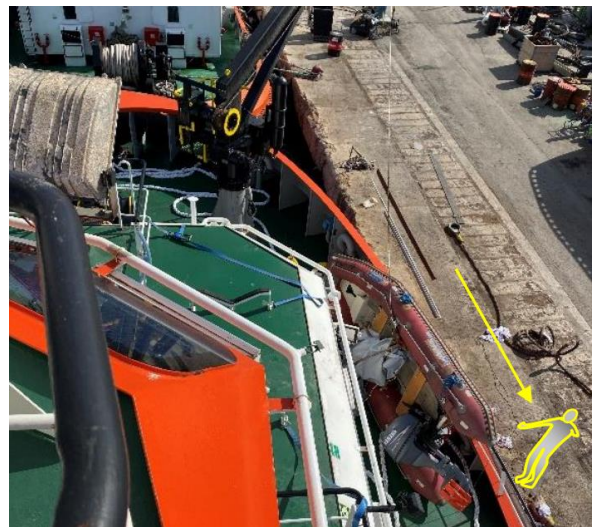
To facilitate the task, one of the crew members stepped on the unprotected outboard side of the rescue boat. At this time, he attempted to slacken the tension on the lifting slings holding the rescue boat. As soon as he operated the yellow handle, the rescue boat swung outboard, struck the crew member, and threw him onto the quay.

- The crew members were not entirely familiar with the rescue boat davit operation - the davit’s slewing mechanism was activated accidentally, causing the rescue boat to swing outboard, dragging the crewman along with it;
- A risk assessment was not considered necessary for this task, which was considered trivial or routine;
- The injured person was working on the outboard side, where there were no guard rails fitted, nor was a safety harness or a hard hat worn.

Final position of rescue boat after the swing and approximate landing position of the injured person
