1 Computer Error caused a DP incident

2 Human Factor caused a DP Undesired Event

3 DP2 Service Operations Vessel (SOV) DP Incident

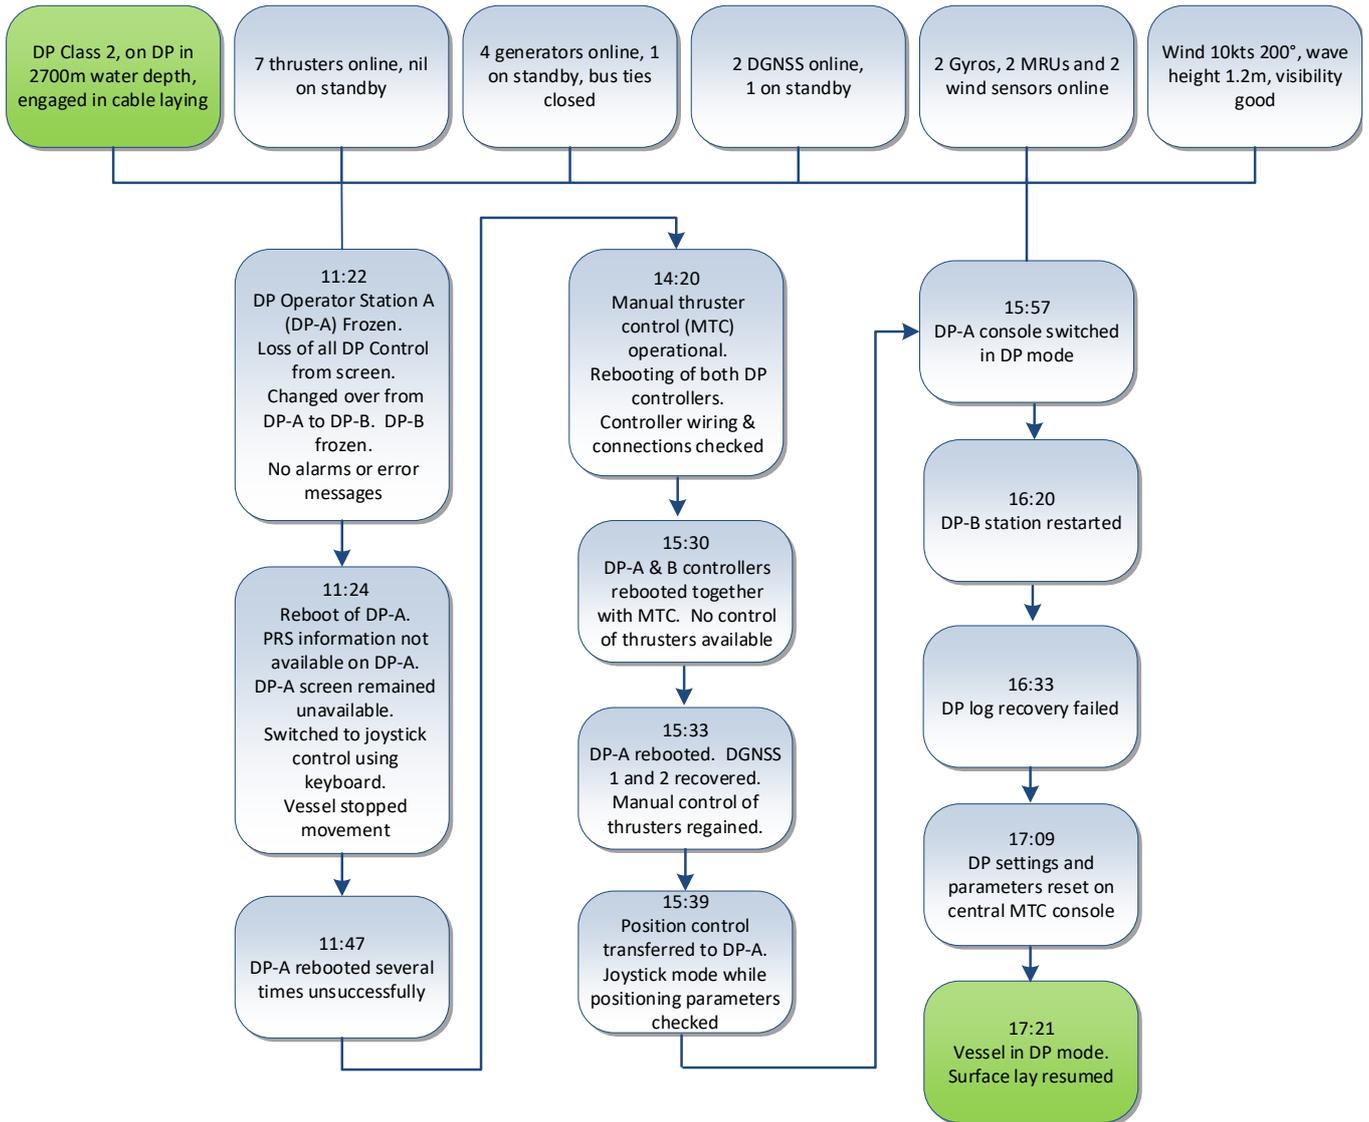
The report detailed that there was a “bug” in DP-A station. To resolve the issue DP-A and B as well as MTC stations were stopped at the same time, so to avoid the restarting station copying corrupted information from an online controller affected by the bug. The report highlighted that there had been no regular software updates executed and the equipment was getting older with more frequent reboots while in operation.

This event highlights the need to ensure a robust management of change process around software and software updates. The event report did not highlight the use of activity specific operating guidelines nor any change to DP status during the incident. Although not detailed in the report, the DP committee questioned the use of manual thruster control instead of Independent Joystick mode which may have aided station keeping during investigation works. Although not related to the event the number of references seems inadequate. IMO MSC Circ 645 and IMO MSC.1 Circ 1580 guidance documents state that for DP 2 or 3 operations:

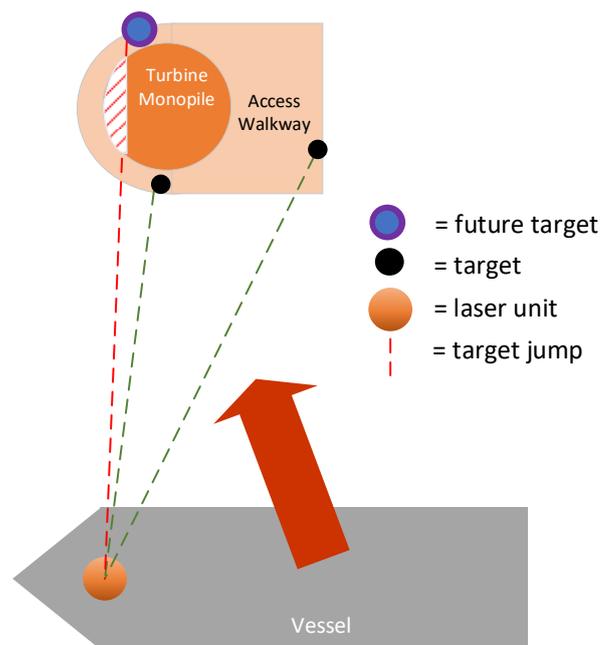
VESSEL APPROACH

The distance to the tower was 40m when the SDPO commenced a move of the vessel towards the tower in order to get the vessel alongside for walk to work operations. After the move was completed, the SDPO deselected the laser position reference from the DP desk in order to change the laser target. The SDPO changed the selection of the target because it would get obstructed by the railings of the walkway around the turbine when the vessel would move closer. The 'new' selected laser target had a clear sight with the laser position reference transponder/receiver unit. Once the laser signal was stable the SDPO enabled it back in DP. Shortly after, the vessel arrived in final position and the SDPO informed the walk to work management team.

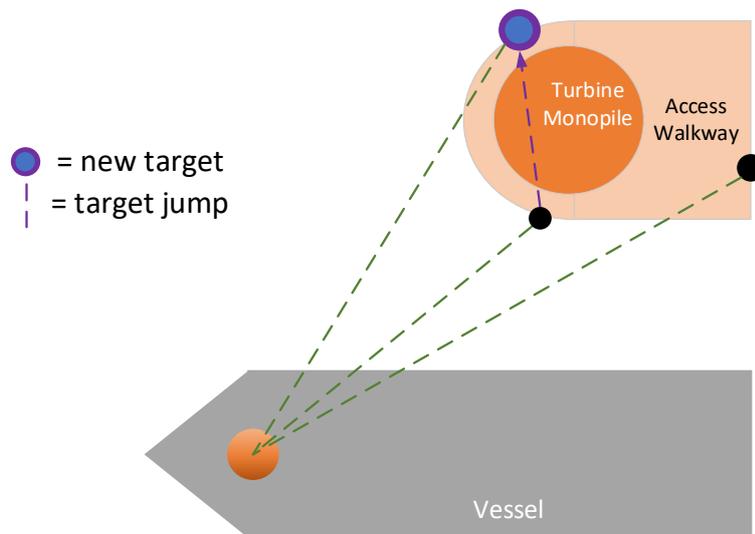
VESSEL IN FINAL POSITION

When the SDPO was looking to the reference system main view, he saw that the DGNSS were at the bottom on the edge of the median test line and that the laser reference had disappeared from the view (view range set to 5m). At this time, the DP system alarmed, “Reference prediction error Laser”, and, “Reference median deviation laser”. The SDPO informed the walk to work management team to standby. As the SDPO could clearly see that both DGNSS were operating well, he disabled the laser reference from DP. As expected the vessel started to accelerate towards the tower and the SDPO deselected the sway axis to stop the movement towards the wind turbine.

During the station keeping event, the maximum position excursion towards the wind turbine was around 2 meters and heading deviation around 2 degrees.

1. The fast acting response of the crew undoubtedly prevented this event from becoming more significant.
2. The planning of the use of position references is of key importance in such an operation where there is a relatively small target area such as a monopile of a wind turbine. The smaller the area, the more challenging the risk of target jumping becomes. The number and placement of targets is of paramount consideration.
3. The use of difference sensor technology may have avoided this event. For example, microwave position references.
4. The event report did not highlight the use of activity specific operating guidelines nor any change to DP status during the DP event.
