1 LTI: Hand injury during diving operations

2 Learning outcomes from a real time diver recovery

4 Inhalation of toxic fumes during hot work

5 UK HSE: worker fatally injured in oil drum explosion

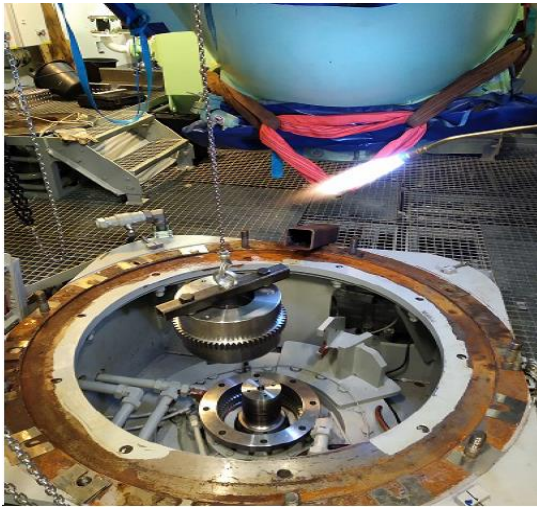
<p><i>Coupling hub during heating process</i></p>	<p><i>Section 2 of MSDS Sheet for anti-rust chemical used, which was identified subsequently as “Rust Keeper 555 (ADR)”</i></p>

In order to change out the thruster coupling, the component had to be heated to 120-150 °C. The temperature in the bow thruster room (not a confined space area) was 32-35 °C and the ventilation set up assessed in the planning was to mitigate the heat and provide some cool airflow through the room. The coupling was heated up and when it reached the required temperature, this led to a release of toxic fumes from the anti-rust chemical used on it.

Our member noted that a lack of knowledge of the spare part (thruster coupling) being coated with the toxic anti-rust agent, and subsequently lack of removal before heating and installation, lead to the intoxication of crew members. Ventilation was used for air cooling rather than toxic air extraction

Be aware of the possibility of toxic anti-rust agents and therefore ventilation should always follow a risk assessment process where identification of potential risks such as intoxication should be considered first.
