## 1 Fatality - explosive failure of corroded fire extinguisher

## 2 MSF: Tank corrosion

### 3 NTSB: Fire on laid up Dive Support Vessel

## 5 MSF: Engine damage after routine maintenance

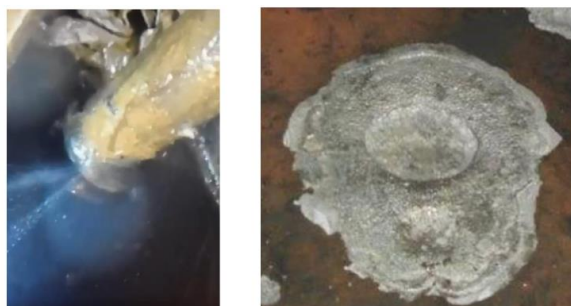
A pinhole leak was discovered in the structure beneath the sounding pipe. This allowed salt water to enter the space from outside the tank. The vessel was sent for repairs.

Initial investigation by the ship's engineers concluded that the striking plate at the bottom of the sounding pipe was missing. This allowed the brass weight to repeatedly strike the steelwork, damaging the paint coating and exposing the steelwork to corrosion.

- The tank had been inspected and maintained in accordance with company procedure;
- The brass weight of the sounding tape had damaged the paint coating on the striking plate and steelwork below;
- A corrosive chemical had been incorrectly disposed of and introduced to the tank, accelerating the corrosion process;
- The acid may have become trapped under bubbles of damaged paint, allowing concentrated corrosion over the short time;
- The combination of exposed steelwork and caustic solution destroyed the striking plate and steelwork below.

- Effective repairs were carried out onboard in collaboration with third party welders and divers;
- All crew were reminded of the importance of correct chemical handling – including safe disposal. On board a vessel, there are many different chemicals used; some of these chemicals pose a serious health risk with some being extremely caustic. These chemicals should be used in the appropriate and prescribed way and not misused;

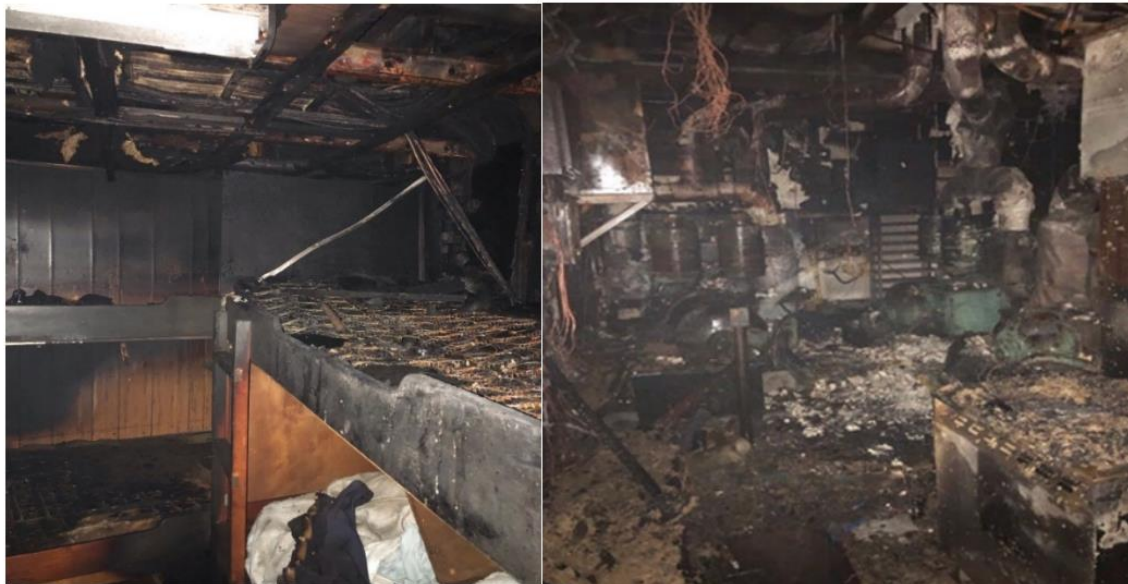
**Fire damage to living quarters (left) and generator room (right). (Source: Coast Guard)**

The NTSB noted that the *fire started in the generator room on the wall area common to the mess area*, and that the investigators *could not rule out the possibility of an electrical short as the potential source of the fire*

The National Transportation Safety Board determines that the probable cause of the fire aboard the DSV was an electrical short from an unidentified source located on the forward bulkhead within the generator room. Contributing to the undetected propagation of the fire was the lack of continuous monitoring of the vessel while it was docked at the shipyard.

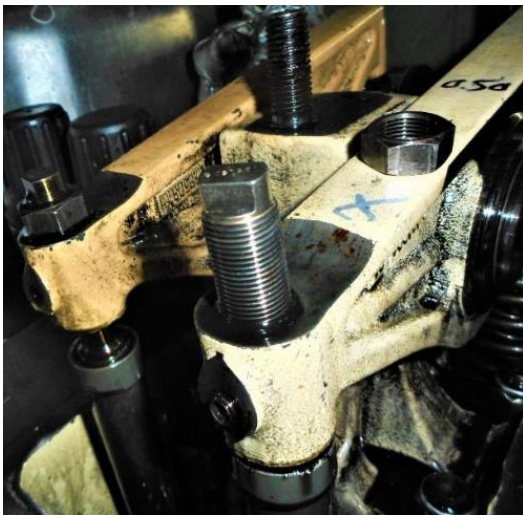
*showing rocker arm adjusting screw with locking nut removed / dismantled*

the locking nut of the adjusting screw from the exhaust rocker arm (that regulates the clearance of the exhaust valve) had become loose. The most likely cause of this is that when reassembling, the locking nut had not been tightened as per the manufacturer's requirements.

- Ensure that maintenance is conducted according to the manufacturer's requirements;
- After maintenance always carefully (double) check that all parts are properly (re-)assembled;
- Always check torque using a torque wrench as per manufacturers manual.

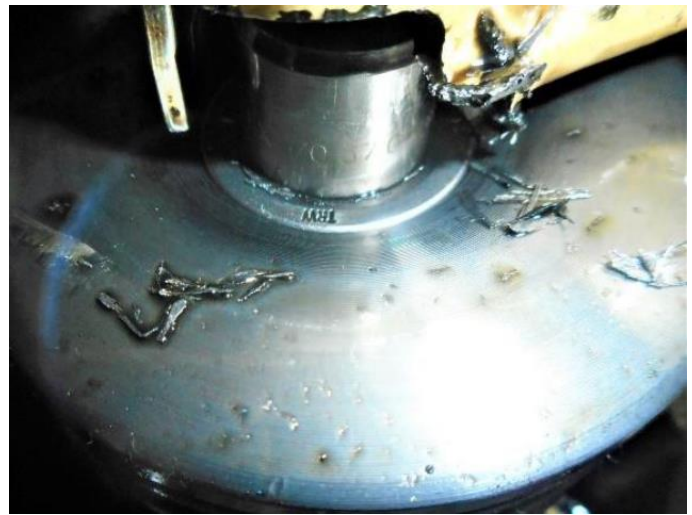
*showing partial destruction of the exhaust valve tappet tip, showing also the valve roto cap*

Upon inspection, damage was found in a valve gear assembly of a cylinder. Investigation showed that 86 running hours before the incident, valve adjustments had been carried out. When removing the cylinder cover, small metal particles and partial destruction of the exhaust valve tappet tip was found. The evidence available indicated that
