1 Failure of EGS valve stem on dive helmet

2 Dropped object during lifting operations

3 MSF: Potential dropped object

4 Dropped Object - door detached from TMS during dive

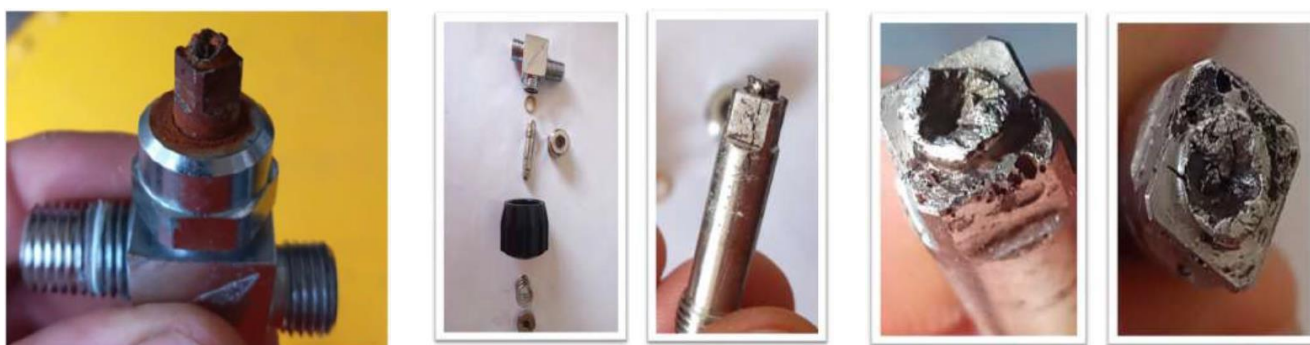
A dive technician stripped the valve and discovered the break to be located at the valve stem – where the threaded portion meets the square section. Both parts of the valve stem, adjacent to the break, were noted to be pitted and a fine hairline crack was noted. The failed component was replaced with a new spare. Following a gas leak and function test, the dive helmet was placed back into service. The failed component was sent ashore for further investigation.

The member arranged an independent laboratory review of the material to try and identify the root cause. The finalised laboratory report indicated that failure occurred as a result of pitting and stress corrosion cracking under the action of the chlorides present in salt water.

- Following its investigation our member took the following actions:
 - The company preventative maintenance system (PMS) was modified to require NDE dye penetrant testing of EGS valve stems for all base and field diving helmets at a minimum of 12 monthly intervals.
 - Internal instructions were issued stating that if the post-dive, inspection, or maintenance routines recommended by the

manufacturer highlighted any concerns, the relevant valve stem(s) should undergo immediate NDE dye penetrant testing. If any anomalies are then detected, the component should be discarded and replaced.

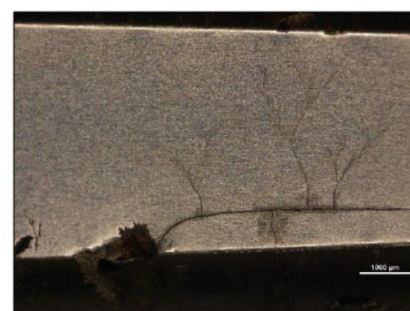
Since these measures were put in place our member has identified three additional valve stems with stress-like indications in the material. Note the pin hole in this example that our member detected in a rental asset.

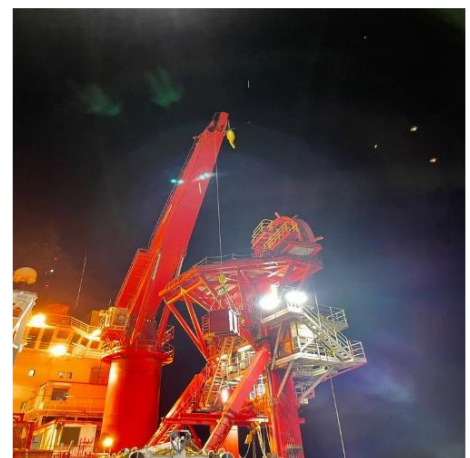
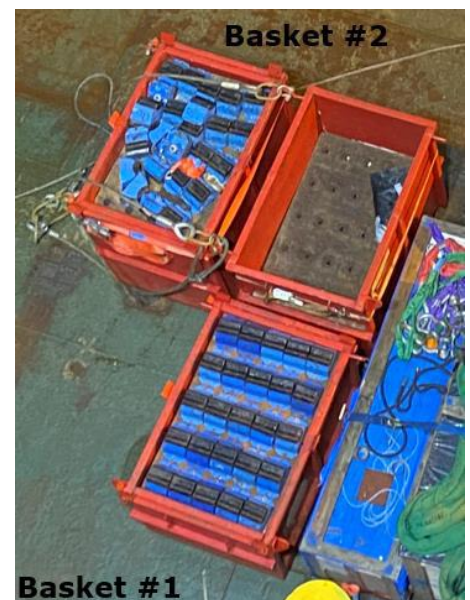
A part weighing 8.5kg fell over 15m from a pipelay tower to deck. The incident occurred when tensioner pads were being changed out on a Tilttable Lay System (TLS). The discarded pads were packed into two dedicated tensioner pad baskets on the TLS tower for transfer back to deck. The crane operator lifted a first basket and placed it in the landing zone on deck. When lifting the second basket, a higher boom angle was needed in order to clear the TLS. As the basket cleared the TLS, it started swaying. This movement was amplified after the basket hit the crane boom, causing a single tensioner pad to fall from the basket down to the main deck.

- The dropped object (tensioner pad) resulted from the excessive movement of an unsecured load;
- The change-out of tensioner pads was considered a "routine lift" and did not require a designated Lift Plan (with a specific slew path identified);

- The locking mechanism on the side door of the tensioner pad basket was found to be inadequate and could have quite easily sprung open.

- An alternate slew path with a high boom angle would have avoided the basket striking the crane and cause increased swing;

- A cover or net fitted to the basket would have prevented the pad being displaced.

- Check all lifting appliances, supports and baskets to ensure they are fit for purpose including that doors have secure locking mechanisms;
- Never overfill and always secure the load in open top containers;
- Crane operators and banksman should work together to identify the best possible routes for moving equipment around the vessel taking sea state/swell into consideration;
- The vessel bridge should always be consulted before starting lifting operations, to ensure the sea state and vessel movements are within limits and where practical a heading to reduce vessel movement is taken.

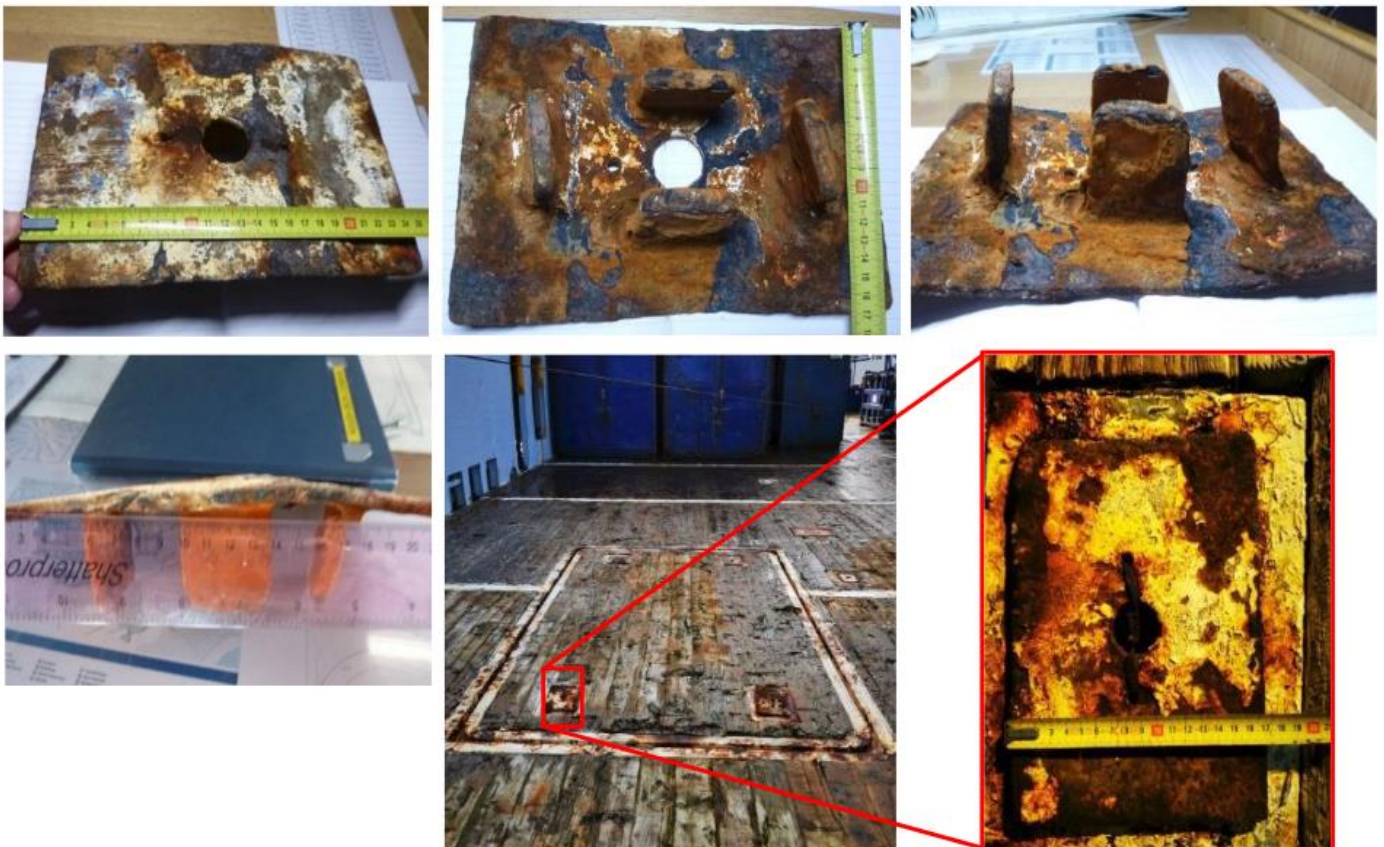
A metal plate of size 25 x 17 x 6cm, weighing 1.6kg, was found inside a forklift pocket hole on a 10' container when the container was landed onto a platform from a vessel. The MSF noted that the size and weight of the plate meant that this potential dropped object could have been life-threatening had it hit someone.

The MSF noted that *“one of the possible reasons that this particular plate may have been washed from its position within the main deck could have been that it was quite badly buckled or bent. This could have enabled water breaking onto the vessel’s main deck, to work beneath the plate to lift it.”*

Check pin post/lifting point plates, to ensure:

- that they are not buckled;
- that they fit correctly;
- that they can be secured appropriately.

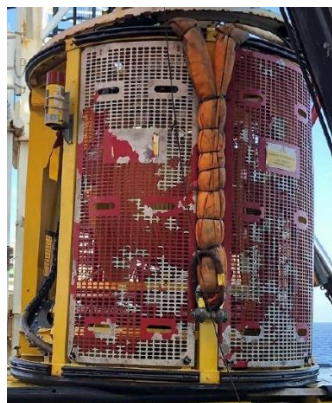
Showing a TMS door in place

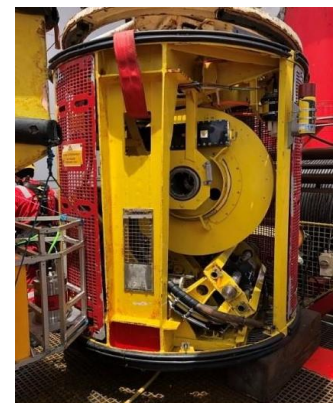
During offshore installation activities a Remotely Operated Vehicle (ROV) and Tether Management System (TMS) recovered to deck was observed to have a TMS door missing. The ROV team confirmed that the remaining doors on the TMS were attached. The aluminium TMS door (2m x 1m x 4mm thickness, approximate weight 15kg) is secured to the TMS frame with 2 pins on top of the door and 2 stainless steel latches on the bottom. In this instance, both the bottom latches failed allowing the door to detach from the TMS frame whilst subsea.

Our members’ investigation noted that there had been no check to confirm secondary retention was in place on the TMS doors as described in the company ROV Operations Checklists.

Showing a TMS door missing

- Check and ensure that all fixings are in good working order and that where required, secondary retention is used;
- Review pre-dive/post-dive checklists and add any additional items as required based on the existing condition of the TMS. Purely as an example, for *this specific TMS*, our member added “confirm that tie wraps are in place”;
- Consider the potential environmental, safety, schedule and legislative impacts from items dropped/lost at sea.

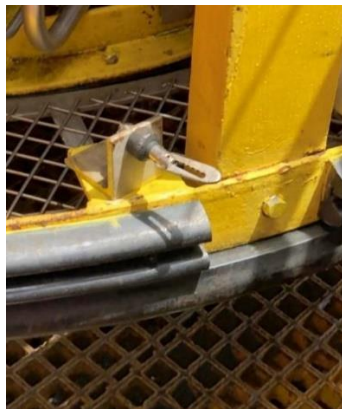
A bottom securing latch

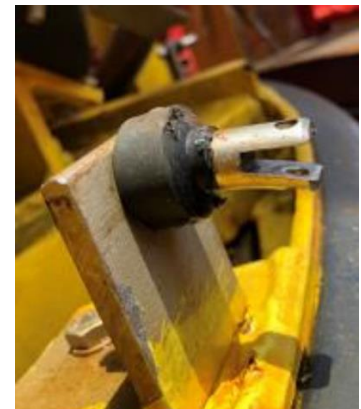
A failed latch

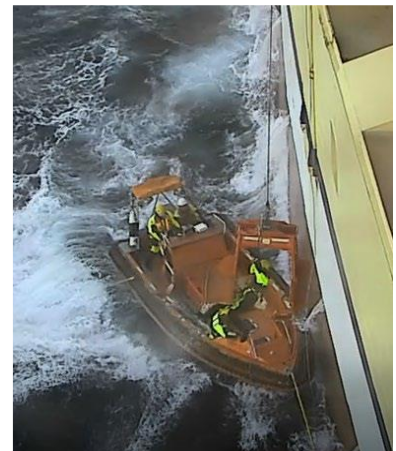
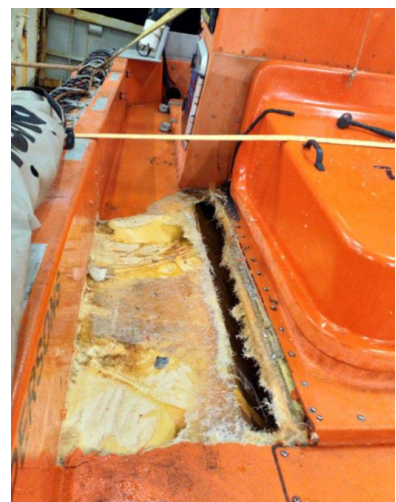
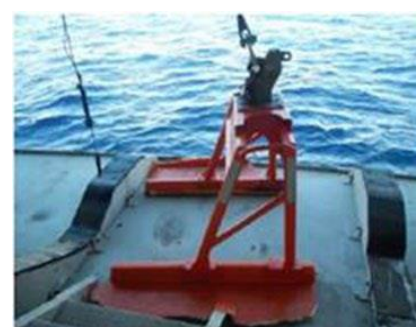
The incident occurred when the FRC was attempting to come alongside a vessel in good weather with choppy seas. During recovery, the complete lifting frame detached from the boat. No one ended up in the water, but one member of the boat crew was pulled up with the lifting frame and fell down into the boat. The crew member sustained only minor injuries. An investigation and checkup of similar boats revealed cracks around the lifting frames.

- Investigation uncovered cracks, delamination and potential weaknesses in the structure of the anchoring of the lifting frame on this type of FRC.

- Surface cracks are early signs, but it is very difficult to assess severity and any potential delamination as the attachment of the lifting frame is inside the hull.

In this case, a management decision was taken to cease use of this specific type of FRC and notify the manufacturer immediately. Members may wish to:

- Inspect all FRC, lifeboats and workboats lifting frames and attachments;
- Ensure that there is an appropriate focus on inspection and the detection of cracks in planned maintenance systems.
