1 Overheated transformer activated fire alarm

2 Mains extension melted – not fully paid out

3 Catering crew unfamiliar with firefighting systems and emergency stops

4 Incidents relating to hatches and doors

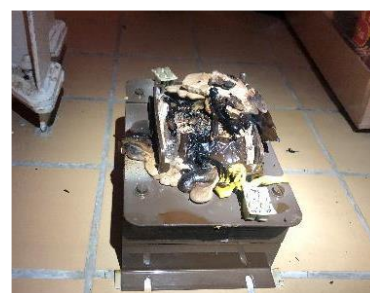
An under-rated transformer was installed, which causing overheating and thermal degradation of the transformer which subsequently tripped the breaker and activated the vessel's fire alarm. The incident occurred after the boiler in the mess room became faulty and needed replacement. The original boiler had an internal transformer within the unit, but an identical boiler was not available onboard. A new boiler was sourced and installed, along with a new transformer in the dry store switchboard cabinet.

During commissioning, the unit tripped, and a burning smell was noted. Subsequently the fire alarm activated, and the vessel crew were instructed to leave the accommodation and the fire team were deployed to investigate.

The vessel electrician had incorrectly calculated the rating of transformer required accommodate the new boiler. He applied the correct formula but input the wrong values.

- There was a positive and immediate response from the electrician and motorman to prevent further escalation;
- The calculation used to determine which transformer was needed was incorrect due to lack of concentration and a typo. This led to an underrated transformer being used. The actual load was 4 times the rating of transformer;
- The current should have been checked with a clamp-on meter during the initial switch on – this would have identified the overcurrent, giving the electrician the opportunity to switch off the boiler before the transformer overheated;
- Whilst there was poor ventilation to the transformer unit, this was not the root cause. It was also found that flammable material was stored outside and inside of the electrical cabinet.

Overheated transformer

- Review replacement of transformers in the vessel electrical systems to determine if replacement transformers are correctly rated;

- Complete an immediate inspection of all electrical cabinets, electrical equipment and panels to ensure there are no materials stored adjacent to them which could present a fire hazard. This should also be a focus of regular work place inspections;
- In dedicated storage areas, indicate **no storage zones** on the deck around electrical cabinets.

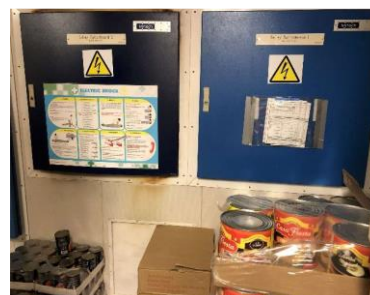
location of the switchboard cabinet where the transformer was installed

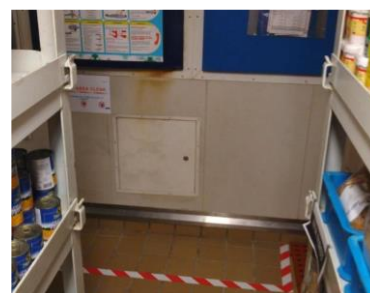
the switchboard, clear of flammable material with 'keep clear' zone marking in place.

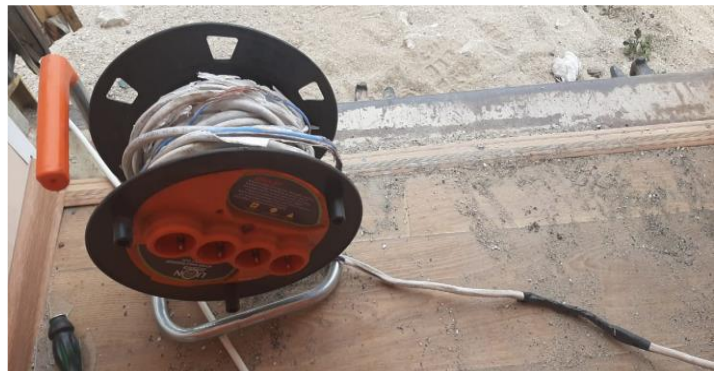
A mains extension cable melted during use. This occurred during cutting on deck on a vessel in dry dock; sub-contractors did not fully pay out an extension cable reel they were using to power their equipment. As a result there was induction heating and a melting of cable cord.

Additionally, it was noted that the extension cable was damaged and fixed by tape in places.

The sub-contractor personnel were unaware of the dangers of induction coil heating on mains extensions not fully unwound. The extension cable and reel had not been inspected by a qualified person before use, and given the fact that it had a taped repair, should never have been used at all.

- Thorough inspection of mains electrical cabling before use;
- Fully pay out coiled mains extension cables before use;
- Consider the use of specialist 110v electrical equipment.

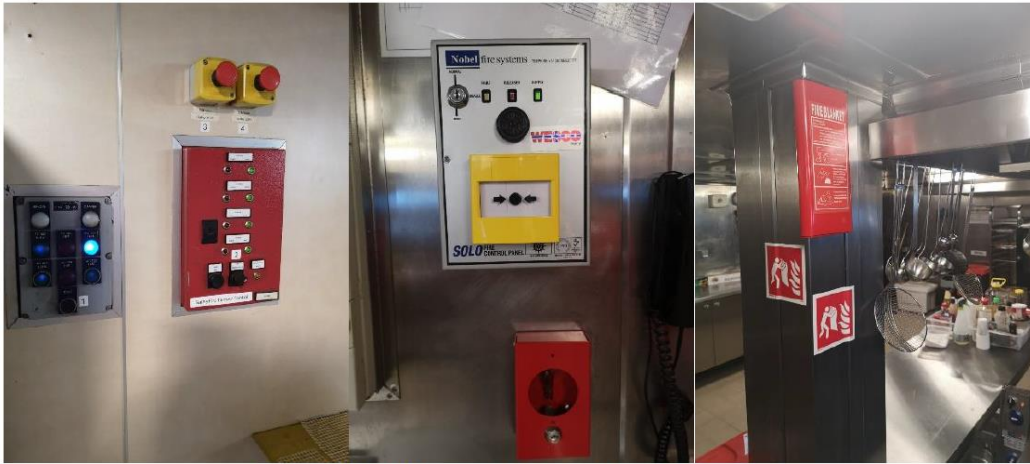
During a recent incident on a members' vessel, the catering crew were found to be unfamiliar with the firefighting systems and electrical equipment emergency stops.

Galley firefighting systems and emergency stops

The lack of awareness came to light when there was a water leak in the galley during testing of the vessel's fire pumps. The water leaked into electrical equipment and there was the potential for electrocution of the catering crew. The engine room crew were called and were able to safely isolate the galley electrical systems using the power supply emergency stops. The catering crew however were unfamiliar with the emergency stops.

- Ensure that all catering personnel complete all mandatory familiarisation on joining the vessel;
- Review levels of awareness with your catering crew and if required, cause catering crew to repeat appropriate familiarisation;
- Chief Stewards should regularly emphasize the location and use of galley firefighting systems and emergency stops in daily Toolbox Talks;
- Maintain galley fire drills, and if necessary, increase the frequency of galley-related fire drills to ensure all catering crew have sufficient awareness **and confidence** to use galley related firefighting systems and electrical emergency stops for galley equipment;
- Ensure emergency stops in the galley are fitted, operational, visible, easily accessed and marked appropriately.

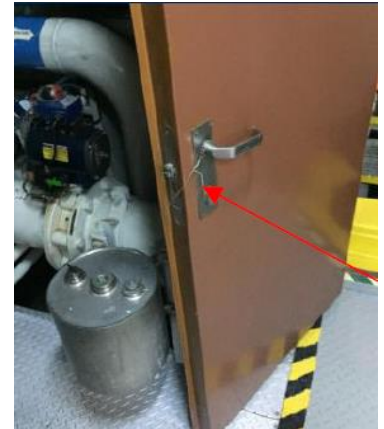
#1: Fire door held open by wire

A fire door in the engine room was observed to be wired open – it was being kept open with piece of wire.

- Our member notes:
 - Lack of safety awareness of the crew on the fire doors’ main purpose;
 - No-one challenged this unsafe condition;
- IMCA notes that the deeper question as to WHY the door was wired open, is not dealt with here. Was it for convenience? Was it that the engine room was overheating?

Fire doors should be kept shut because they need to be closed in order to prevent the spread of fire and smoke. Propping or wedging them open compromises the safety of the vessel crew, putting them at serious risk, should a fire occur.

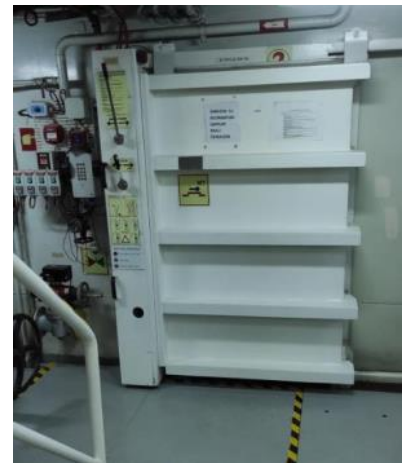
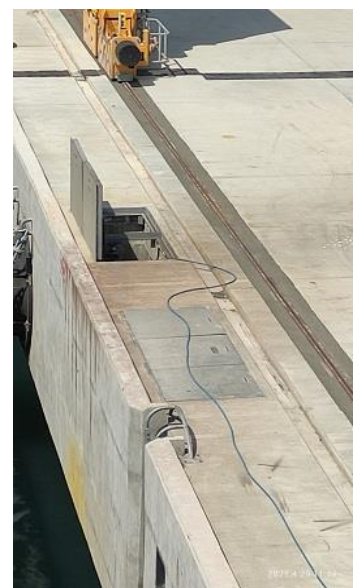
#3: Hatch left open on the quay – a successful intervention prevents a potential accident

Two open hatches on the wharf in close vicinity to the vessel were observed and reported by vessel crew members. There were no barricades or safety signs installed, despite the potential fall hazard inside from 2 m height. Following this intervention, the hatches were closed and locked by wharf service personnel.
