1 Failure of dive chamber overhead door centre pin

2 HSE: Catastrophic failure of marine loading arm

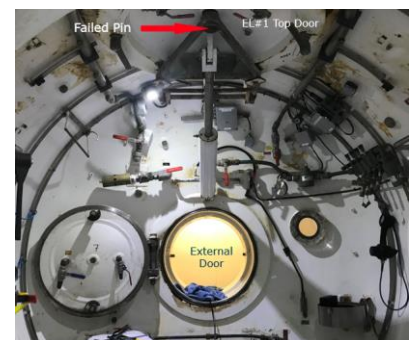
The entry lock

Minutes after a dive team transferred from the entry lock into the diving bell, there was a failure of the diving bell overhead door centre pin. A “bang” was heard and it was seen that components of the top door mechanism had failed.

The top door hinge pin, weighing 0.5kg, fell from its position approximately 1.8m to the deck of the entry lock; there was no-one in the entry lock at the time.

Doors with a similar design should be checked for cracks at the earliest opportunity.

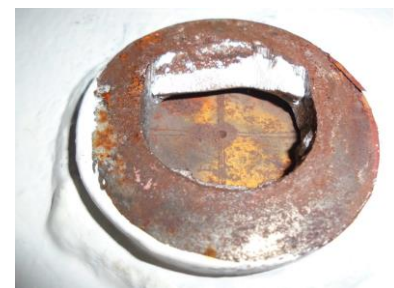
Our member estimates that the door would have been operated between 1500 – 2000 times per year for an average diving year (200-250 days diving), and suggests that the root cause is likely to be design related, corrosion and cyclic stress fatigue cracking (applied over many years).

Portion of pin remaining on door

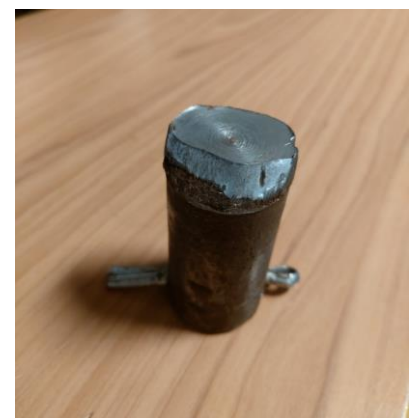
Broken Pin Section

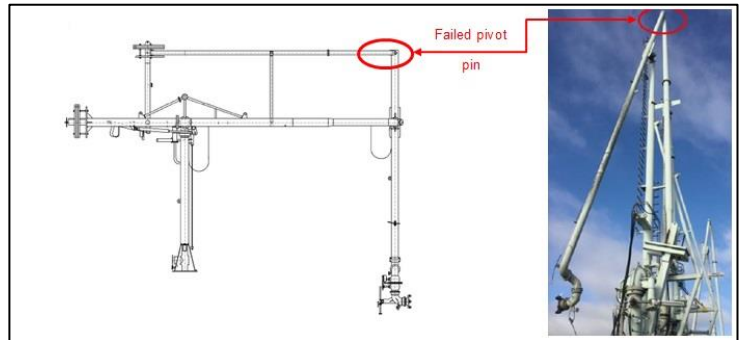
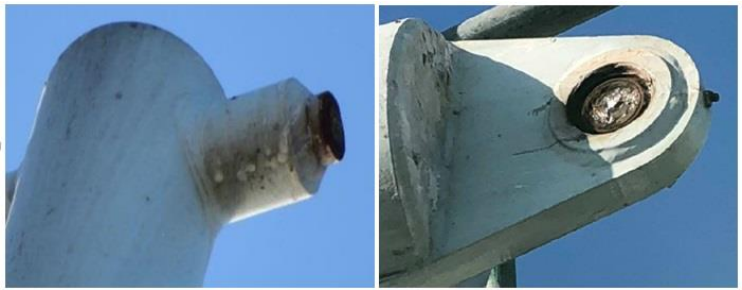
Investigation found that a failed pantograph pivot pin led to the resulting collapse of the arm.

The immediate cause of the failure was from corrosion of the bearing that led to a complete fracture, emanating from the circumference. The underlying causes were inadequate inspection and maintenance practices which had led to the corrosion. The failure to properly inspect and maintain an MLA could result in a serious risk of a joint failing, allowing the pantograph arm to fall – with the potential of causing death, serious injury or damage to process pipework.

There was no convenient means of accessing the pivot pin for inspection and maintenance. As a result, it had not been lubricated during servicing by several different contractors.

- As soon as practicable, inspect structural components such as the pivot pin and seals, ensuring they are in good condition
- Implement the updated inspection and maintenance programme, ensuring it is suitable and sufficient, and capable of detecting and remedying any foreseeable deterioration before it results in unacceptable risk
