## 1 Worn Components Create Unwanted Thrust

## 2 Environment Causes DP Incident

### 3 DP2 Supply Vessel DP incident

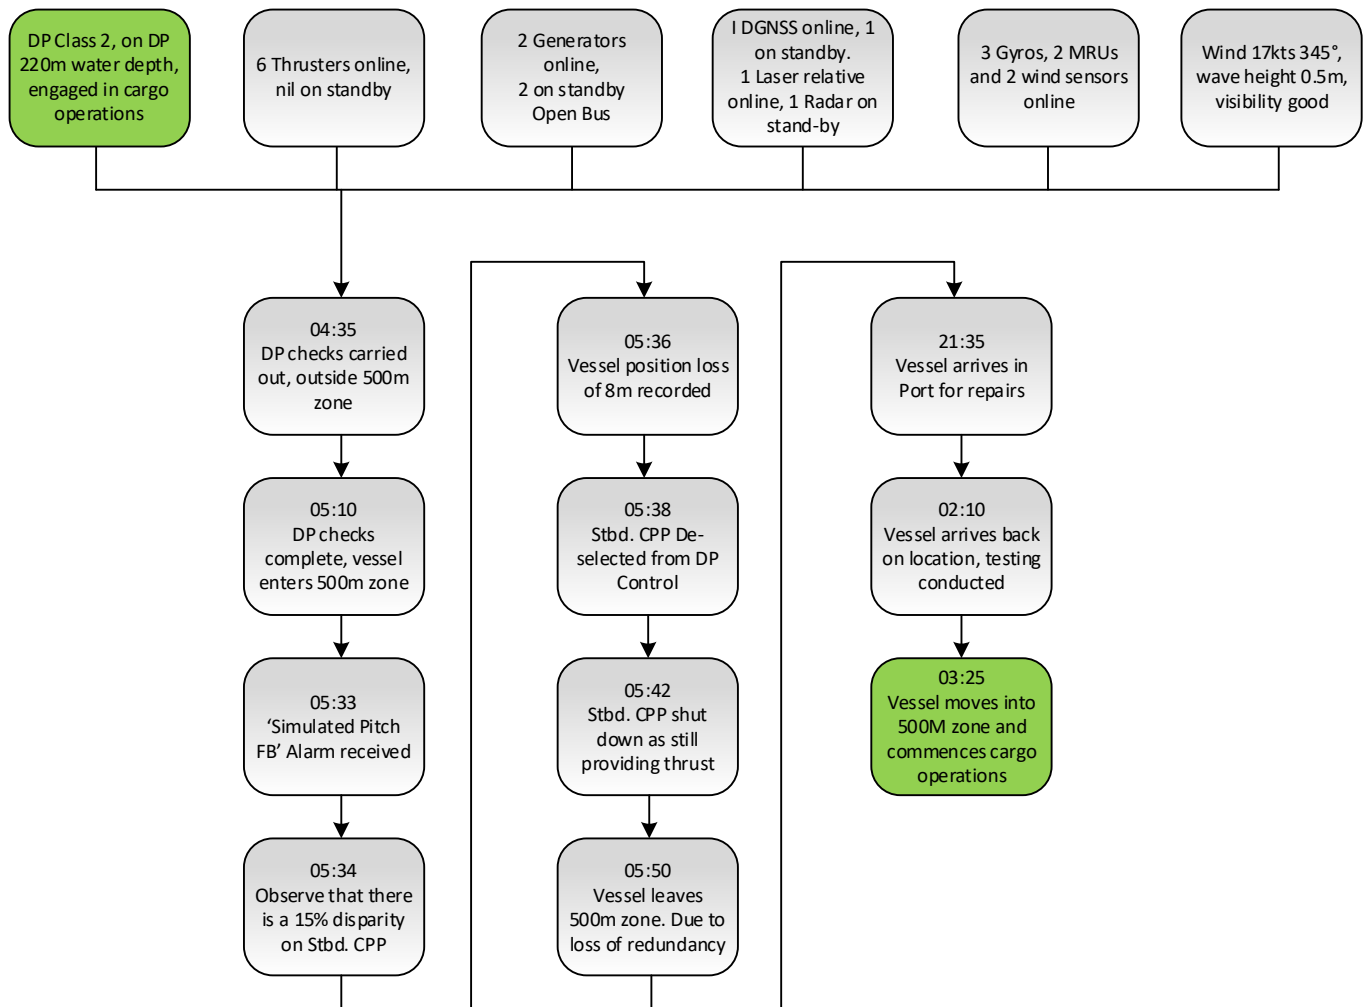
It was found that a worn key within the coupling of the step motor (providing feedback) caused unwanted travel of the thruster pitch. The vessel was forced to return to port to source a spare part, a 'used but good' part was located and fitted.

1. In most direct driven CPP systems there are some failures that can lead to uncontrolled thrust and the emergency stop needs to be employed by the DPO, before the excursion becomes too significant. DPOs should not hesitate to use the emergency stop on thrusters if thruster alarms indicate a thruster control issue.
2. Use of a “second hand” part might be acceptable as a temporary stop gap measure, provided that the part is still within specification.
3. This event highlights the need to annually check and test controllable pitch propellers.  
M 190 Chapter 4.0 Paragraph 4.10:

*“There are many ways in which a variable speed thruster can fail, but the failure effects are generally safe. For vessels with variable speed thrusters of proven reliability, it may be acceptable to carry out the control loop wire break tests on a rolling programme where all tests are carried out over a five-year period. **Controllable pitch propellers should be tested annually.**”*

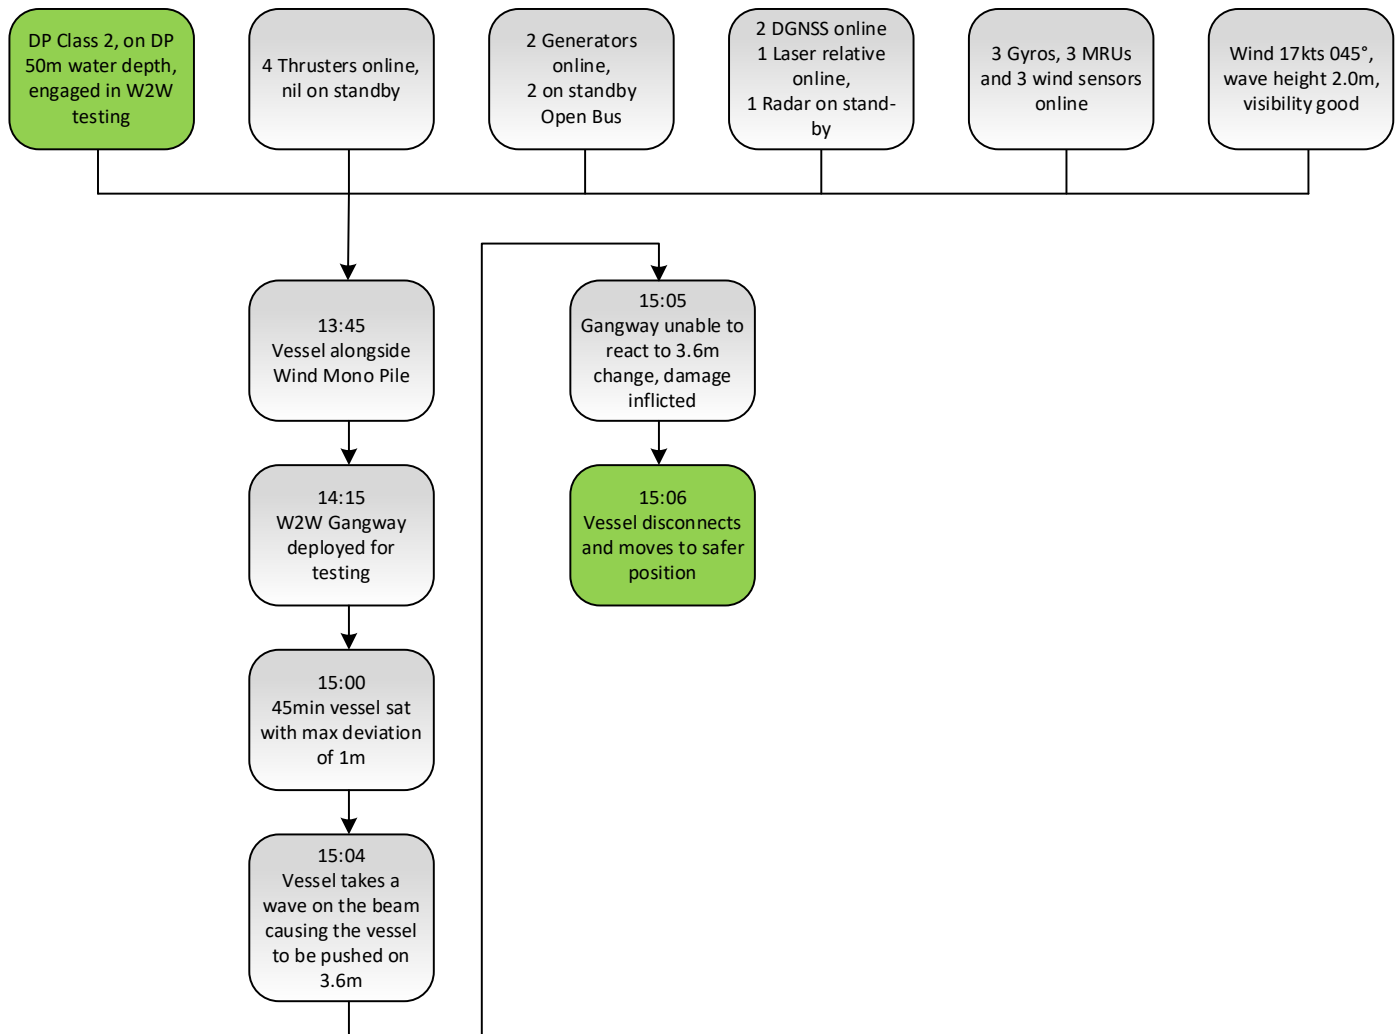
The wind monopile is only equipped with a single landing point. Several DP setups were tested to define the optimal vessel heading and performance.

The capability of the DP System with the present set-up was not as expected during the W2W operation.

When the sea was on the beam of the vessel, earlier experience had shown that operating the aft azimuth thrusters in Bias was causing larger rolls of the vessel than when operating the aft azimuth thrusters in Variable mode. This applies for a significant wave height, Hs 2m and upwards, therefore variable DP control was selected.

1. Larger waves and wave trains are commonly reported to be the cause of excursions/loss of position, therefore this must be considered within the planning and the ASOG. Operating with beam seas (and drift on) should be avoided when this can be expected.
2. The selection of Bias mode always requires careful consideration, Bias mode may have reduced the push off, provided the azimuth thruster athwartship was thrusting into the weather.

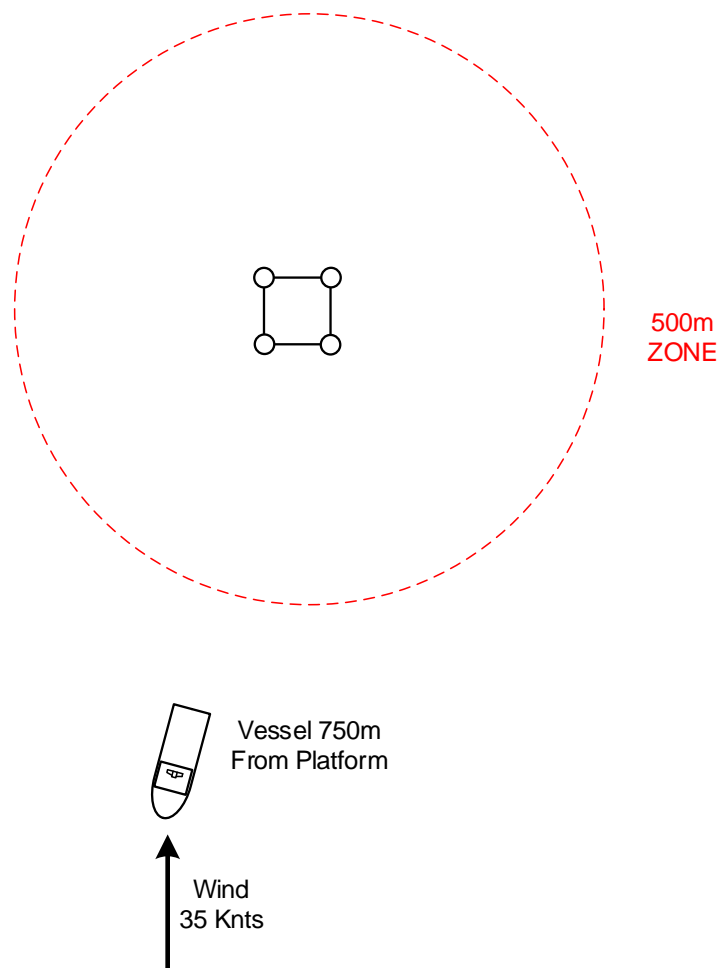
Note that the vessel was upwind of the platform and in a 'Drift on' position. The area was difficult to find a safe drift off position due to location of several other platforms and sandbanks with shallow water.

**Figure 1 - Vessel on stand-by outside 500m Zone**

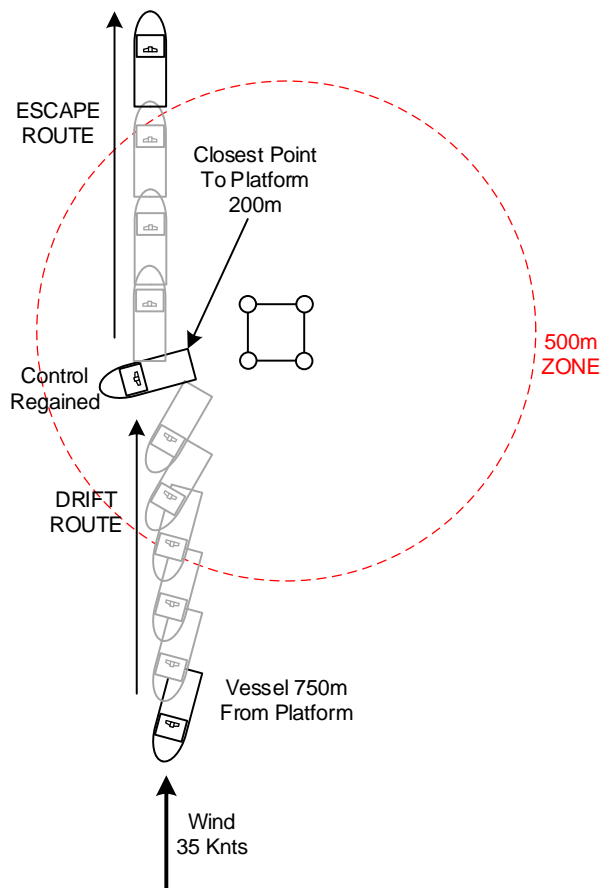
Whilst carrying out 'daily checks' on the running engine the engineers accidentally activated the emergency stop, this resulted in an immediate blackout. The vessel started to drift towards the 500m Zone and it was observed that the wind speed was increasing. As shown in Fig 2 below.

**Figure 2 - Direction of Drift**

As the vessel started to drift, the standby generators started and connected, however blackout recovery was a manual process that required re-setting of breakers and starting of critical machinery. As a precautionary measure an anchor was deployed that held the vessel until full manoeuvring control of the vessel could be gained. The anchor held the vessel 200m from the platform and once thrusters were back in control the vessel exited the 500m zone.
