1 COBRA bailout system – guidance note

2 Acetylene quad fire on quayside

3 Descending Stairs Safely

5 Fault in high voltage equipment

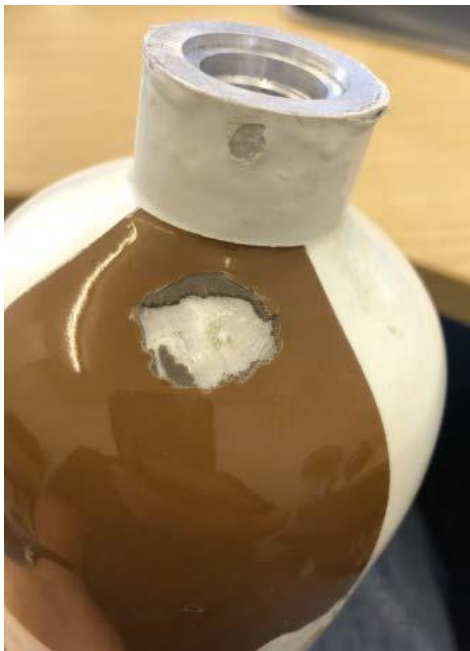
Users have reported blistering and flaking of the lacquer on the cylinder exterior, and premature, excessive corrosion on the exposed aluminium at the cylinder neck, as seen in these images:

Flaking External Lacquer

- Blistering and flaking
 - JFD has investigated and worked closely with the cylinder manufacturer (Worthington Industries) who have categorically stated that flaking of the lacquer is a known but trivial characteristic of composite cylinders. The typical cause is due to air, which is trapped in the composite matrix during manufacture, being forced out during cylinder charging. It is thought that use in a hyperbaric environment can cause this issue to re-

occur due to helium migrating under the lacquer over a period of time and then expanding when the set is removed from the dive system.

- JFD advises users to check the external condition of the COBRA cylinders every time the COBRA set is removed from the dive system for maintenance, recharging or any other reason. If the cylinder condition is deemed questionable, a replacement should be fitted and the cylinder inspected by an IDEST facility before re-use.

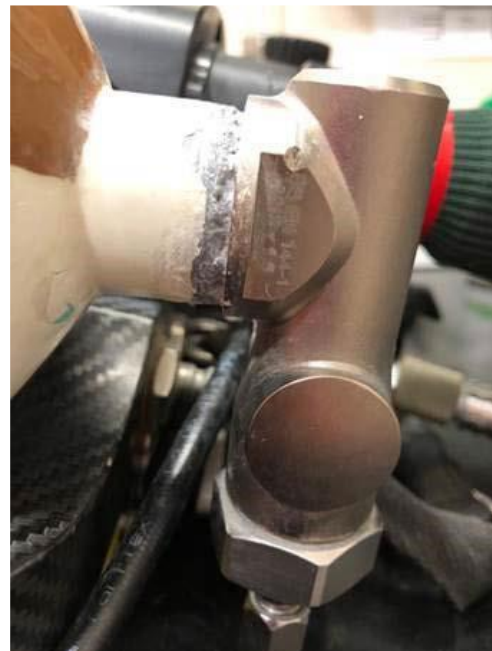
Excessive Corrosion at Cylinder Neck

- Premature, excessive corrosion
 - JFD carried out an evaluation of the cylinders in question which were certainly corroded beyond what was acceptable for the time in service and, in fact, subsequently failed inspection at an IDEST facility. JFD has contacted the manufacturer to investigate the possibility of a problem with this particular batch of cylinders. To date, the manufacturer has not responded with any information. Your ongoing understanding and support in this matter is much appreciated.

- Additionally, JFD are currently investigating the possibility of supplying a different brand of composite cylinder which has a stainless steel liner. This should eliminate all corrosion issues.

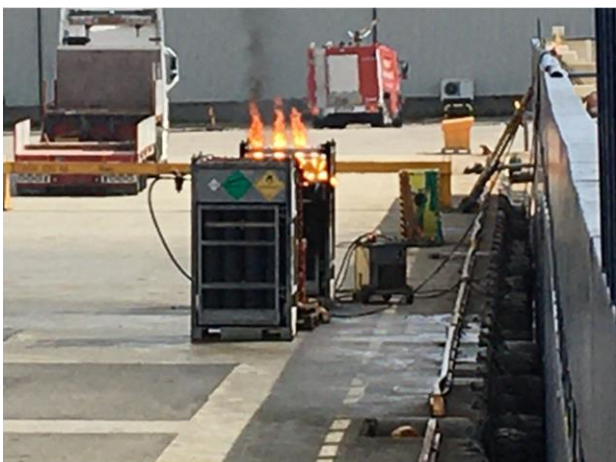
Acetylene quad burning

At 16:10 the firewatcher noticed fire coming from the top of the acetylene cylinders and informed the vessel bridge. The marine crew immediately contacted the local fire bridge and mustered all the crew into the galley. The local fire brigade arrived and applied water for approx. 10 minutes before pulling back to a safe distance of 300 meters allowing the acetylene quad to steadily burn.

- Ensure thorough pre-use inspections are performed on all oxygen/acetylene equipment;
- Ensure there is an appropriate storage area for gas quads on the quayside;
- Check carefully, your emergency response procedures for gas cylinder and gas quad fires.

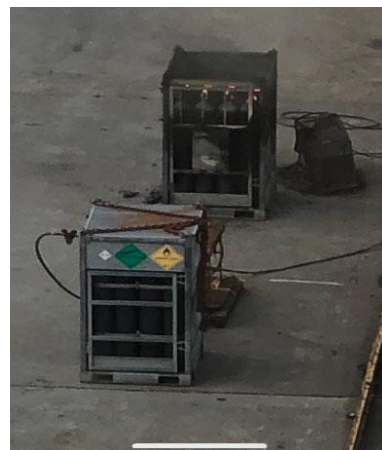
Acetylene quad fire (almost) extinguished

At 20:15, on recommendation from the emergency services, all non-essential personnel were evacuated via the Port lifeboat and transferred to a rescue boat and then taken ashore to a safe location for the night. The acetylene quad was allowed to burn off through the night and following further cooling with water the quad was lowered into the sea to bring it to ambient temperature. The quad is currently available for further investigation.

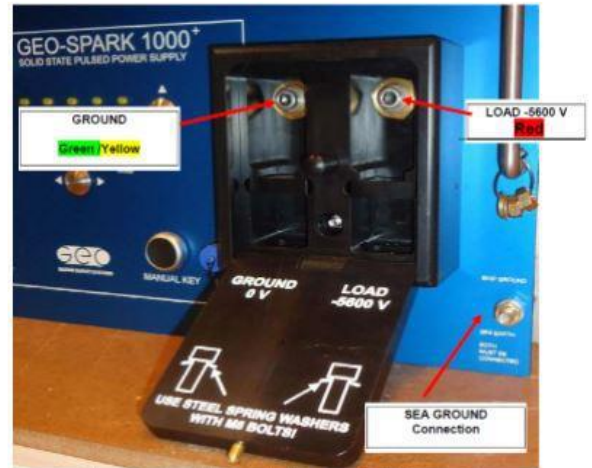
A serious fault was discovered in high voltage (-5600 V) equipment; the fault caused sparks to be observed across the high voltage terminals. Portable seismic survey “sparker” equipment was mobilised on a vessel. During initial tests of equipment, a spark was observed on the -5600 V High voltage terminals.

- This issue presents if the terminals are loose. They were tightened but the issue persisted;
- The incorrect washer type was used on the high voltage terminals. The manufacturer recommends conical spring washers. Standard split spring washers were used instead on the terminals. Also, a specific brass flat washer is recommended by manufacturer;
- After servicing by the manufacturer and feeding back the details of the fault observed, the manufacturer confirmed the bolts on the high voltage terminals were not threaded all the way to base of bolt. As a result, if incorrect thickness washers were being used this would not allow the terminals to be fully tightened;
- Three days had been planned for training. Owing to delays caused by poor weather only three hours was available for training – there was *perceived* pressure to get the job done in a rushed way.

- Ensure crew working with high voltage systems are trained and competent to work on the respective type of system;
- Ensure crew are familiar with risk assessments and safe systems of work for the type of equipment they are working with;
- When a safety issue presents on a high voltage system “STOP WORK”, isolate the power and report it to the appropriate authority;
- Report and investigate in a timely way: the delay in reporting this incident led to issues during the investigation. Crew could not remember the detail due to extended period of time. Immediate investigation post-incident is extremely important to ensure accurate information can be collated on what happened from all witnesses.
