1 US Coast Guard: Wire rope terminations

The United States Coast Guard (USCG) has issued [Marine Safety Alert 04-21](#) relating to wire rope terminations. The Safety Alert addresses the importance of verifying the condition and manufacturing of wire rope terminations used in various systems that utilize wire rope in a load-handling capacity (e.g., lifesaving appliances, cranes, lifting slings).

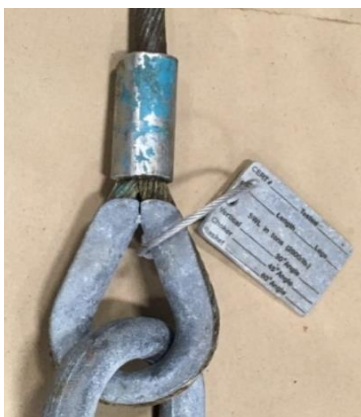
Fig. 1 This fitting has a uniform appearance

- Visually examine wire rope terminations for abnormalities that may indicate improper installation (Figure 1 shows a crimp with a uniform appearance, Figure 2 shows out-of-roundness, and Figure 3 shows ridges created by over-crimping);
- Compare fitting dimensions against the manufacturer’s specifications/tolerances for the completed fitting (i.e., does the length and diameter fall within fitting manufacturer specifications);
- Verify through documentation related to the manufacturing of the assembly that the materials were properly selected and that the termination type does not reduce the SWL of the wire rope below the minimum safety factor for the type of service.

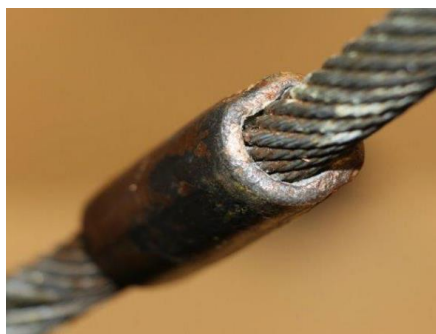
Fig. 2 Completed fitting is not “round” nor within manufacturer specifications

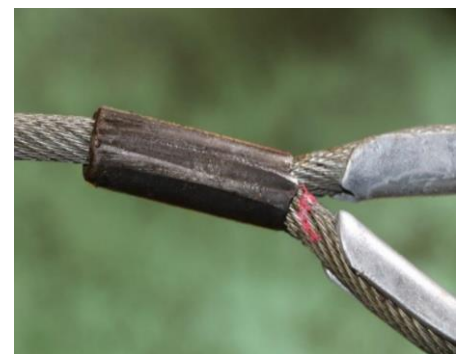
Fig. 3 Fitting is deformed with “ridges” of extra material present from over-crimping

IMCA notes that over-crimping can also be caused by the incorrect crimping die being used during manufacture. Ensure that all wire ropes and their terminations are inspected by a competent person prior to being used.

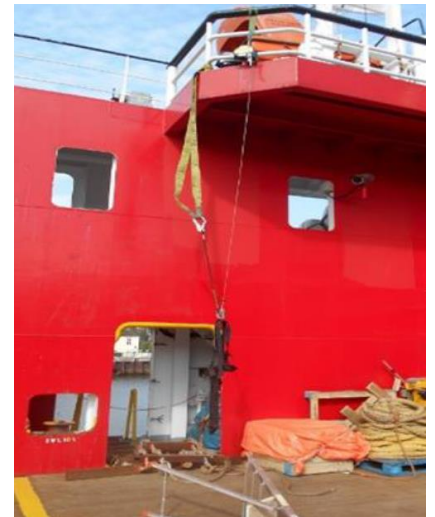
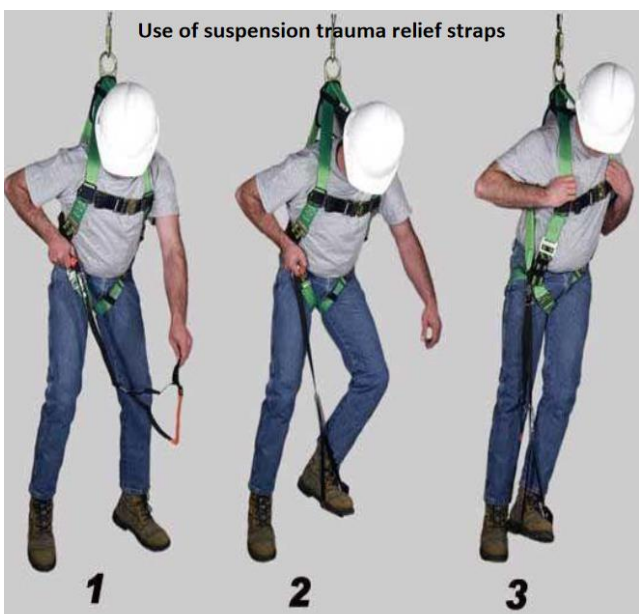
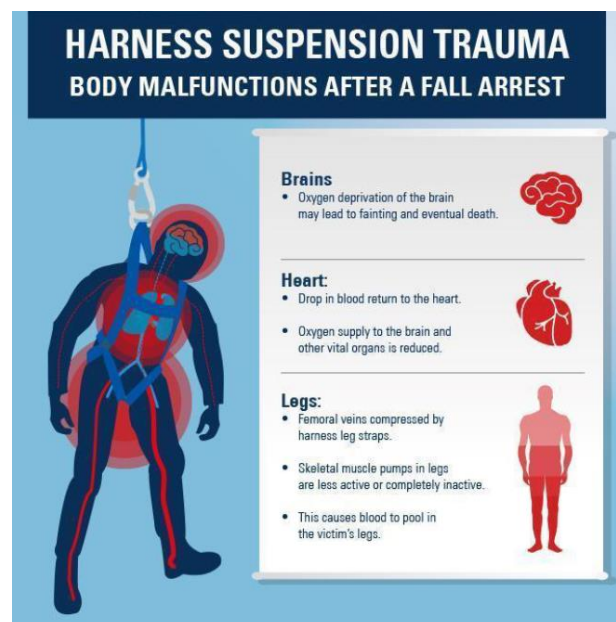
When suspended in the harness, the straps around the legs and limbs may have obstructed the blood flow, as indicated in the graphics on the following page, which is commonly known as suspension trauma.

- Performing drills and exercises to a realistic scenario is of course essential to ensure crew can act promptly and effectively in emergency situations. **However, the risks of such exercise should always be carefully assessed;**
- The risk of trauma from being suspended in a harness can be effectively reduced by using suspension trauma relief straps after falling into the harness, this places the weight of the body on the feet while awaiting rescue;
- Consider also the reverse scenario: what happens if someone falls overboard during a Man Overboard Drill, or if a real fire breaks out during a fire drill?
